FINAL REPORT
ON THE ACCIDENT OF 24 SEPTEMBER 2003
IN LUXEMBOURG
TO THE LUXAIR EMBRAER E145
REGISTERED LX-LGZ

Final issue: December 2010

Report N° AET-2010/AC-01

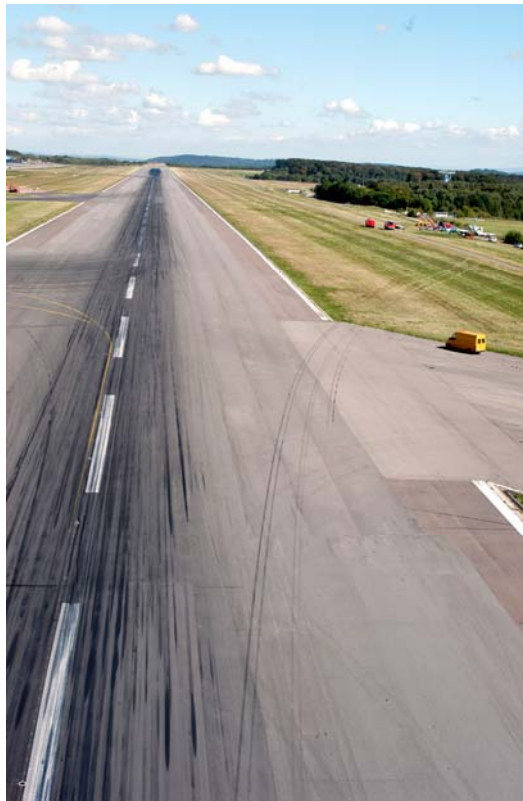
Figure 1. Tire marks on the runway

Rubber marks from all tires were visible throughout the roll-out phase, some more pronounced than others. Immediately apparent were the rubber marks from the nose gear. The aircraft departed the runway in a right skidding motion, which was reversed in the grass area.

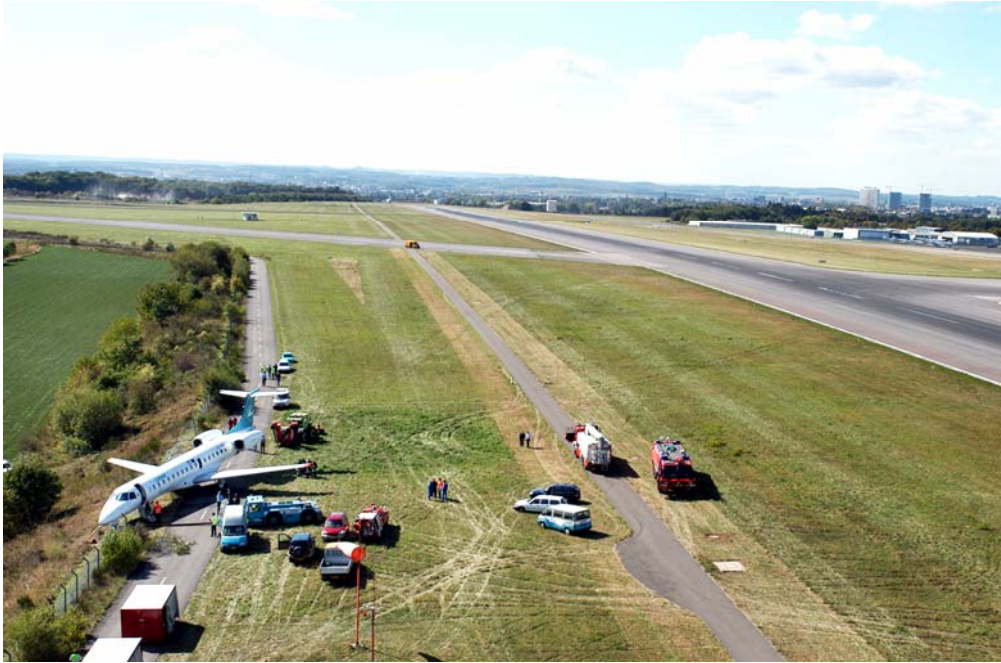
Figure 2. Aircraft was arrested by the airport boundary fence

The aircraft landed on RWY 06 and 5 seconds after touch down the aircraft veered to the right and departed the runway into the grass area. It was stopped by the airport perimeter fence on the edge of a downslope embankment.

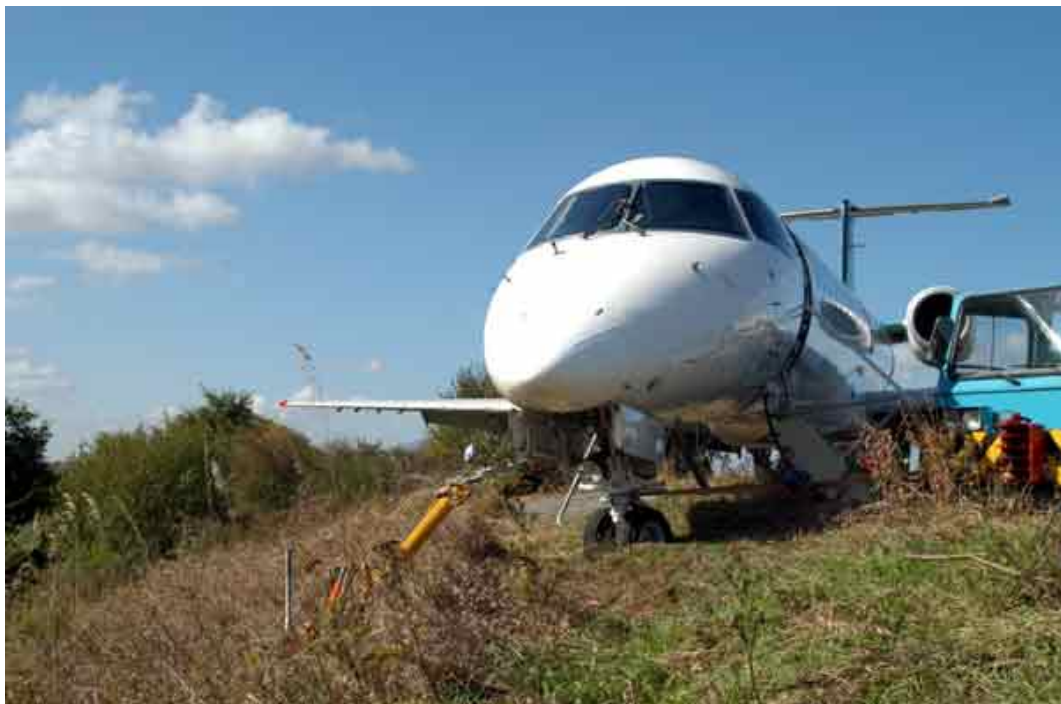
Figure 3. Close-up view of aircraft halted by fence

The aircraft was severely damaged on its RH side, the fuselage being punctured in several places, the whole leading edge of the RH wing was damaged when it knocked down the fence posts and some flap damage occurred as well by the posts and the fence sliding underneath the wing.

The nose landing gear remained pointed to the right at a substantial angle. EMBRAER analysed the skid marks and estimated the wheel angle between 30-40°.

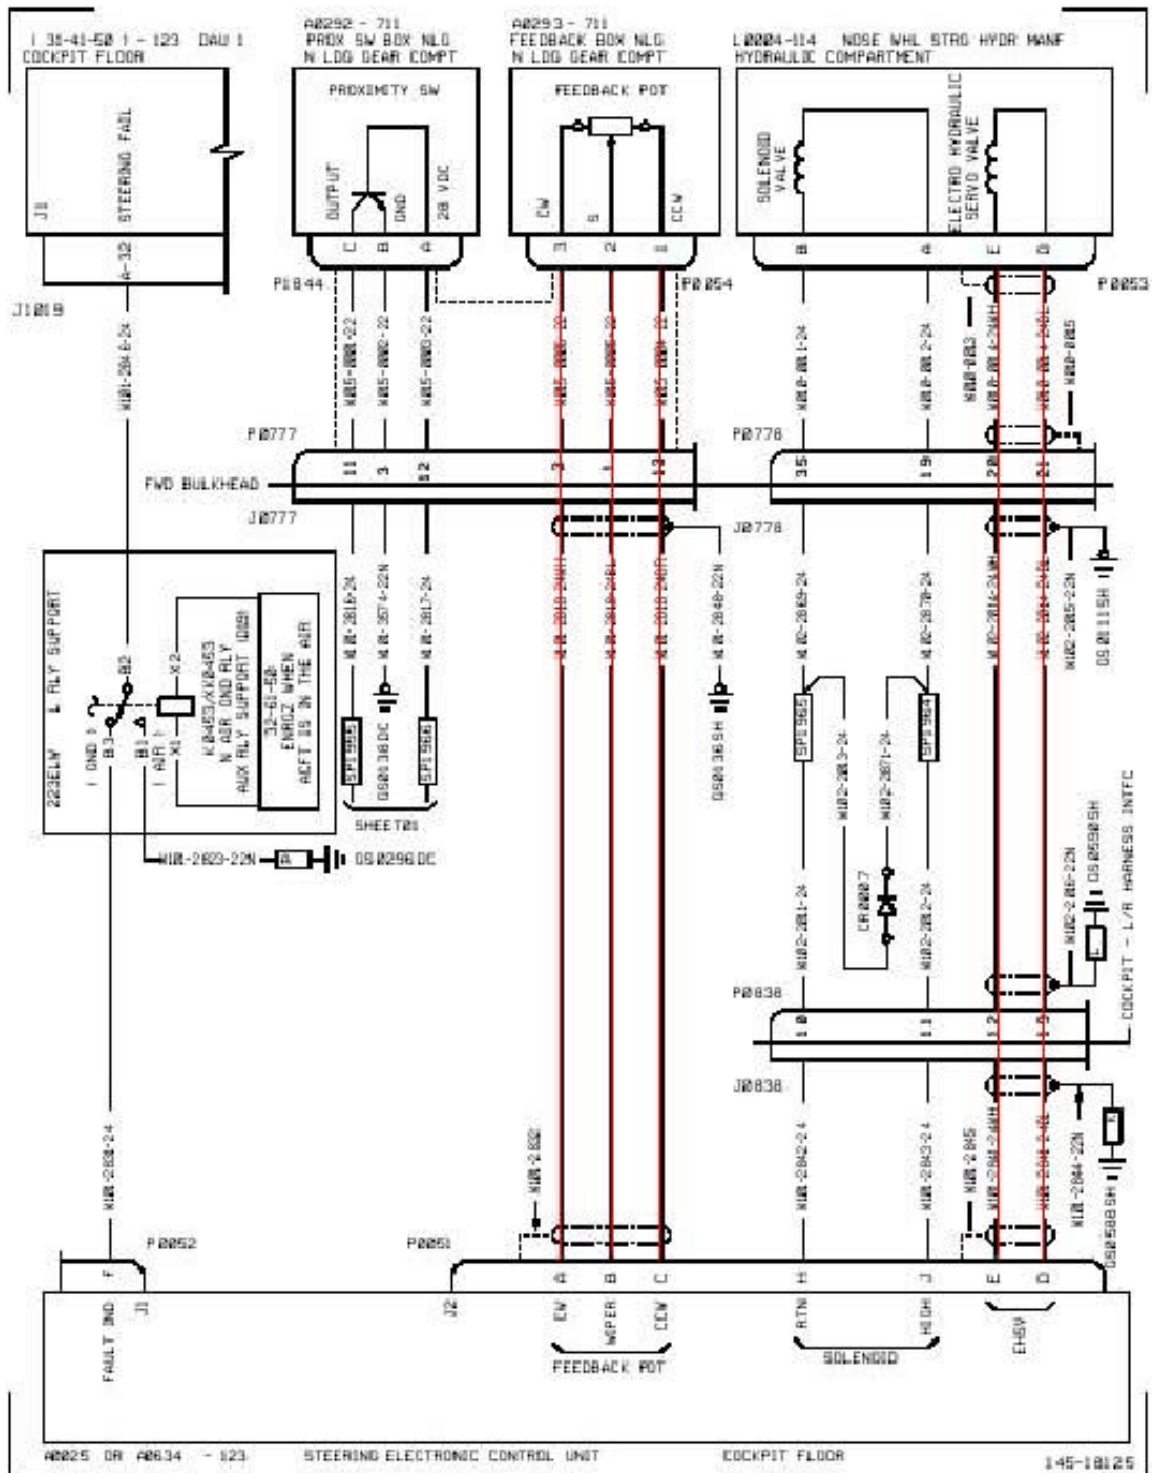
Figure 12. Harness connections

Connector P0051 (SECM) / connector P0054 (Feedback potentiometer)
 Connector P0053 (Hydraulic Manifold) / Ground

No discrepancies were found.

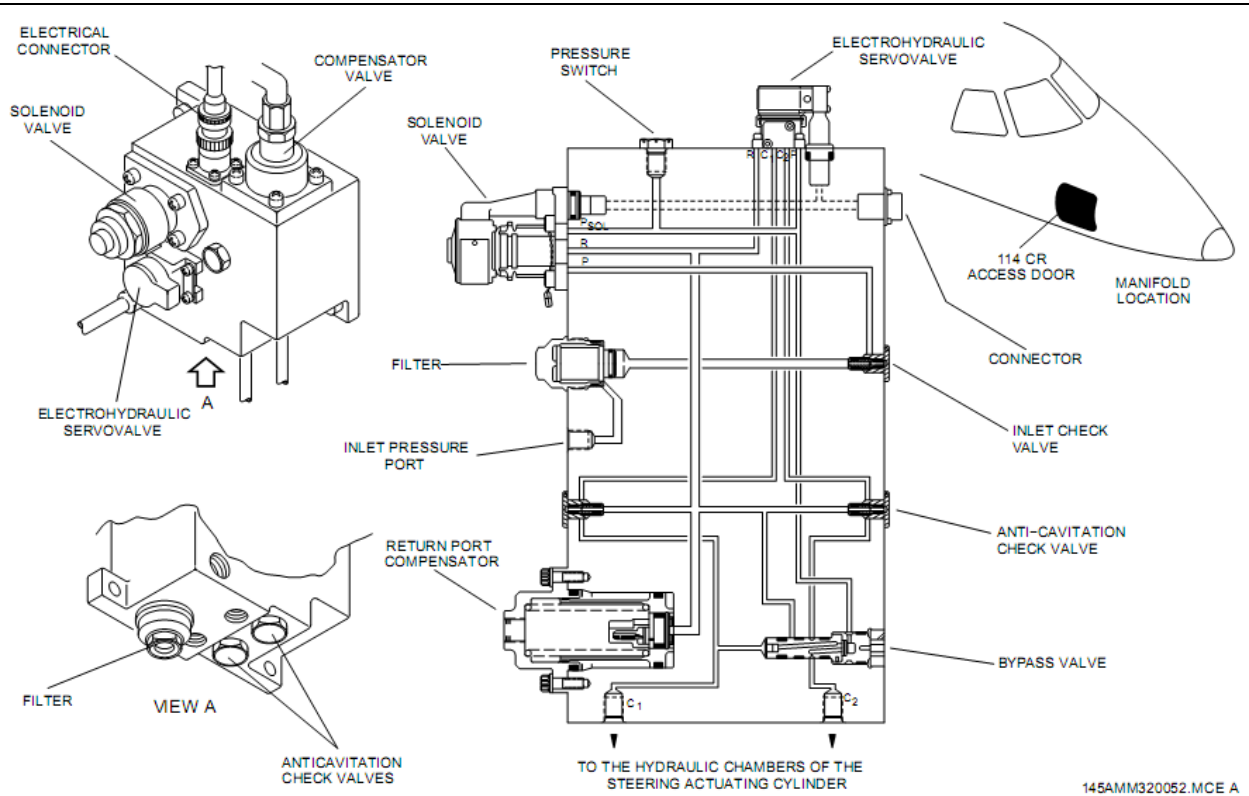
Figure 15. Hydraulic manifold assembly

During the internal leakage test it was noted that the Electronic Hydraulic Servo Valve (EHSV) P/N 22253282-103 S/N 102 pressure was fluctuating ± 100 psi around neutral. This has been considered to be an anomaly and was specified in the test record. A first reaction was that the EHSV would get an unstable flow which might result in an oscillating nose gear.

The manifold was disassembled, witnessed also by an FAA inspector, for a precautionary visual inspection for any abnormalities. The only finding was that the inlet check valve (P/N 72900-301) cap retention fingers had all four broken off, but retained in the cavity. As implied above, the check valve was still functioning properly during test. No secondary damage was noted in the Nose Wheel Steering assembly as a result of the cap failure.

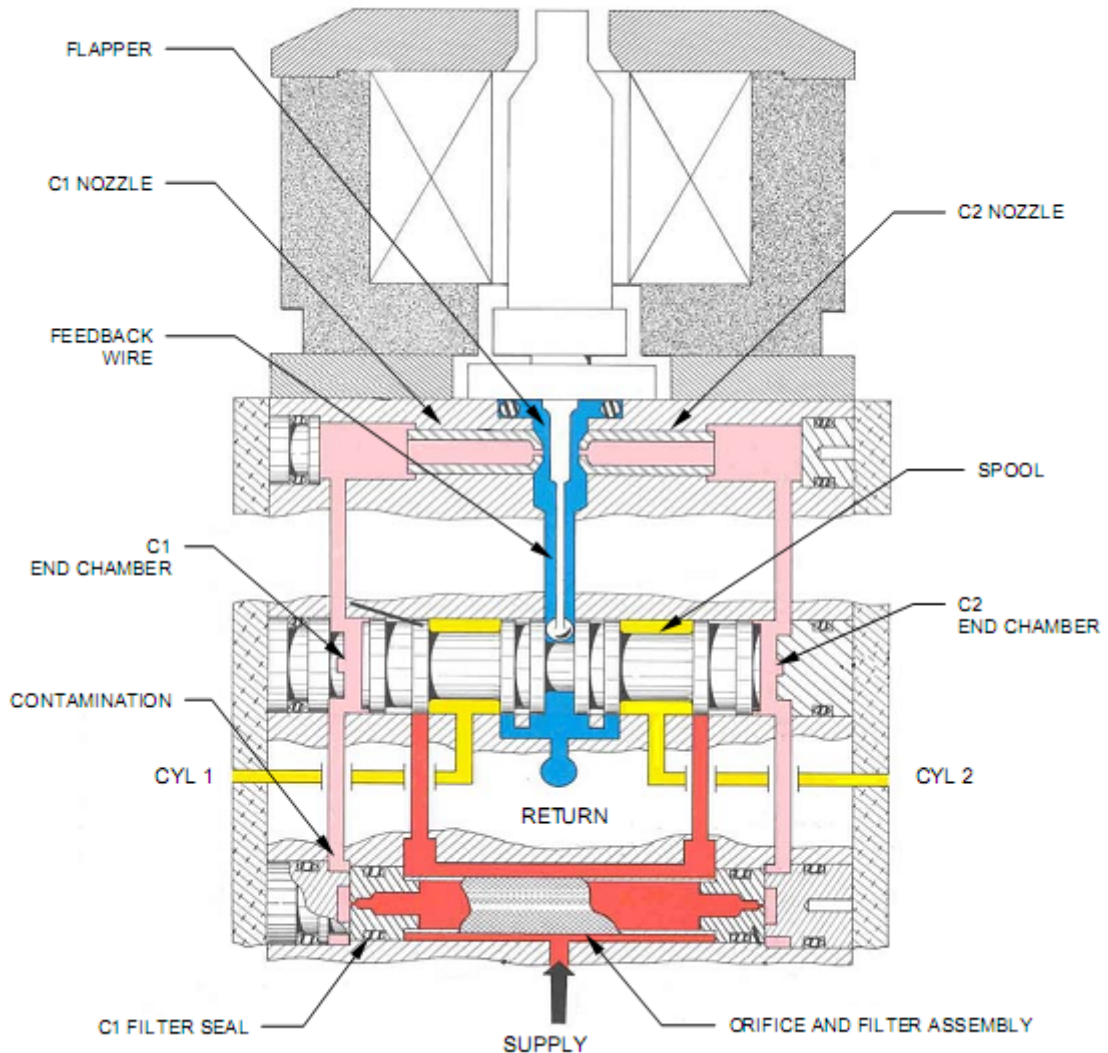
Figure 17. Hydraulic schematic showing location of contamination

- Functional check revealed that the unit was not operating correctly
- Low internal leakage indicated a restriction in the first stage.
- C1 nozzle behaved as if blocked, however, no contamination was recovered from the C1 nozzle when the unit was disassembled
- Rubber-like contamination was found in the C1 first stage cavity upstream of the C1 nozzle
- Damage (nibbling / extrusion) was found on the C1 filter seal
- Material composition of the contamination was found to be consistent with the C1 filter seal
- Filter bore was found to be oversize by 0.0018 inch
