FINAL REPORT
ON THE COLLISION BETWEEN A
CARGOLUX OPERATED BOEING 747-400F
REGISTERED LX-OCV
AND A MAINTENANCE VAN
ON RUNWAY 24
AT LUXEMBOURG AIRPORT (ELLX)
ON 21 JANUARY 2010, 11:53 UTC

DATE OF ISSUE : 10 DECEMBER 2012

Report N° AET-2012/AC-01

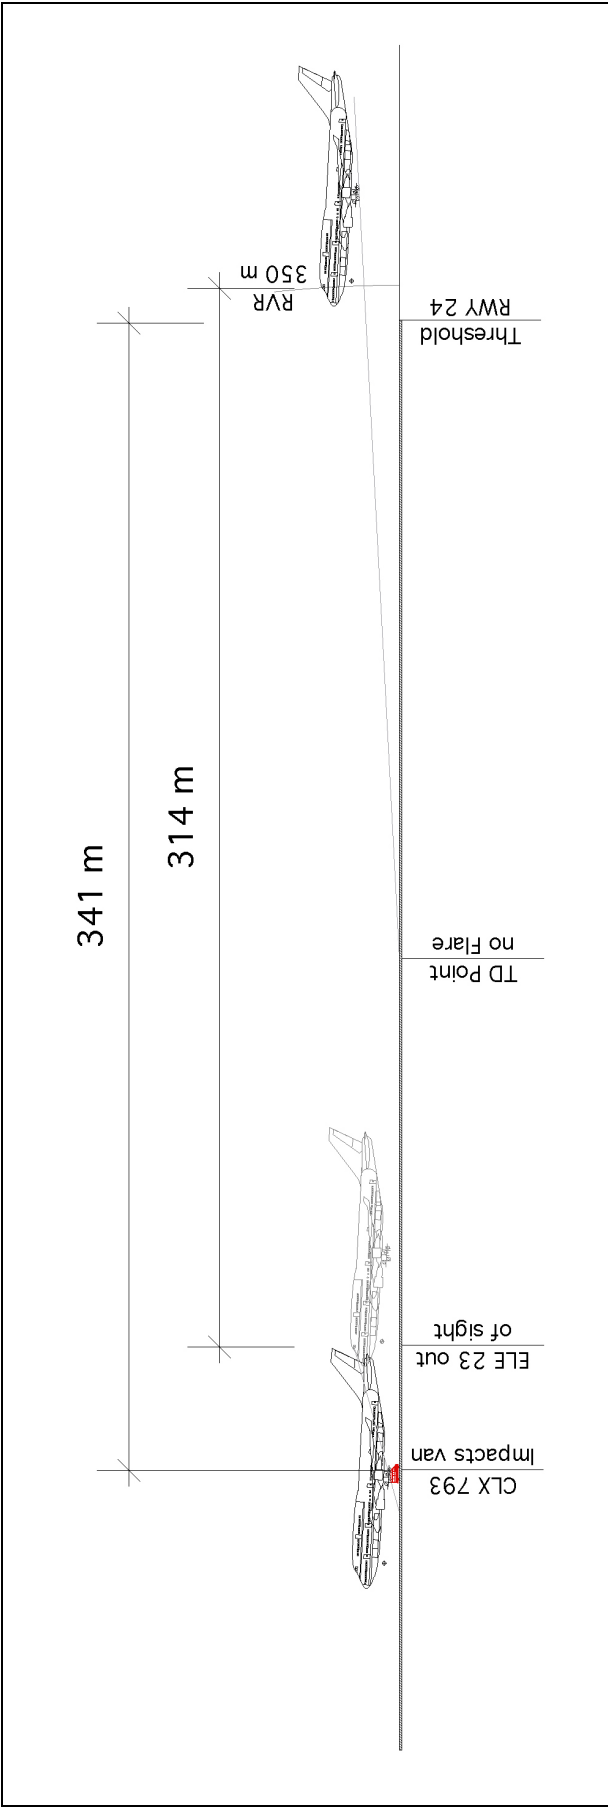
The van was positioned at approximately 341 meters from the runway threshold and the aircraft had a groundspeed of approximately 150 kts (= 77 m/s) when crossing the threshold until shortly before touchdown. The horizontal distance travelled by the airplane over which the car could be seen was about 314 meters. Based on those numbers, the PF had an estimated 4 seconds to see the obstacle on the runway and to decide whether or not to take avoiding actions. The collision occurred half a second later. It should be noted that runway lights in the touchdown zone were at high intensity due to the prevailing fog, which made it more difficult for the pilot to identify any obstacle on the runway. Furthermore, when the pilot went head up during final approach, he was looking out for expected visual cues, not the unexpected presence of a runway obstruction.

In a conversation with the PM during taxi to the parking position, the PF mentioned that a go-around briefly flashed through his mind when he saw the car on the runway. The PF stated in the occurrence report that he saw the van in the touchdown zone for the first time after calling out 'landing' at 17 ft radar altitude. Initiating a go-around at that point would have resulted in an approximate altitude loss of 17 ft (= DH), accounting for the spool-up time of the engines and the subsequent recovery of a positive ROC. The roof of the van being situated 8 ft above the runway (nil runway slope on that portion), a collision with the van could not have been avoided. The landing sequence is illustrated in Figure 3.

Figure 3: Landing Sequence: Source Boeing, VW, AET

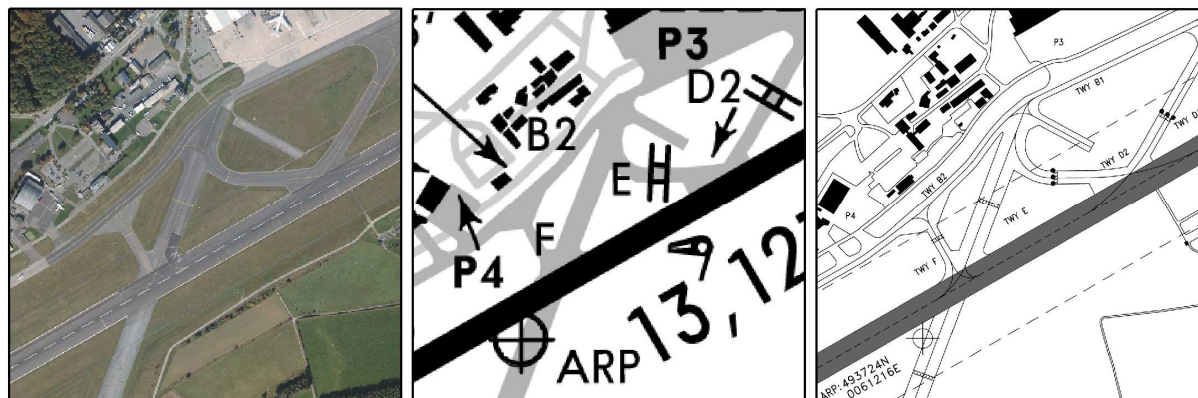
The AIP states that with LVP in progress, 'arriving aircraft shall vacate the runway using exits C, D2, E or B4'. The PM asking to vacate via taxiway Foxtrot instead of Echo is probably due to an inattention. The intention was to actually turn off the runway via Echo but the designators of taxiways Echo and Foxtrot were mixed up. This may partly be attributed to the fact that Echo and Foxtrot both have the same origin on the runway and that their depiction on the Jeppesen aerodrome chart could lead to confusion.

Figure 4: Aerodrome Chart (Source ACT, Jeppesen, AIP Belgocontrol)
