FATAL ACCIDENT ON BOARD JUAN SEBASTIAN DE ELCANO ON 3 NOVEMBER 2014

DATE OF ISSUE: 22 December 2016

Report N° AET/TM-2016/01

**Fatal accident on board *Juan Sebastian de Elcano*
on 3 November 2014**

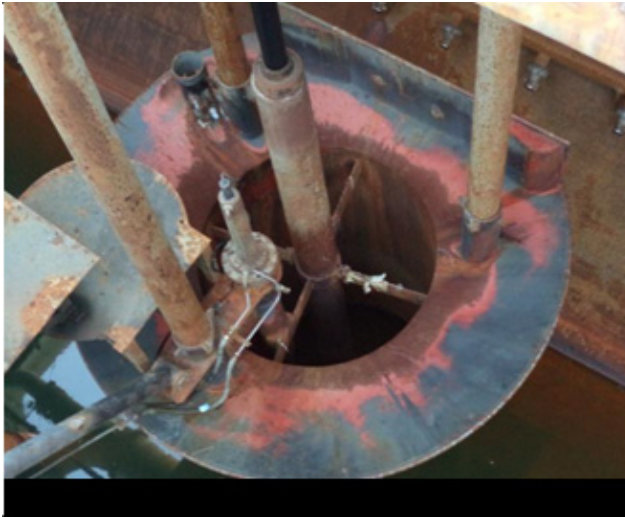
Figure 3.1 - Fore Overflow
(Source: Operator)

At around 10:00 AM, during coffee break, the crew started filling the hopper. The fore overflow was positioned at 11.82 m, while the aft overflow was blinded off.

At around 11:07 AM, the lowest position of the overflow reached 8.62 m (-3.20 m in 1'39") and within another minute, the final position of the overflow settled at 9.62 m (-2.21 m since initial position in 2'30"; +1.00 m in 51").

According to the 2nd Pipe Operator (day shift), the boat bumped into the overflow due to the strong current induced by the outflowing water. At that point, the Apprentice Pipe Operator stood up and tried to get a hold at a part of the overflow structure. It can be assumed that due to the weight shift, the boat became unstable and capsized. The two occupants subsequently fell overboard into the hopper and got sucked through the overflow.

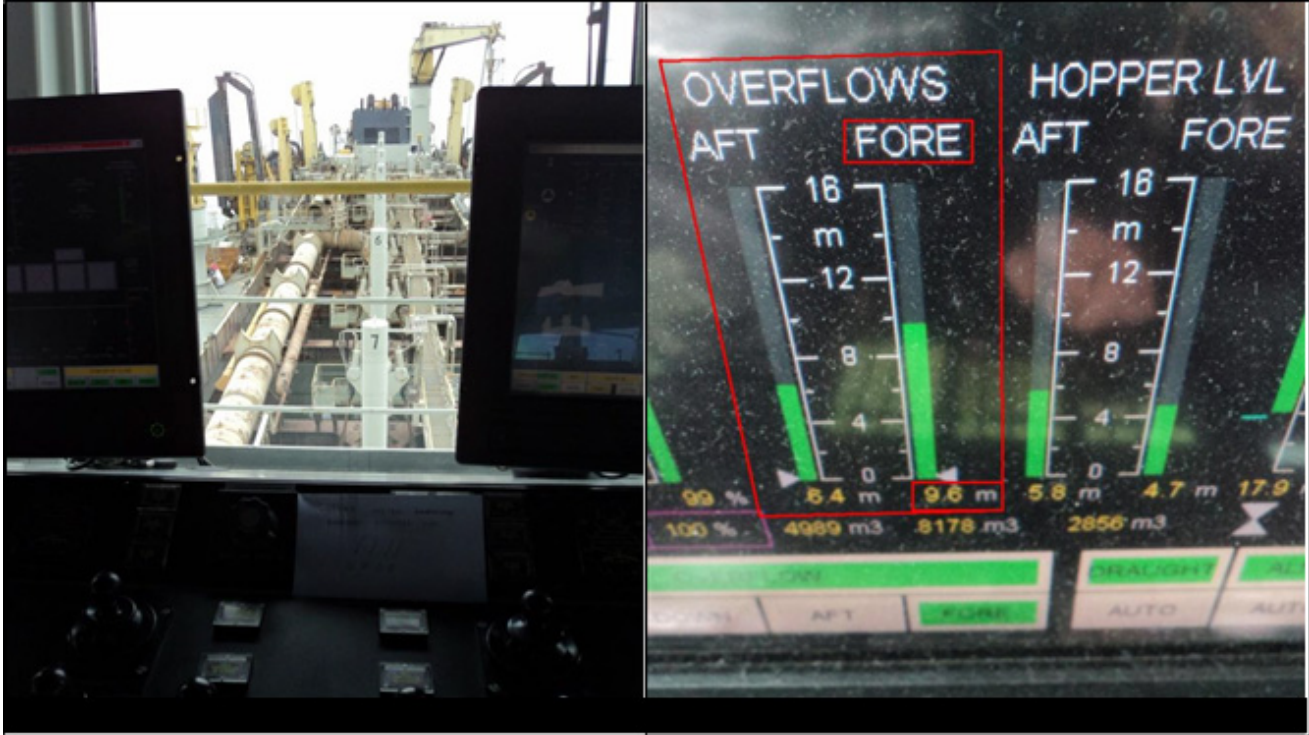
Figure 3.6 - View from Dredge Desk over the Hopper (Source: Operator) **Figure 3.7** - Overflow Level (4 Nov. 2014) (Source: Operator)

The initial position of the overflow was 11.82 m. When the overflow started to move down, both Pipe Operators were still at SB aft inside the unsecured boat in the hopper. They started to paddle to the front PS of the hopper. The boat moved forward and towards the overflow due to the current induced by the outflow of the water through the overflow.

The event shows that the strength of the current induced by lowering the overflow too rapidly can be hazardous for a small unsecured boat or a person in the hopper. In general, lowering the water level in the hopper is likely to create a highly dynamic and uncontrollable environment and thus raise the risk for personnel working in that environment above ALARP. It should therefore be stressed that in order to control the increased risk, no person should be in the hopper and the boat should be secured during every water level change.

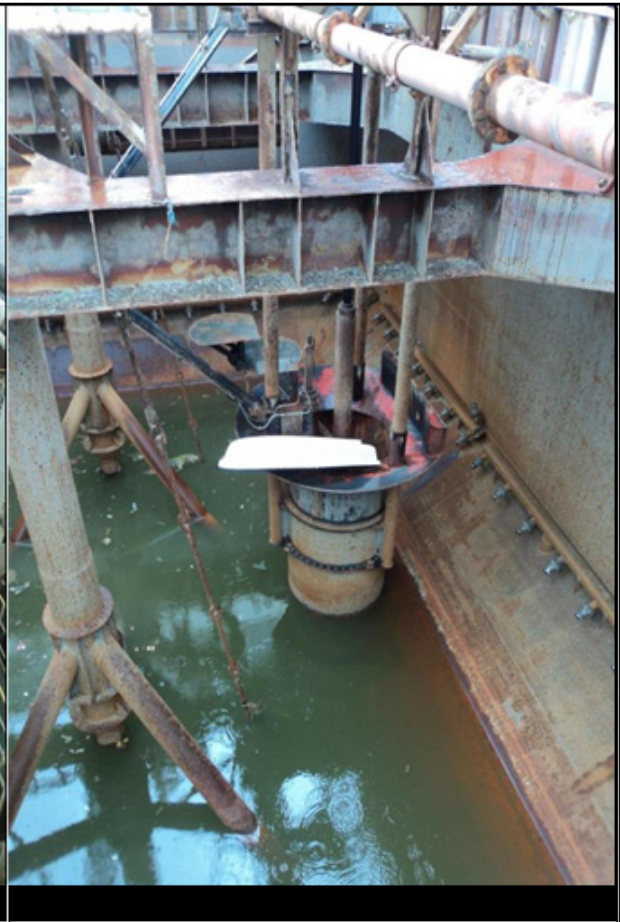
Figure 3.12 - Overturned boat on fore overflow
(Source: Operator)

The Chief Officer Day, who heard the shouting of the apprentice electrician through the open door of the bridge, came outside, saw part of the overturned boat on the overflow and immediately tried to reach the Captain. The Captain, who had given his internal mobile vessel phone to the bridge (internal mobile bridge phone was out of service), could not be reached as he was on his morning round and checking a SB sliding piece. So the Chief Officer Day went down to the main deck.

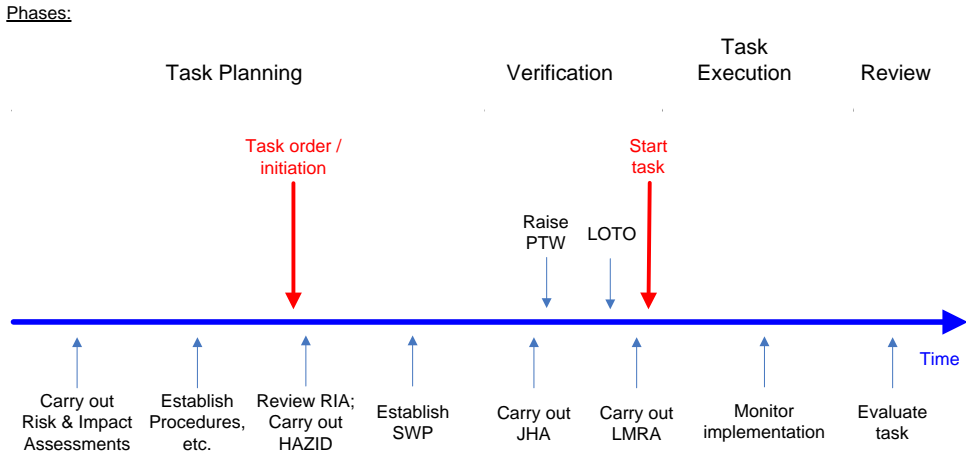
Figure 3.2.2.1.: Hazard Management Timeline (Source: Operator)

In accordance with the HM system, for tasks contained in the Risk and Impact Assessment register, a number of assessments shall be carried out before the start of the task (Fig. 3.2.2.1.: Hazard Management Timeline). Since the task was not part of the Risk and Impact Assessment register, neither the Job Hazard Analysis defined in the HM system, nor the associated Hazard Management (Risk Assessment Procedure) was available at the time of the occurrence and there was no operational Safe Work Practice for the performed task at the time.

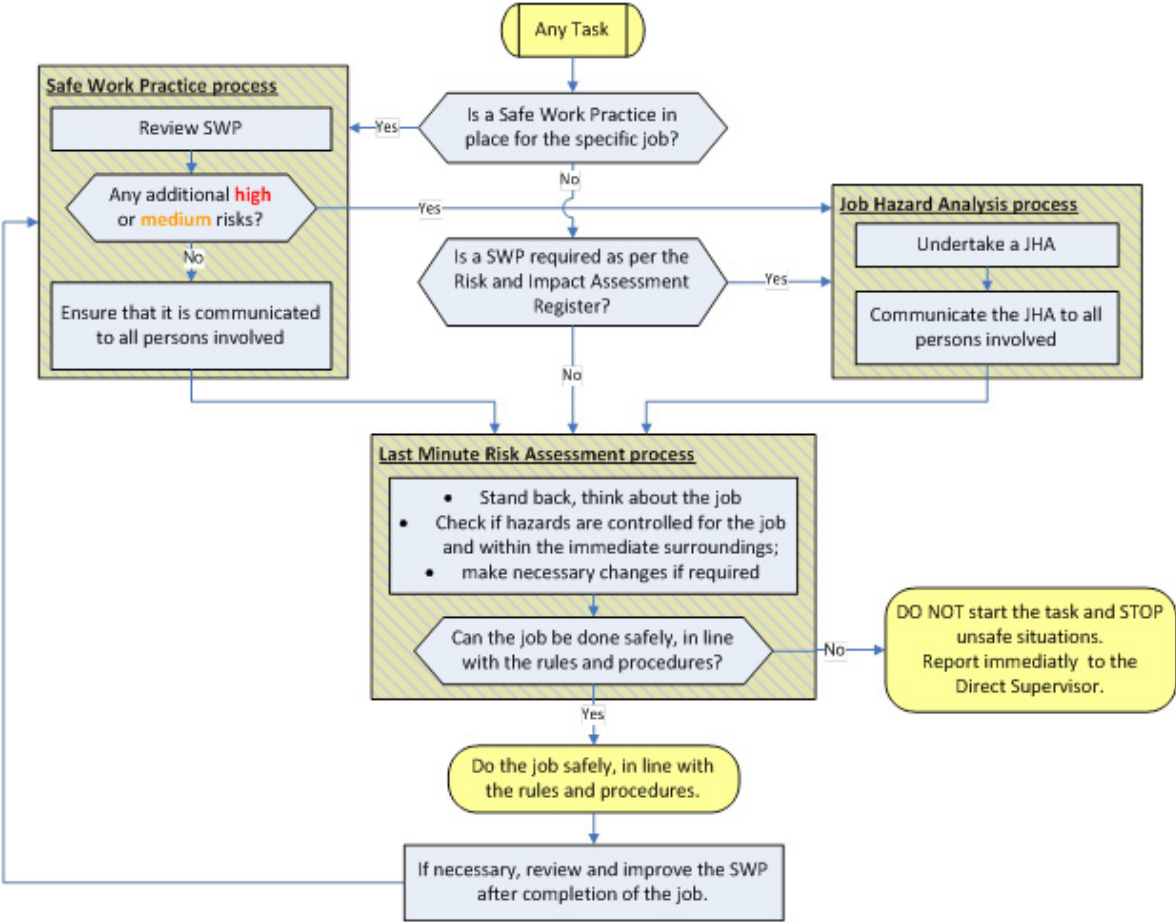
Figure 3.2.2.2.: Task specific approach (Source: Operator)

According to Figure 3.2.2.2, the JHA is an integral part of any new SWP and begins with the breakdown of a task into basic job steps. Subsequently, the task related potential hazards are identified and appropriate means of control are determined to lower the risk to an acceptable level. The JHA also aims to identify the personnel required to safely perform the task.
