EMERGENCY LANDING OF A CESSNA C140 NEAR FILSDORF (L) ON 9 DECEMBER 2013

DATE OF ISSUE: 29 DECEMBER 2017

Report N° AET/AC-2017/02

FACTUAL REPORT

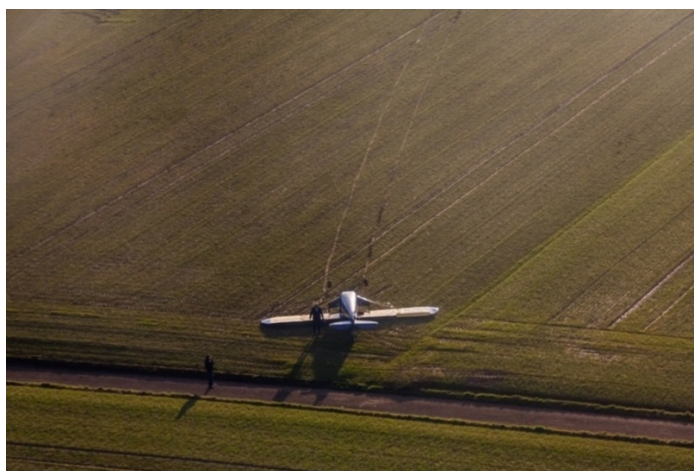
None of the occupants was injured, but the aircraft sustained damage to the propeller, the vertical stabilizer and the left hand wing and strut.

The pilot reported that the emergency landing in the crop field was uneventful, but due to a road cut at the end of the field, braking was applied at low speed causing the airplane to nose over and come to rest in an inverted position. Damage was sustained to the propeller, the vertical stabilizer and the left hand wing and strut.

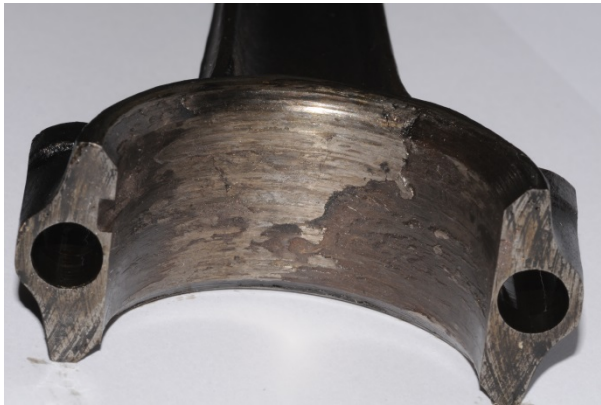
Picture – a

The post-accident engine inspection performed by the maintenance company, in presence of the AET and the DAC, revealed that material from the connecting rod Nr. 4 bearing had melted (Pic. a). Furthermore, metal parts from the rod bearings were found in the engine oil (Pic. b) and scratch marks were visible on the inside surfaces of the remaining connecting rod bearings (Pic. c & d: connecting rod bearing cyl. Nr. 2).

The post-accident engine inspection revealed important material wear and the failure of the connecting rod bearing of cylinder Nr. 4.

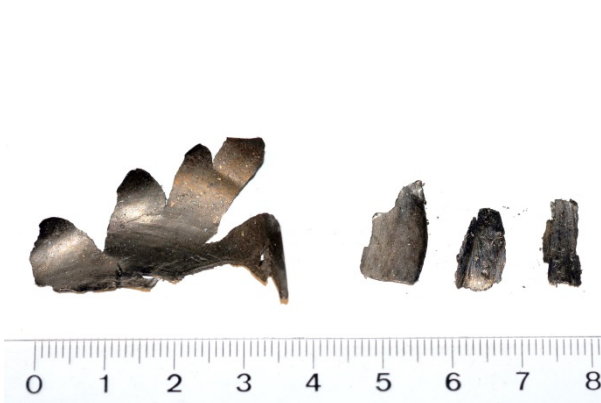
Picture – b

4 September 2013	Last performed maintenance inspection.
20 September 2013	The company that performed the oil analysis on 19 September 2013 notified the maintenance company that the particle quantifier (PQ) index indicated a high content of magnetic ferrous particles (the PQ refers to the total amount of magnetisable iron in a sample). Copper and iron levels were increased.
20 September 2013	The maintenance company informed the owners about the oil analysis results.
22 September 2013	The maintenance company explained to the owners that the results of the oil analysis were partially caused by the worn tooth of the starter, as the metal particles of the worn starter motor are collected in the oil filter by gravity, together with the metal from other worn parts of the engine. The maintenance company informed the owners that a request for an engine extension would be addressed to DAC.
24 September 2013	The maintenance company addressed a request for extension (10 hours) to DAC and included the information that metal (supposedly from starter gear) was detected in the oil filter.
