FACTUAL REPORT

EMERGENCY LANDING OF A CESSNA C140 NEAR FILSDORF (L) ON 9 DECEMBER 2013

Report N° AET/AC-2017/02

**Emergency landing of a Cessna C140
near Filsdorf (L) on 9 December 2013**

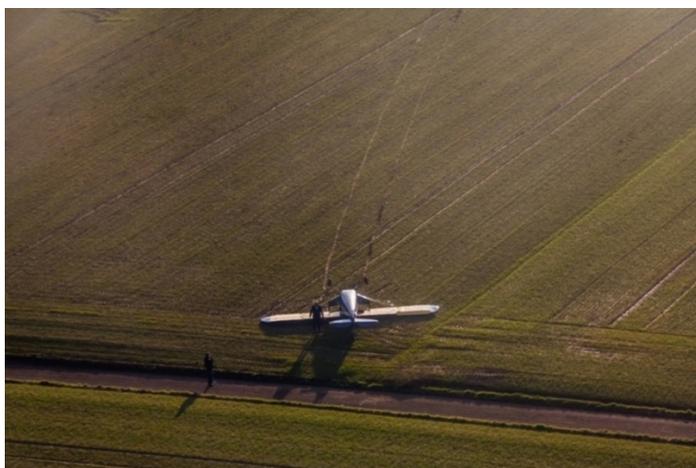
None of the occupants was injured, but the aircraft sustained damage to the propeller, the vertical stabilizer and the left hand wing and strut.

The pilot reported that the emergency landing in the crop field was uneventful, but due to a road cut at the end of the field, braking was applied at low speed causing the airplane to nose over and come to rest in an inverted position. Damage was sustained to the propeller, the vertical stabilizer and the left hand wing and strut.

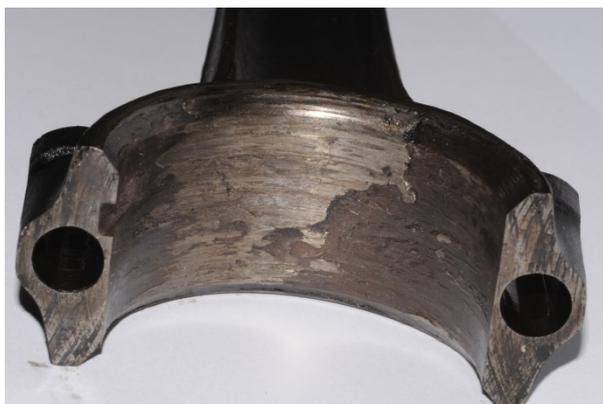
Picture – a

The post-accident engine inspection performed by the maintenance company, in presence of the AET and the DAC, revealed that material from the connecting rod Nr. 4 bearing had melted (Pic. a). Furthermore, metal parts from the rod bearings were found in the engine oil (Pic. b) and scratch marks were visible on the inside surfaces of the remaining connecting rod bearings (Pic. c & d: connecting rod bearing cyl. Nr. 2).

The post-accident engine inspection revealed important material wear and the failure of the connecting rod bearing of cylinder Nr. 4.

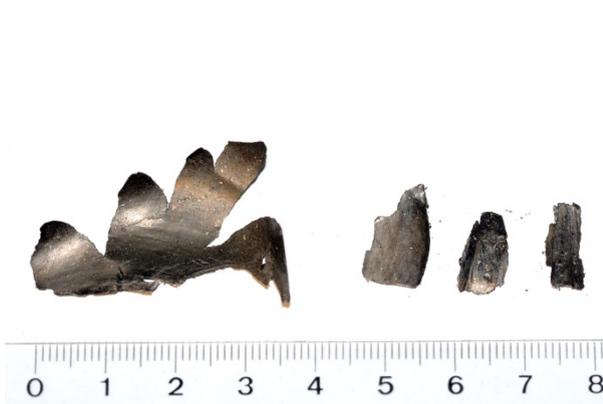
Picture – b

4 September 2013	Last performed maintenance inspection.
20 September 2013	The company that performed the oil analysis on 19 September 2013 notified the maintenance company that the particle quantifier (PQ) index indicated a high content of magnetic ferrous particles (the PQ refers to the total amount of magnetisable iron in a sample). Copper and iron levels were increased.
20 September 2013	The maintenance company informed the owners about the oil analysis results.
22 September 2013	The maintenance company explained to the owners that the results of the oil analysis were partially caused by the worn tooth of the starter, as the metal particles of the worn starter motor are collected in the oil filter by gravity, together with the metal from other worn parts of the engine. The maintenance company informed the owners that a request for an engine extension would be addressed to DAC.
24 September 2013	The maintenance company addressed a request for extension (10 hours) to DAC and included the information that metal (supposedly from starter gear) was detected in the oil filter.
