FINAL REPORT
ON THE ACCIDENT OF 24 SEPTEMBER 2003
IN LUXEMBOURG
TO THE LUXAIR EMBRAER E145
REGISTERED LX-LGZ

Final issue: December 2010

Administration of Technical Investigations

Report N° AET-2010/AC-01

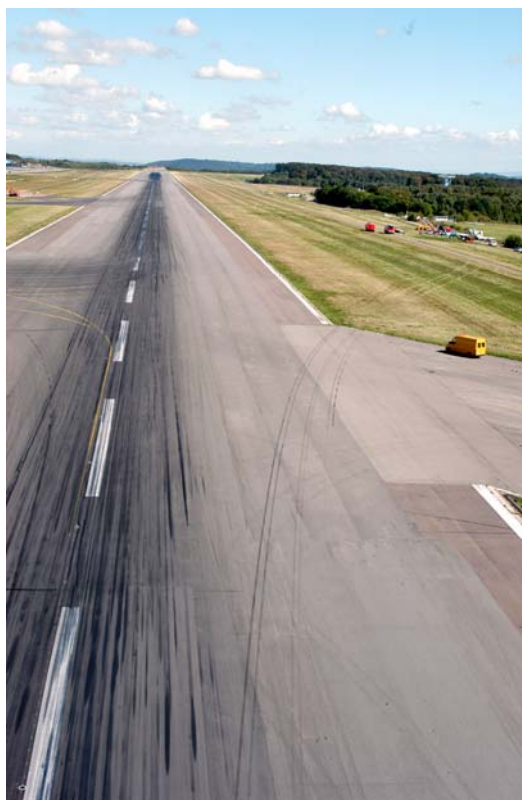
Figure 1. Tire marks on the runway

Rubber marks from all tires were visible throughout the roll-out phase, some more pronounced than others. Immediately apparent were the rubber marks from the nose gear. The aircraft departed the runway in a right skidding motion, which was reversed in the grass area.

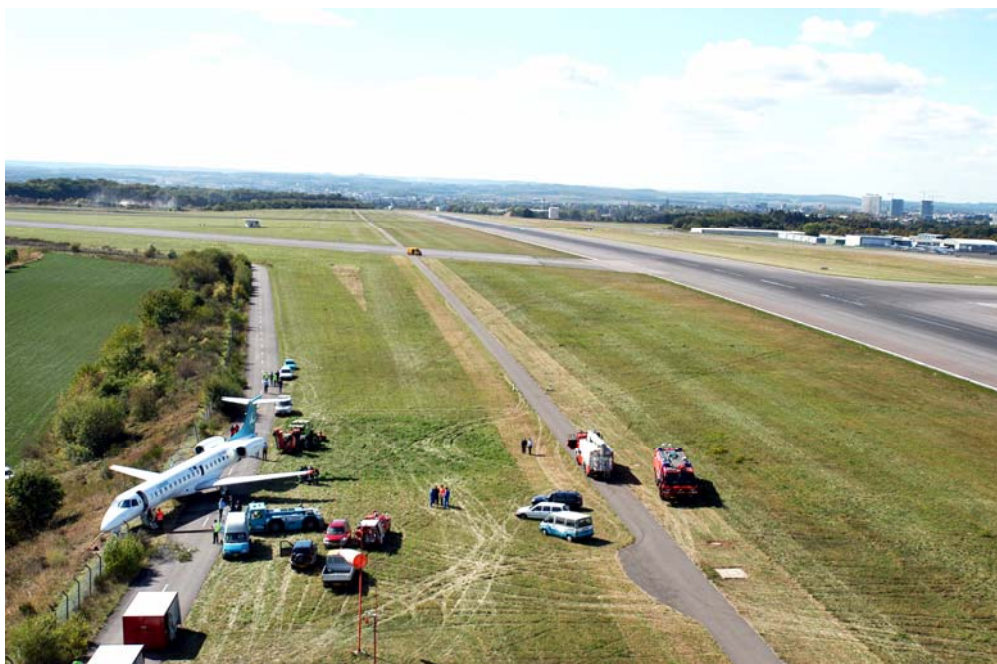
Figure 2. Aircraft was arrested by the airport boundary fence

The aircraft landed on RWY 06 and 5 seconds after touch down the aircraft veered to the right and departed the runway into the grass area. It was stopped by the airport perimeter fence on the edge of a downslope embankment.

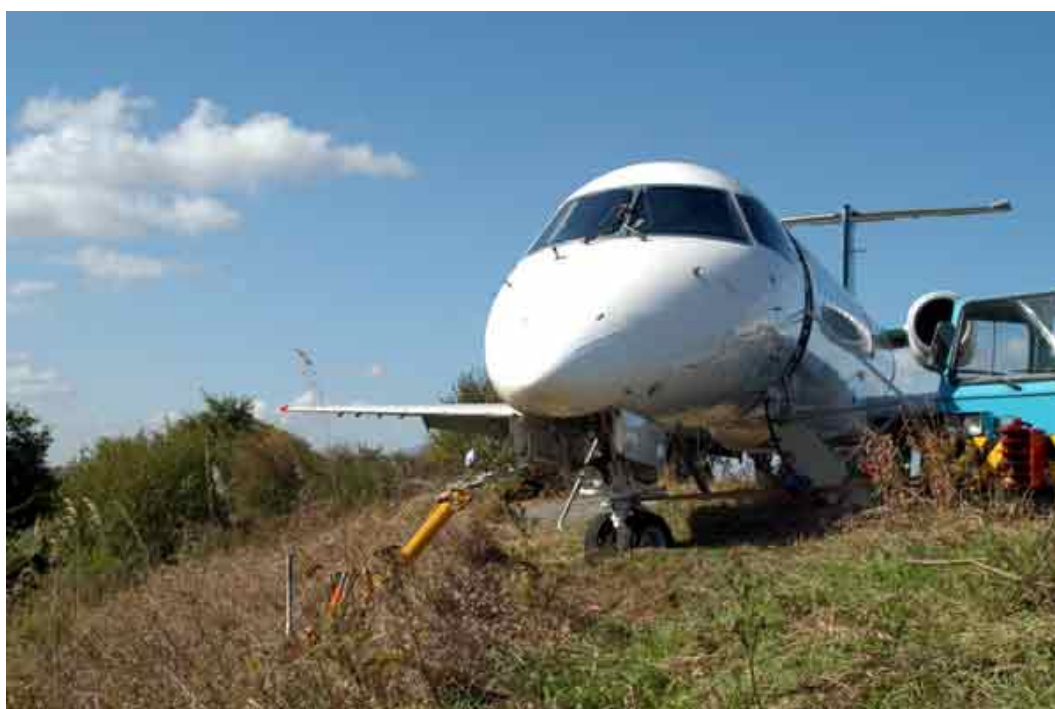
Figure 3. Close-up view of aircraft halted by fence

The aircraft was severely damaged on its RH side, the fuselage being punctured in several places, the whole leading edge of the RH wing was damaged when it knocked down the fence posts and some flap damage occurred as well by the posts and the fence sliding underneath the wing.

The nose landing gear remained pointed to the right at a substantial angle. EMBRAER analysed the skid marks and estimated the wheel angle between 30-40°.

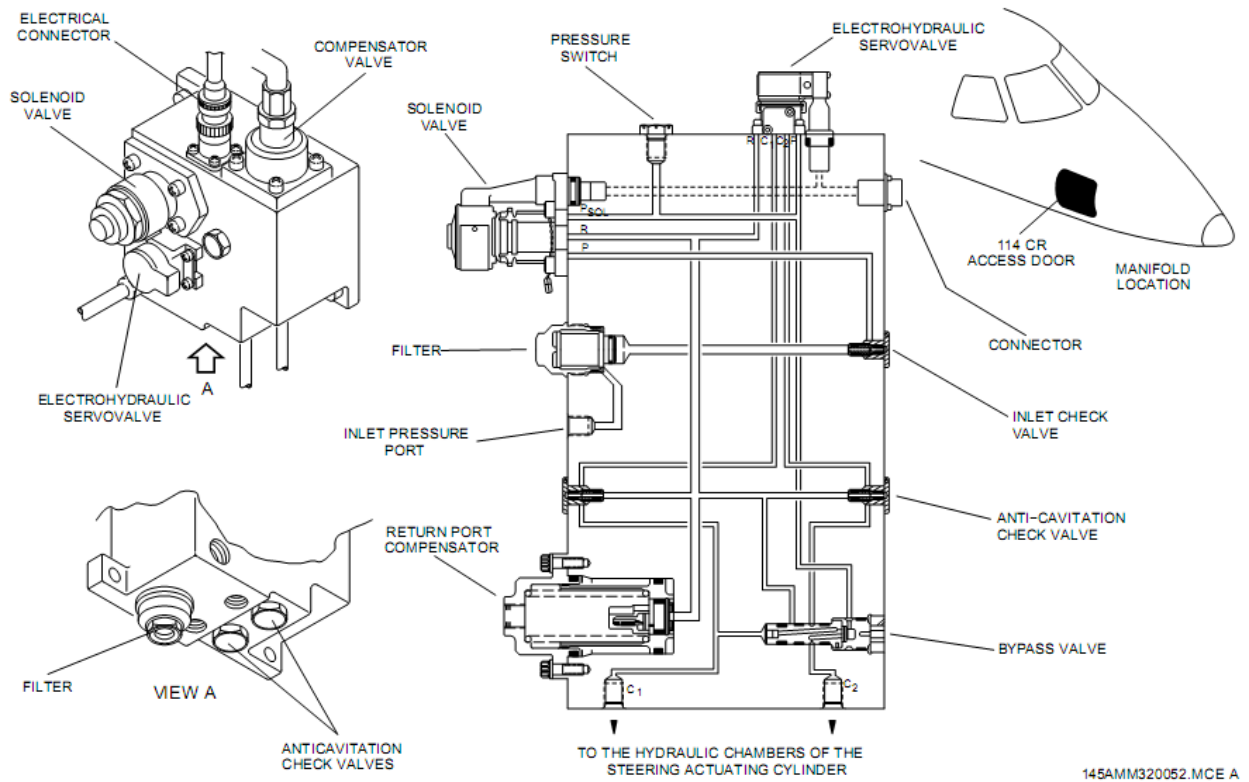
Figure 15. Hydraulic manifold assembly

During the internal leakage test it was noted that the Electronic Hydraulic Servo Valve (EHSV) P/N 22253282-103 S/N 102 pressure was fluctuating ± 100 psi around neutral. This has been considered to be an anomaly and was specified in the test record. A first reaction was that the EHSV would get an unstable flow which might result in an oscillating nose gear.

The manifold was disassembled, witnessed also by an FAA inspector, for a precautionary visual inspection for any abnormalities. The only finding was that the inlet check valve (P/N 72900-301) cap retention fingers had all four broken off, but retained in the cavity. As implied above, the check valve was still functioning properly during test. No secondary damage was noted in the Nose Wheel Steering assembly as a result of the cap failure.

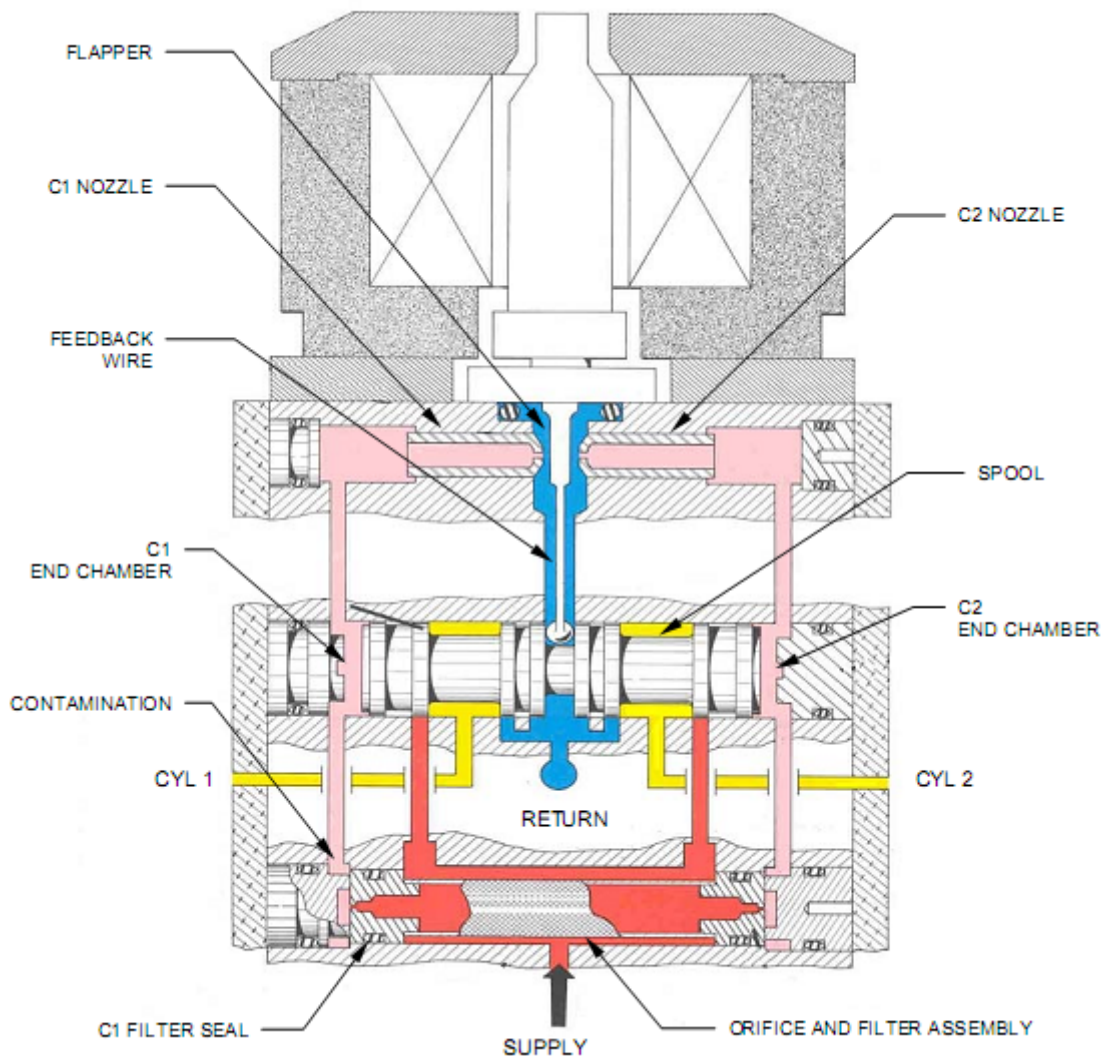
Figure 17. Hydraulic schematic showing location of contamination

- Functional check revealed that the unit was not operating correctly
- Low internal leakage indicated a restriction in the first stage.
- C1 nozzle behaved as if blocked, however, no contamination was recovered from the C1 nozzle when the unit was disassembled
- Rubber-like contamination was found in the C1 first stage cavity upstream of the C1 nozzle
- Damage (nibbling / extrusion) was found on the C1 filter seal
- Material composition of the contamination was found to be consistent with the C1 filter seal
- Filter bore was found to be oversize by 0.0018 inch
