## REPORT ON AIR ACCIDENT AT HONNINGSVÅG AIRPORT VALAN ON 12 JULY 2010 INVOLVING LANCAIR LEGACY 2000, LX-DIN

Date: 24.02.2011  
SL Report: 2011/06

- Type and reg.: Lancair Legacy 2000, LX-DIN  
- Manufacturing year: 2003

Type of occurrence: Accident, runway excursion

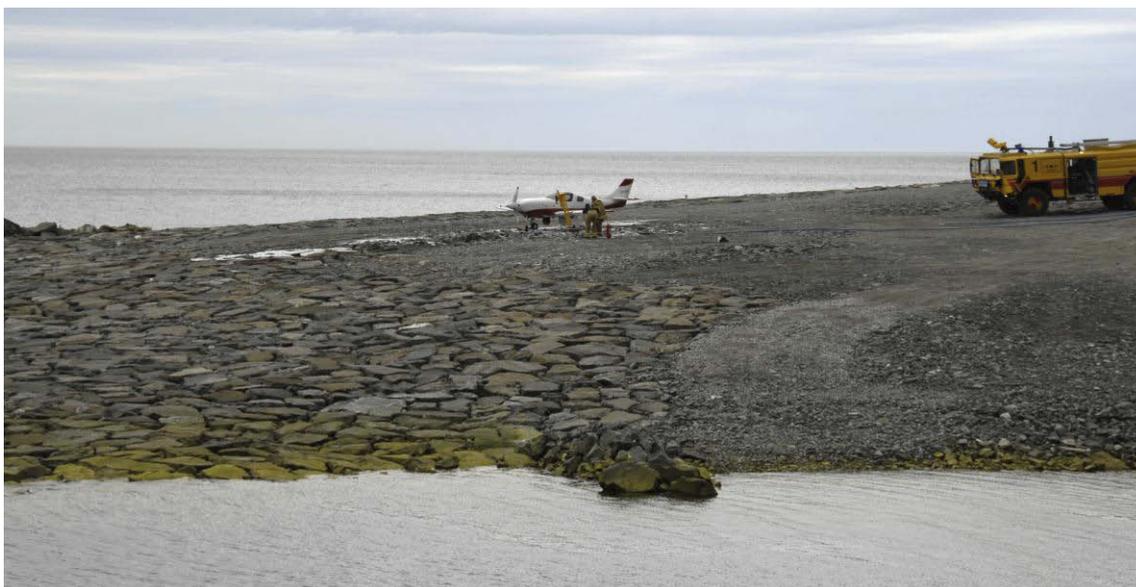
Damage to aircraft: Damage to propeller and left wing leading edge

Other damage: Approach light mast broken

The speed fell after a while, but the aircraft did not have time to stop before reaching the end of the runway, rolling off the end and onto the sloping and stony surface of the runway extension (see Figure 1). The propeller hit a stone and the left wing a light mast before stopping. The two persons on board were not injured.

*Figure 1: LX-DIN photographed after running off in the area near the extension of runway 26.*

In this case, the ground roll exceeded the available landing distance, in spite of touching down in the landing zone. The light mast and the stony surface contributed to the damage to the aircraft although it did not go far off the end of the runway, and also had a relatively low speed. High airspeed, runway slope, brake effect and tailwind are all factors that can increase the stop length. The tendency for bouncy landings also postpones the start of the effective braking. The brake length increases with the velocity squared, indicating that an increase in the landing speed from 80 to 100 kt (25%) will increase the brake length by 56%. The Accident Investigation Board has not carried out any detailed calculations of how much effect the various factors had in this case, but does not consider it unlikely that the aircraft was exposed to tailwind after landing as explained by the commander.

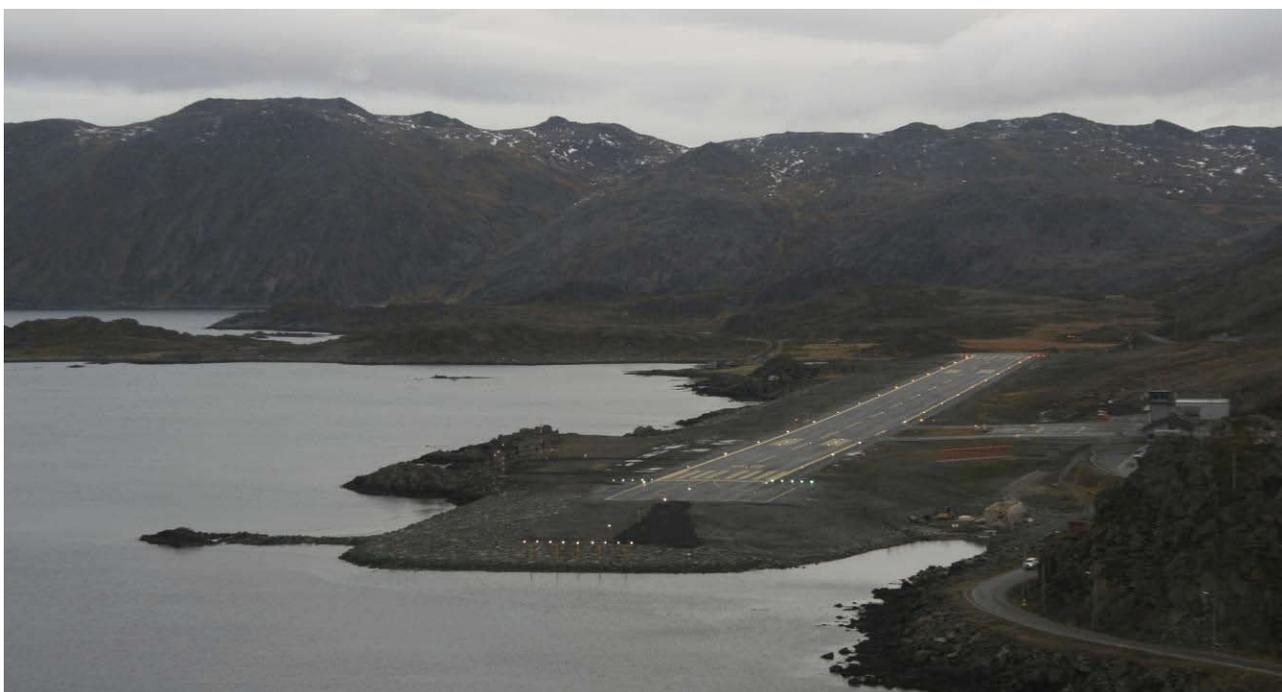
*Figure 2: Honningsvåg airport in the autumn of 2010 (seen towards the northeast).*
