SL 2011/06

REPORT ON AIR ACCIDENT AT HONNINGSVÅG AIRPORT VALAN ON 12 JULY 2010 INVOLVING LANCAIR LEGACY 2000, LX-DIN

Date: 24.02.2011
SL Report: 2011/06

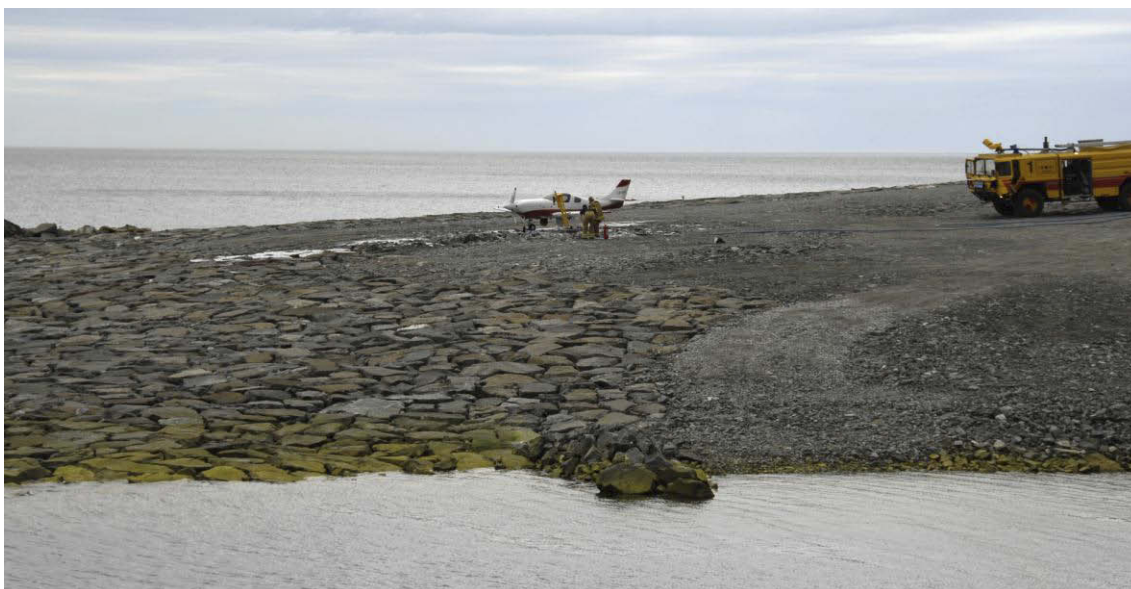
The speed fell after a while, but the aircraft did not have time to stop before reaching the end of the runway, rolling off the end and onto the sloping and stony surface of the runway extension (see Figure 1). The propeller hit a stone and the left wing a light mast before stopping. The two persons on board were not injured.

Figure 1: LX-DIN photographed after running off in the area near the extension of runway 26.

In this case, the ground roll exceeded the available landing distance, in spite of touching down in the landing zone. The light mast and the stony surface contributed to the damage to the aircraft although it did not go far off the end of the runway, and also had a relatively low speed. High airspeed, runway slope, brake effect and tailwind are all factors that can increase the stop length. The tendency for bouncy landings also postpones the start of the effective braking. The brake length increases with the velocity squared, indicating that an increase in the landing speed from 80 to 100 kt (25%) will increase the brake length by 56%. The Accident Investigation Board has not carried out any detailed calculations of how much effect the various factors had in this case, but does not consider it unlikely that the aircraft was exposed to tailwind after landing as explained by the commander.

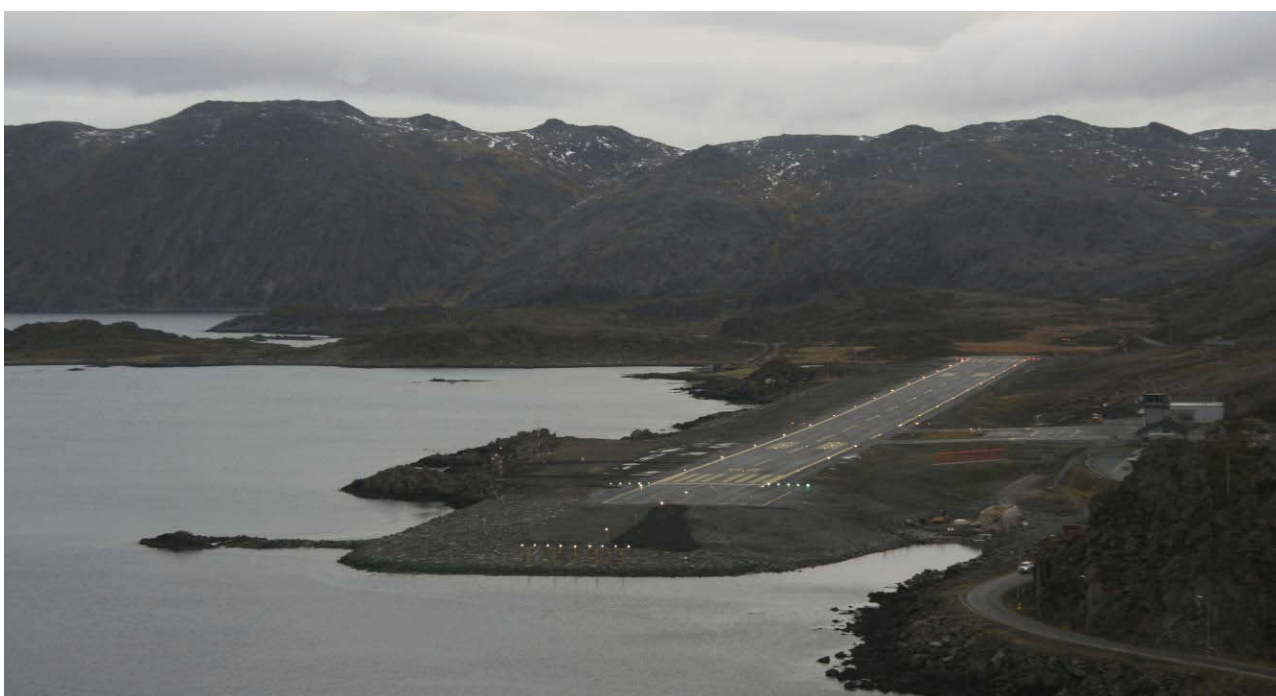
Figure 2: Honningsvåg airport in the autumn of 2010 (seen towards the northeast).
