DATA SUMMARY

Date and time	Thursday, 4 August 2011; 17:05 UTC¹
Site	Madrid-Barajas Airport (LEMD) (Spain)

Registration	LX-LGX
Type and model	EMBRAER 145 LU
Operator	Luxair

Operation	Commercial Air Transport – Scheduled – International – Passenger
Phase of flight	Approach

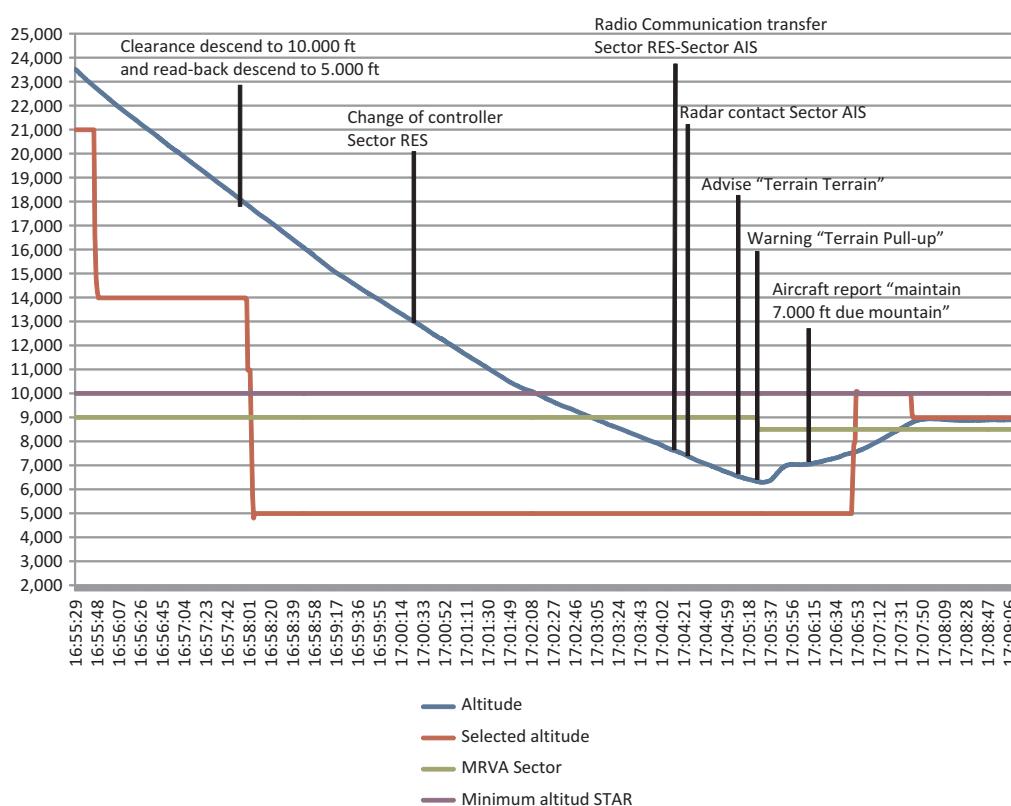
Figure 3. Flight profile of the aircraft during the incident

Based on this information, the aircraft descended below the minimum altitude specified for the STAR at 17:02:13, and below the minimum radar vectoring altitude at 17:03:21. The aircraft was subsequently transferred to the AIS control sector by the RES sector controller when the aircraft was at an altitude of 7,678 ft. Sector AIS reported radar contact with the aircraft when it was descending through 7,349 ft.

The EGPWS was triggered at 17:05:06 with an acoustic "Terrain Terrain" warning. A few seconds later, at 17:05:28, the EGPWS issued a "Terrain Pull Up" alert. At 17:05:31, the crew disengaged the autopilot and increased thrust. The minimum altitude reached by the aircraft was 6290 ft (17:05:32), after which the aircraft started to climb (see Figure 3).

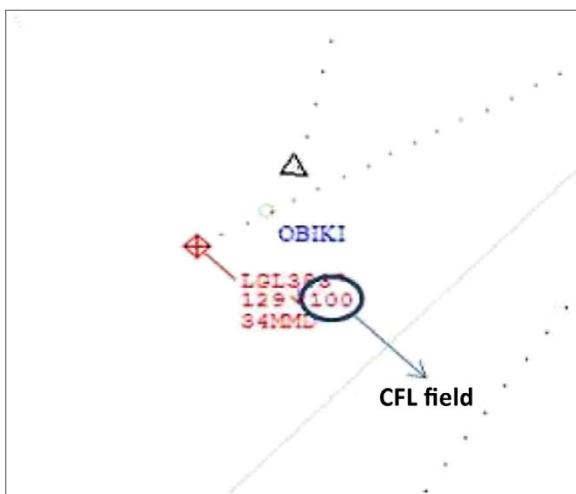
Figure 4. Radar image 17:00:40

Based on the radar information, the offgoing RES sector controller noted on the label of the aircraft appearing on the radar (CFL field¹⁸) that he had cleared it to descend to 10,000 ft. When he was relieved, the aircraft was flying above the minimum altitude set by the procedure and the radar label continued to show 10,000 ft as the cleared altitude (see Figure 4).

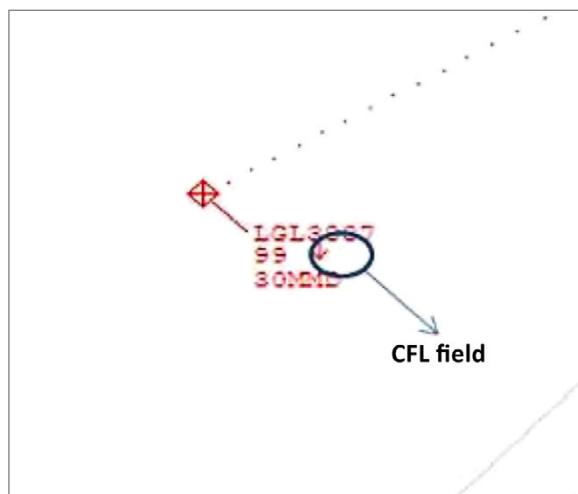
Figure 5. Radar image 17:02:30

The CFL field disappeared from the aircraft's label at 17:02:30 once the aircraft descended below 10,000 ft (see Figure 5).

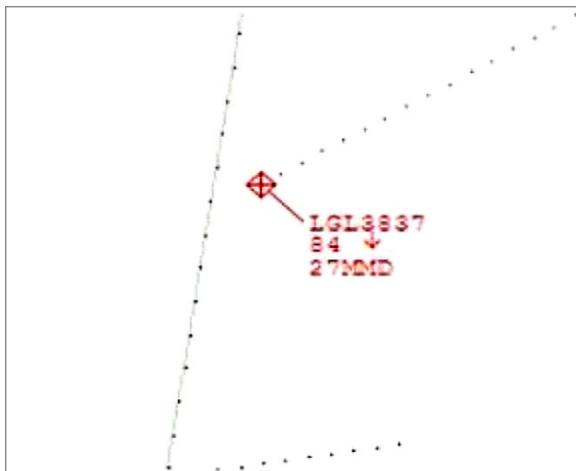
Figure 6. Radar image 17:03:45

By 17:03:45, before it was transferred to sector AIS, the aircraft was already below the MRVA (9,000 ft) and was descending through 8,400 ft (see Figure 6).

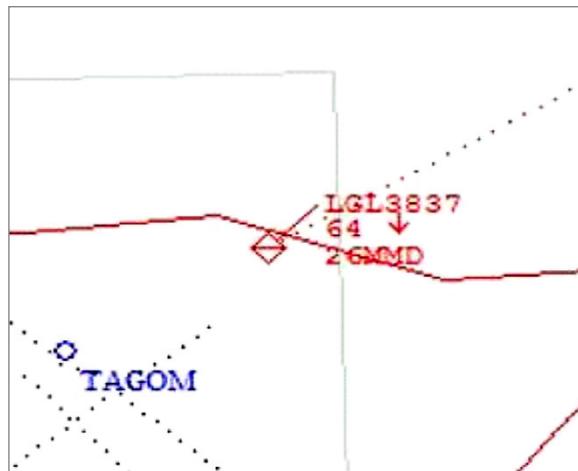
Figure 7. Radar image 17:05:35

The aircraft continued descending until it reached 6,400 ft at 17:05:35, from which point the aircraft began to climb to an altitude of 9,000 ft (see Figure 7).
