Final Report

Collision with trees on final approach

Piper PA28-161 Cadet, LX-AIF

14 April 2013

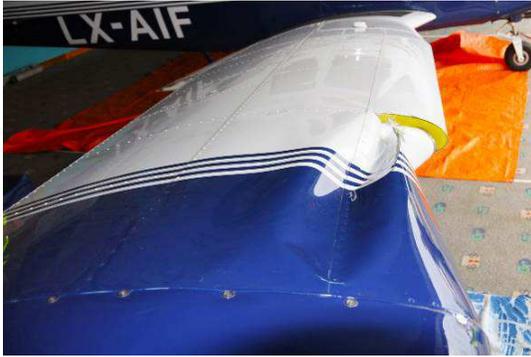
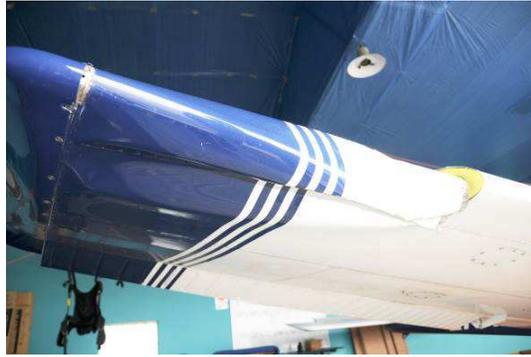
Right wing

The outboard leading edge sections of both wings were substantially damaged on impact with the tree tops. The right-hand aileron also sustained damage.

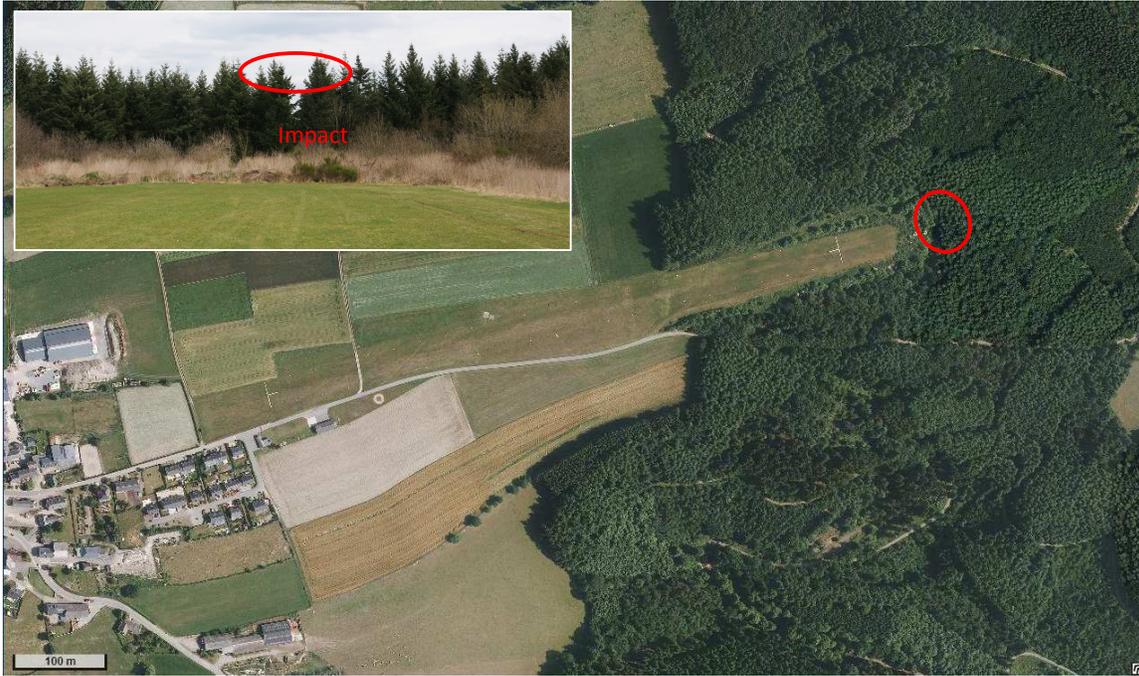
The area of impact was located approximately 120m before the threshold of RWY 26. The pilot explained in an interview that during final approach, the aircraft suddenly lost altitude due to heavy local turbulences and descended below the top of some trees located on the approach path of runway 26. The actual altitude at which the impact occurred could not be determined.

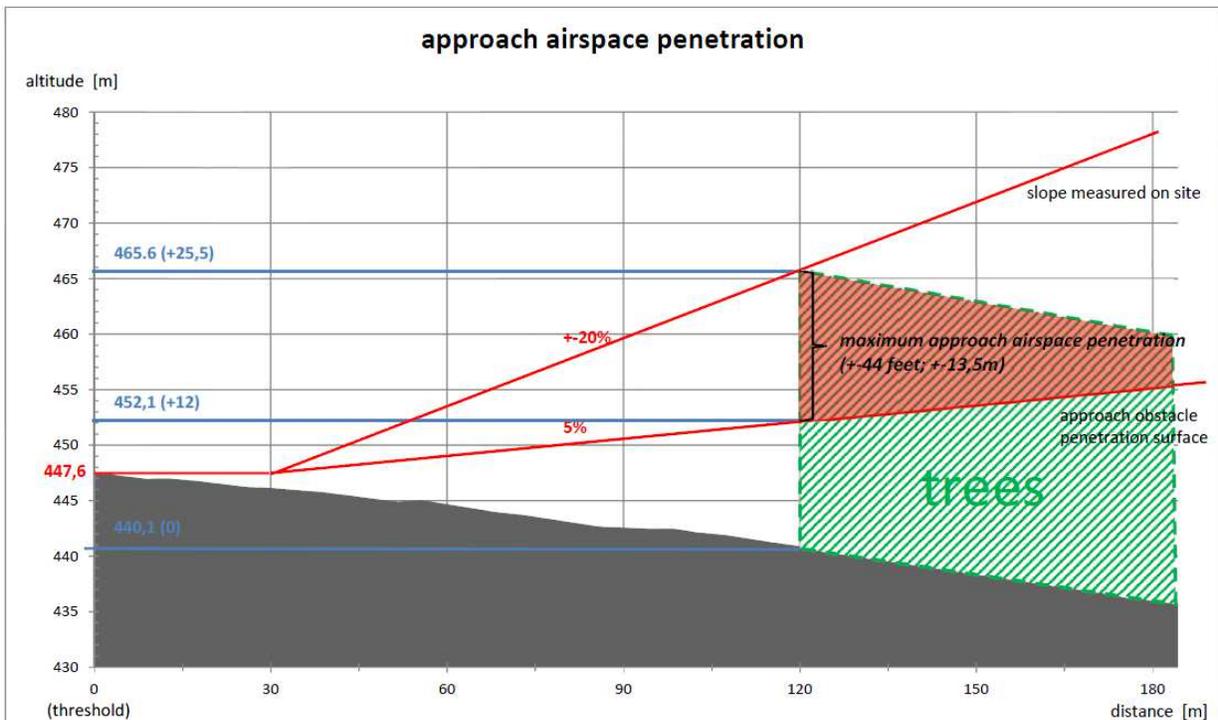
Figure1 : ELNT Approach airspace penetration in reference to chapter 4, Volume I of Annex 14 to the *Convention on International Civil Aviation*.

Figure 1 shows the approximate approach path penetration (red area) by the westernmost trees on the approach path to runway 26. The estimated maximum penetration was about 44.3 feet (13,5m).

A contributing factor was that trees penetrated the obstacle limitation surface defined by ICAO Annex 14 for this type of airfield.
