Final Report

Collision with trees on final approach

Piper PA28-161 Cadet, LX-AIF

Report N° AET-2015/AC-01

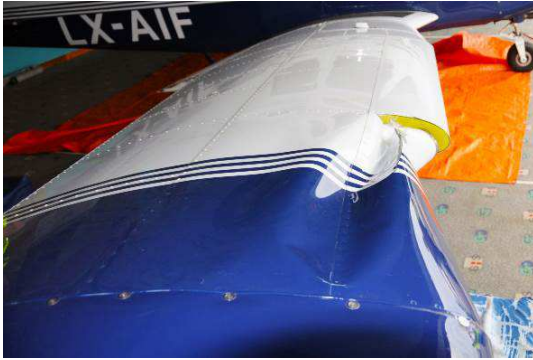
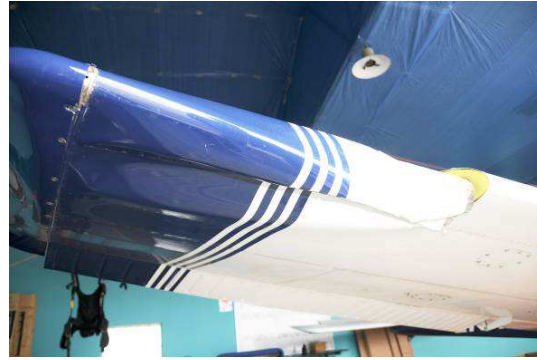
Right wing

The outboard leading edge sections of both wings were substantially damaged on impact with the tree tops. The right-hand aileron also sustained damage.

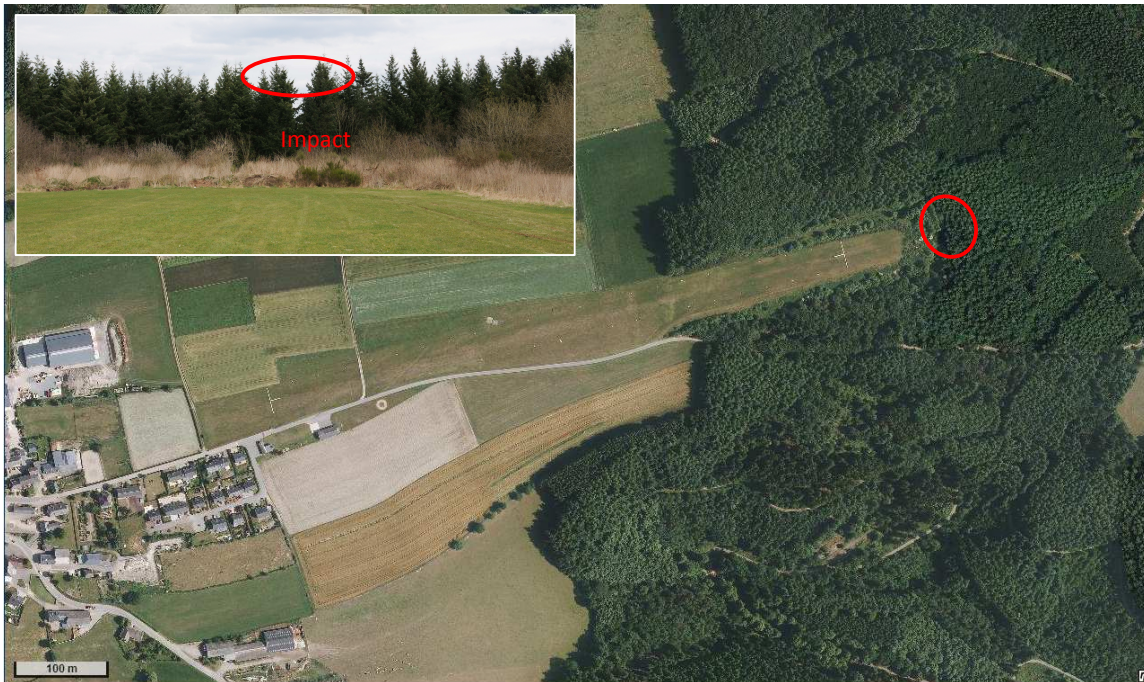
The area of impact was located approximately 120m before the threshold of RWY 26. The pilot explained in an interview that during final approach, the aircraft suddenly lost altitude due to heavy local turbulences and descended below the top of some trees located on the approach path of runway 26. The actual altitude at which the impact occurred could not be determined.

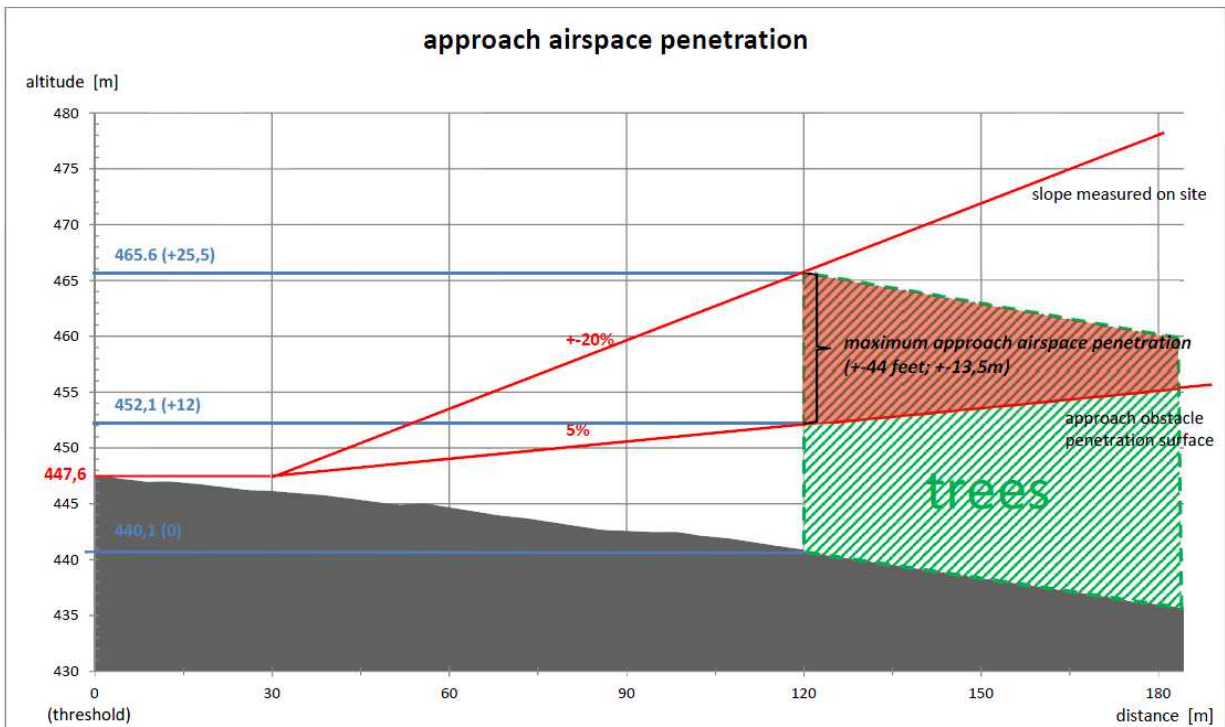
Figure1 : ELNT Approach airspace penetration in reference to chapter 4, Volume I of Annex 14 to the *Convention on International Civil Aviation*.

Figure 1 shows the approximate approach path penetration (red area) by the westernmost trees on the approach path to runway 26. The estimated maximum penetration was about 44.3 feet (13,5m).

It should be noted that there was no mention about trees penetrating the approach path in the aerodrome documentation or on the charts, although the situation was known by DAC.

A contributing factor was that trees penetrated the obstacle limitation surface defined by ICAO Annex 14 for this type of airfield.
