Grounding of *Bosphorus*

Brisbane River, Queensland | 29 October 2013

ATSB Transport Safety Report
Marine Occurrence Investigation
304-MO-2013-011
Final – 22 September 2014

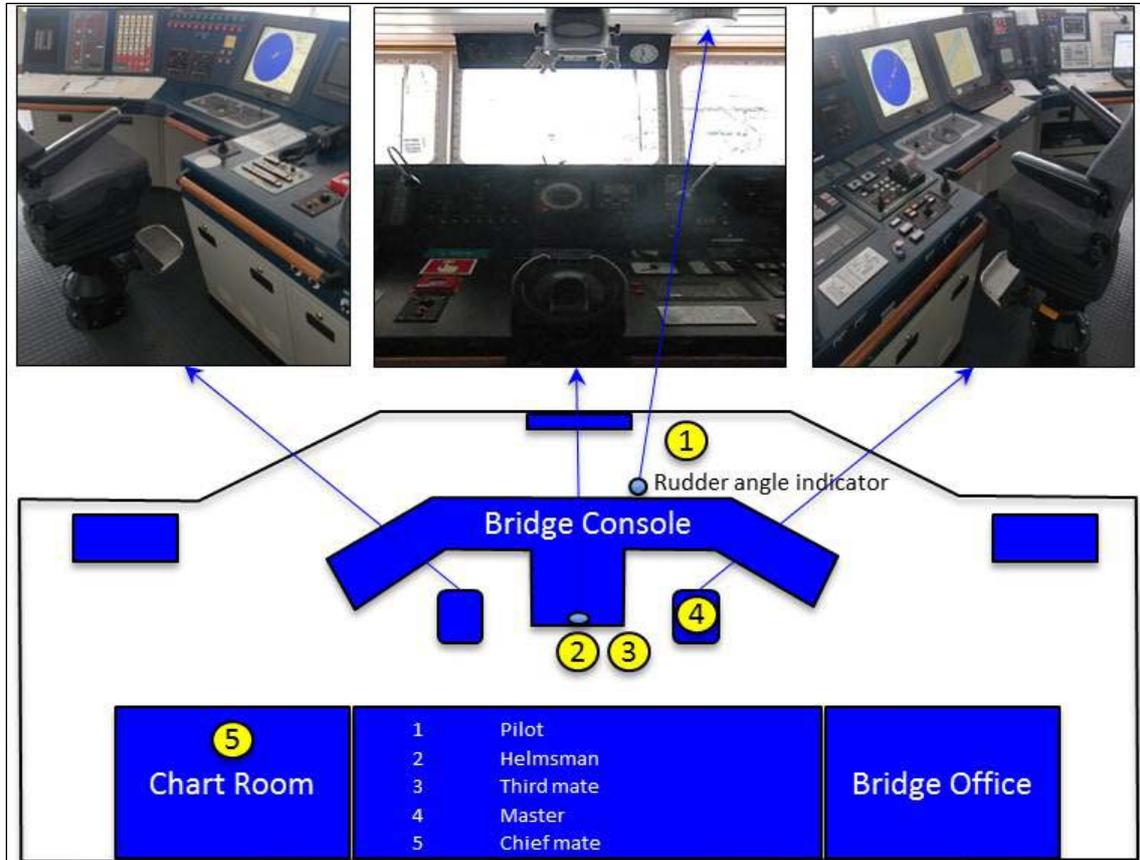
Figure 3: Bridge team positions prior to the grounding

At about 1958, the chief mate instructed the third mate to watch the helmsman. The chief mate then went to fill in the log book and the third mate took up a position to the right of the helmsman (Figure 3).

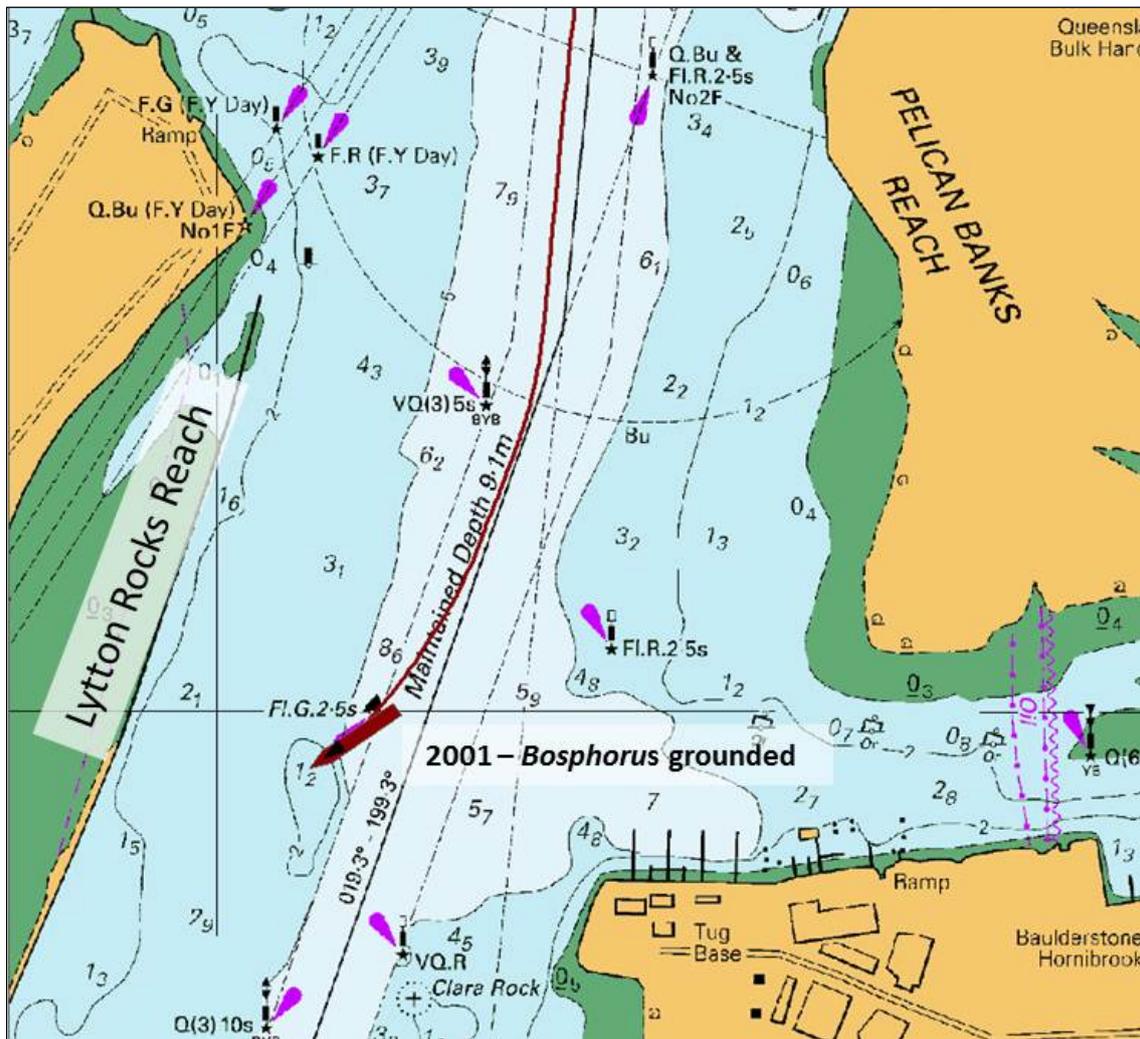
Figure 4: Section of navigational Chart AUS 237 showing the ship's track and grounding

At 2001, *Bosphorus* grounded in position 27° 24.0' S; 153° 09.1' E at the Lytton Rocks Reach Channel (Figure 4).
