Grounding of *Bosphorus*

Brisbane River, Queensland | 29 October 2013

ATSB Transport Safety Report
Marine Occurrence Investigation
304-MO-2013-011
Final – 22 September 2014

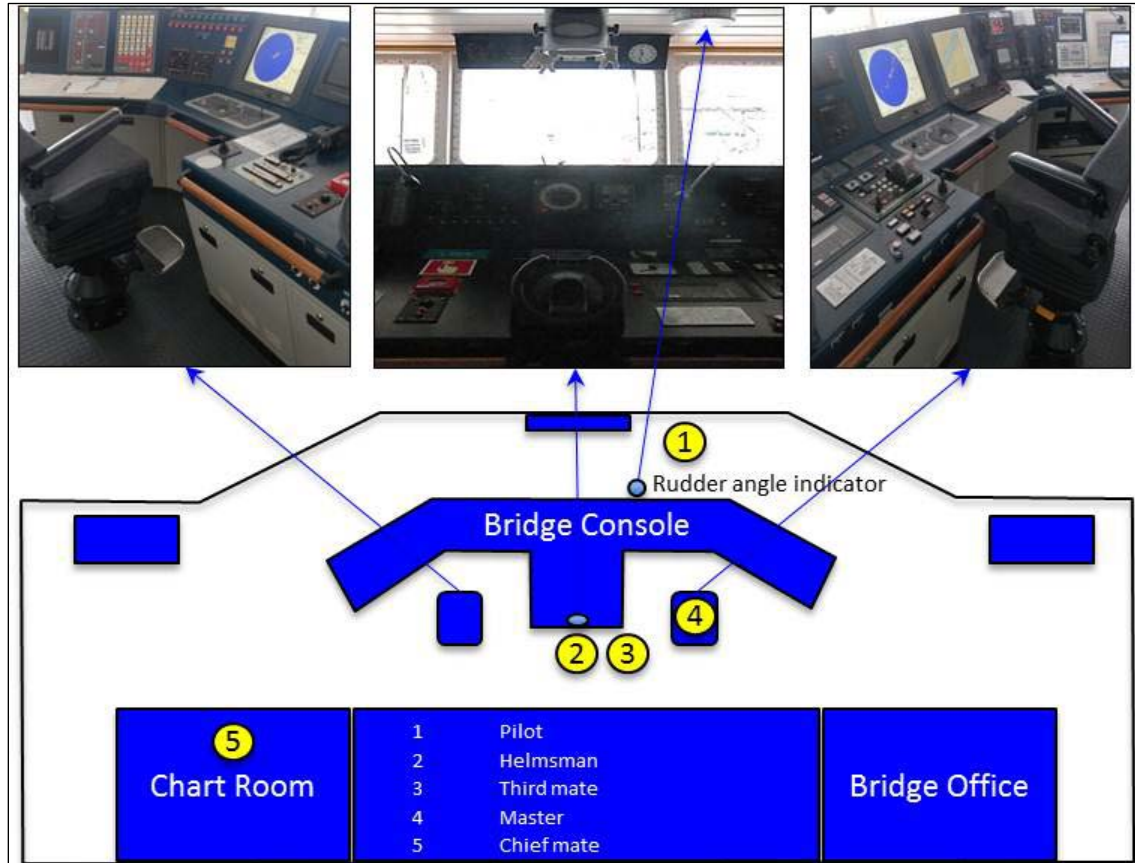
Figure 3: Bridge team positions prior to the grounding

At about 1958, the chief mate instructed the third mate to watch the helmsman. The chief mate then went to fill in the log book and the third mate took up a position to the right of the helmsman (Figure 3).

At 1958, the chief mate asked the third mate to watch the helmsman. While the chief mate had seen the helmsman steer off-course and thought that he was not concentrating on the job at hand, the third mate was not aware of this history and, therefore, did not have a clear understanding of what 'watch the helmsman' really meant.

The third mate acknowledged the chief mate's instruction and stood to the right of the helmsman. No further formal handover activities were conducted. The chief mate then moved to the chart table on the port side of the bridge to fill in the bridge logbook for the end of the 4-8 watch.

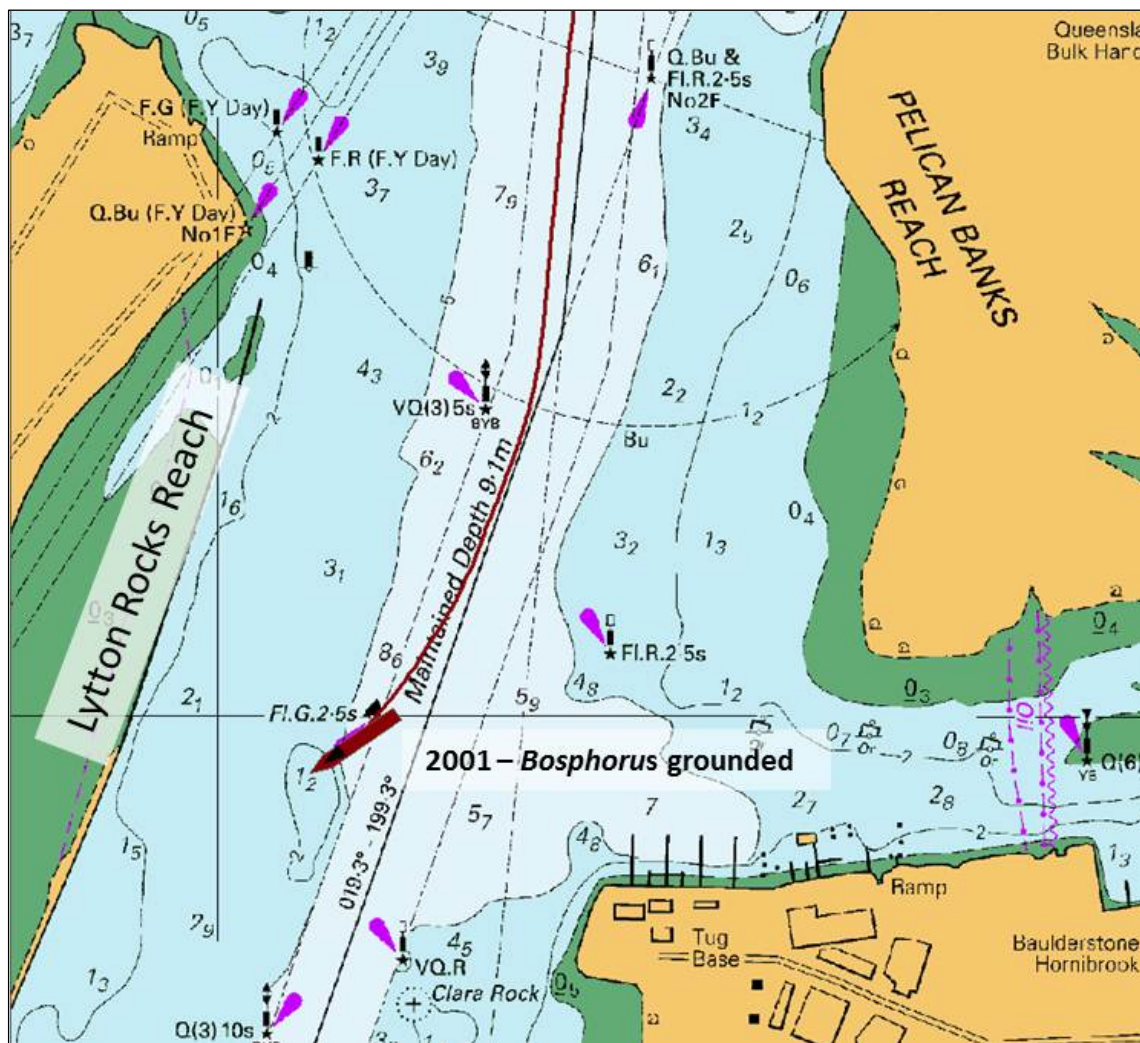
Figure 4: Section of navigational Chart AUS 237 showing the ship's track and grounding

At 2001, *Bosphorus* grounded in position 27° 24.0' S; 153° 09.1' E at the Lytton Rocks Reach Channel (Figure 4).

On 2 November, *Bosphorus* departed the berth and was anchored in Morton Bay to facilitate an underwater hull inspection. Minor scraping to the ship's hull and slight damage to the propeller was identified. The ship remained at anchor until the afternoon of 3 November, when it was berthed at Fisherman Islands container terminal to resume its service.
