Report N° AET/TM-2016/01

**Fatal accident on board *Juan Sebastian de Elcano*
on 3 November 2014**

Administration des enquêtes techniques (AET)

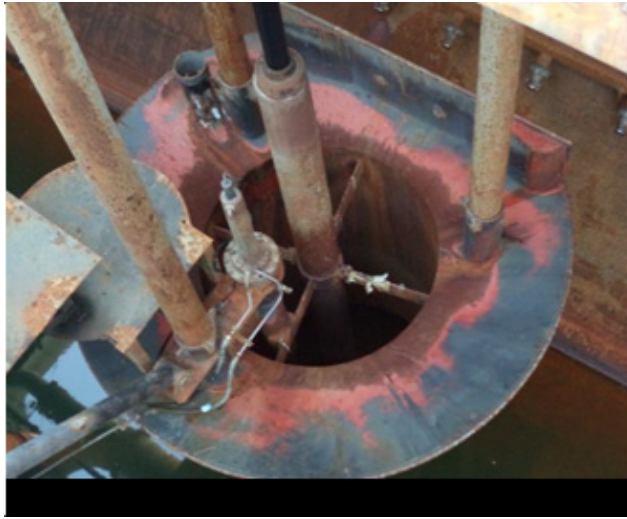
At around 10:00 AM, during coffee break, the crew started filling the hopper. The fore overflow was positioned at 11.82 m, while the aft overflow was blinded off.

Figure 3.1 - Fore Overflow
(Source: Operator)

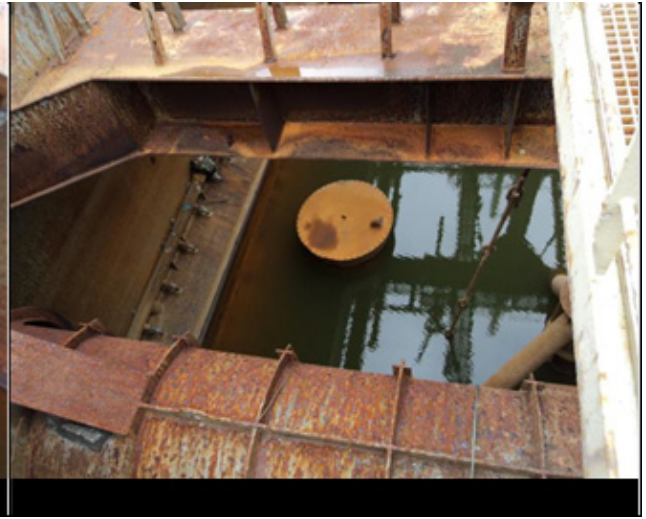
Figure 3.2 - Blinded Aft Overflow
(Source: Operator)

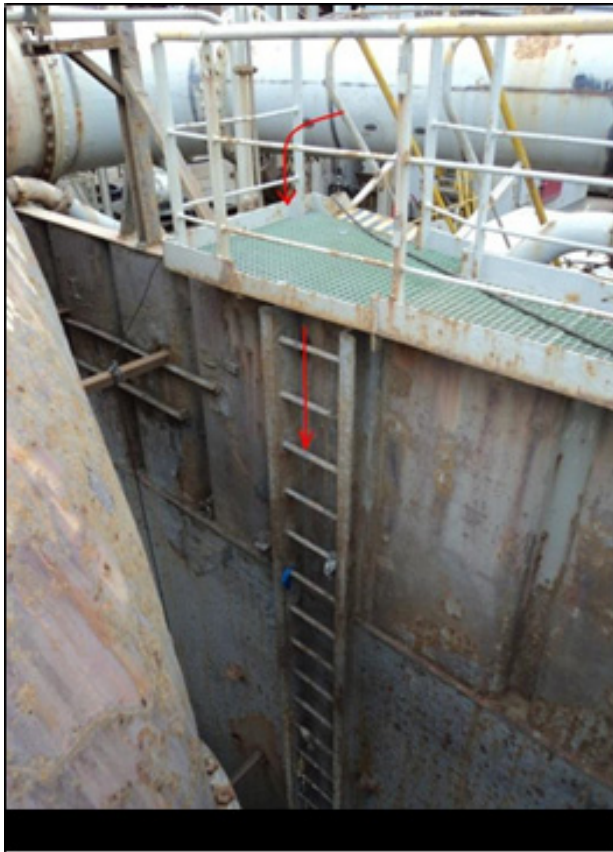
Figure 3.3 - Aft 'Out-of-use' Ladder into hopper
(Source: Operator)

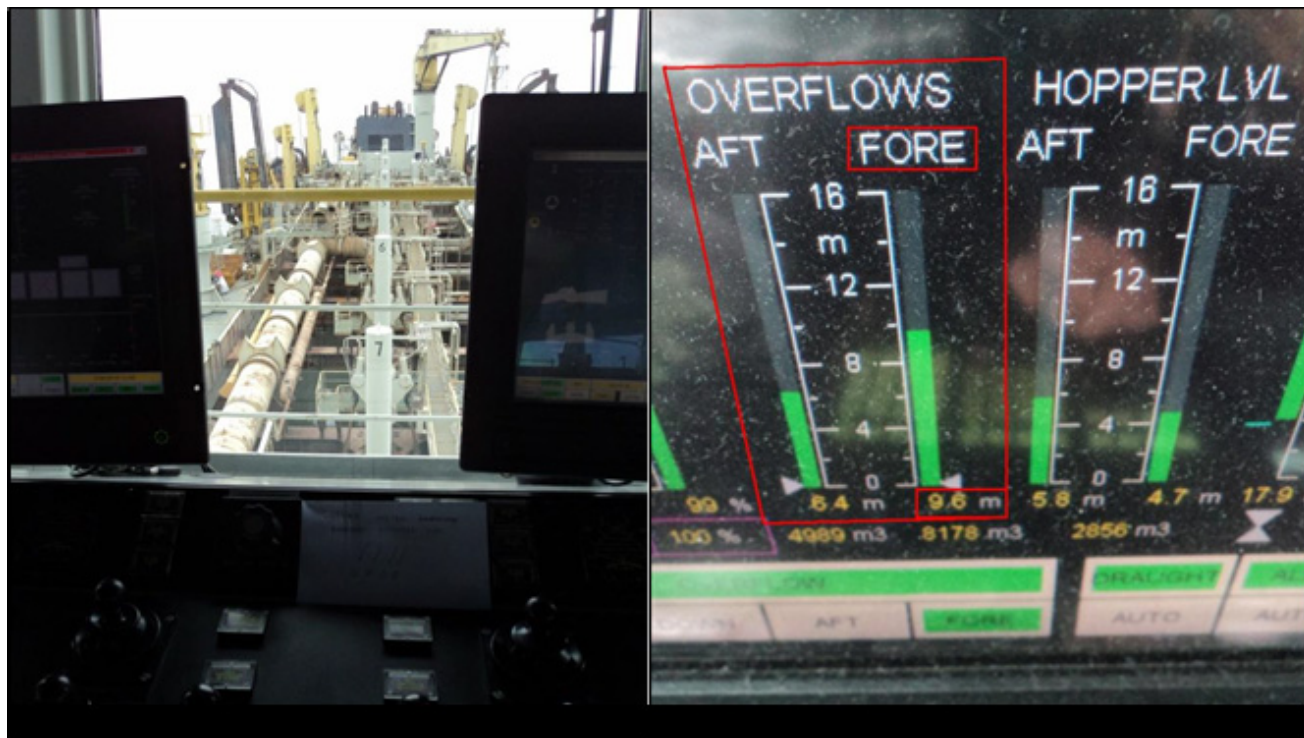
Figure 3.6 - View from Dredge Desk over the Hopper (Source: Operator) **Figure 3.7** - Overflow Level (4 Nov. 2014) (Source: Operator)

The initial position of the overflow was 11.82 m. When the overflow started to move down, both Pipe Operators were still at SB aft inside the unsecured boat in the hopper. They started to paddle to the front PS of the hopper. The boat moved forward and towards the overflow due to the current induced by the outflow of the water through the overflow.

At around 11:07 AM, the lowest position of the overflow reached 8.62 m (-3.20 m in 1'39") and within another minute, the final position of the overflow settled at 9.62 m (-2.21 m since initial position in 2'30"; +1.00 m in 51").

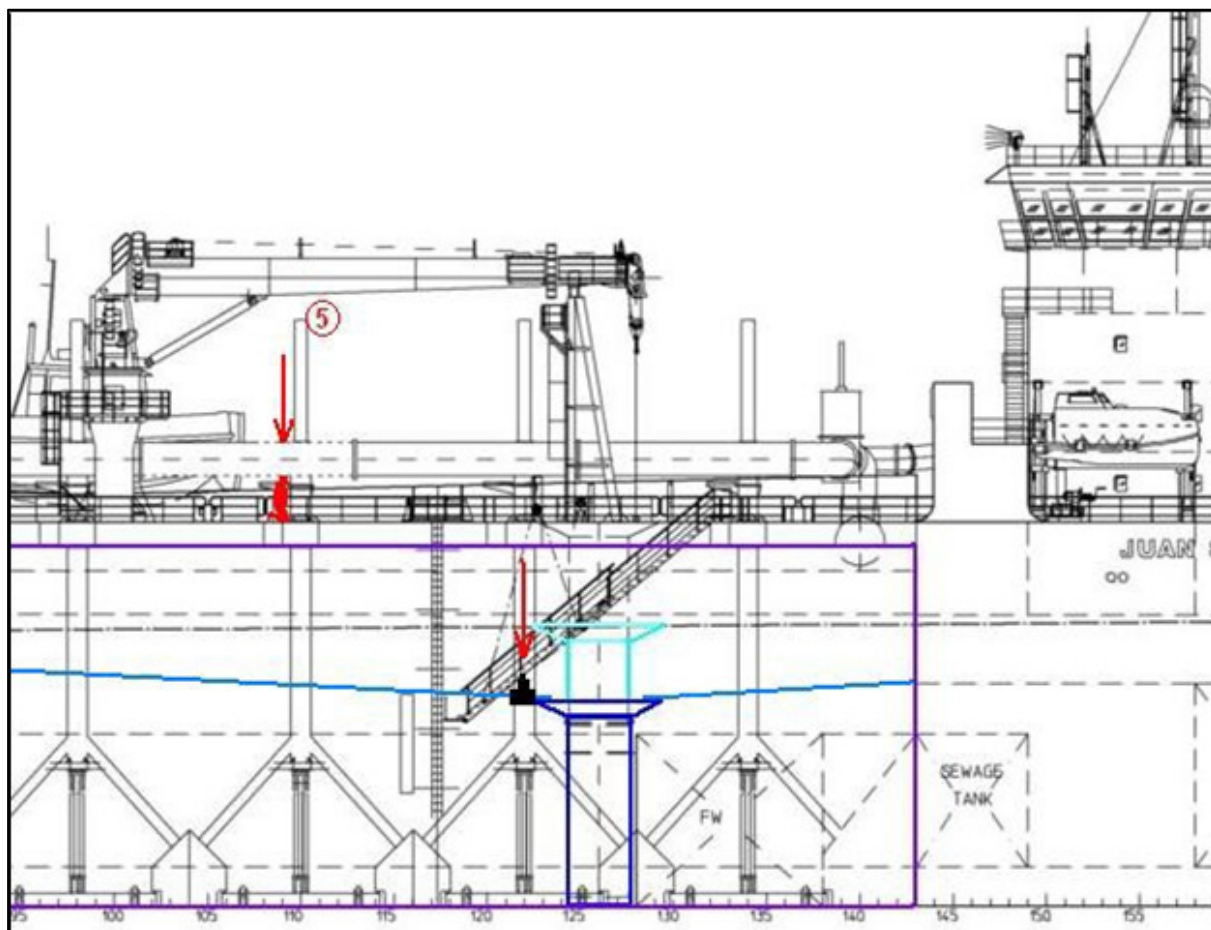
At approximately 11:10 AM, the apprentice electrician, who was disconnecting the measurement sensor of bottom door no. 5 above the hopper, heard unusual noises coming from the hopper. He stepped up from behind his work position to look into the hopper and saw the small boat upside down on the overflow. He couldn't see any of the operators inside the boat and started running towards the bridge, shouting for help.

Figure 3.8 - Position Apprentice Electrician (Longitudinal Section)
(Source: Operator)

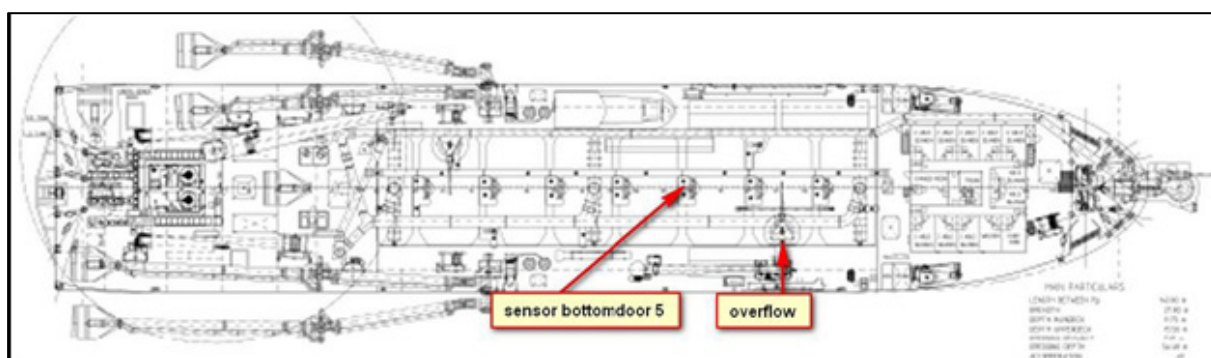
Figure 3.9 - Position Apprentice Electrician (Top View)
(Source: Operator)

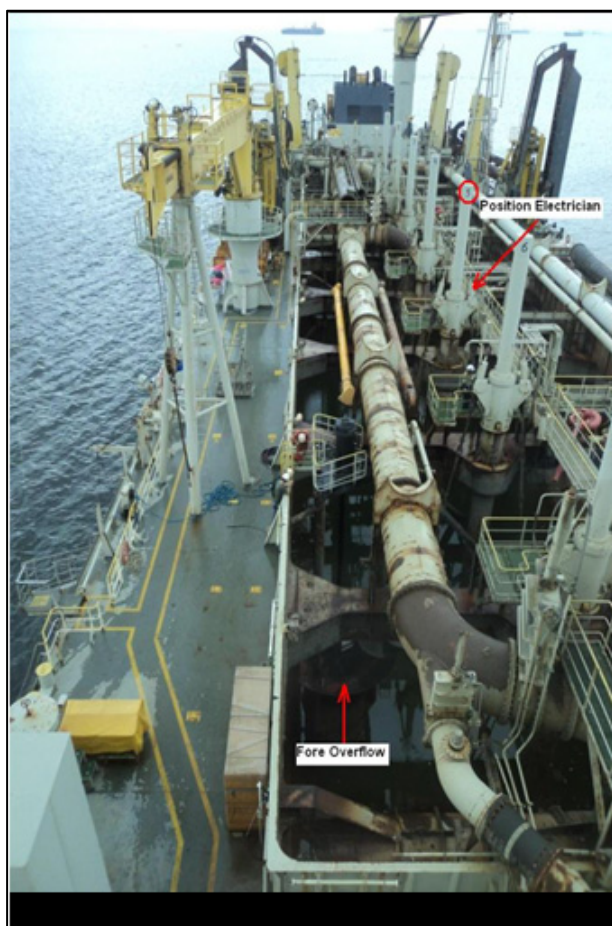
Figure 3.11 - Position Apprentice Electrician
(Source: Operator)

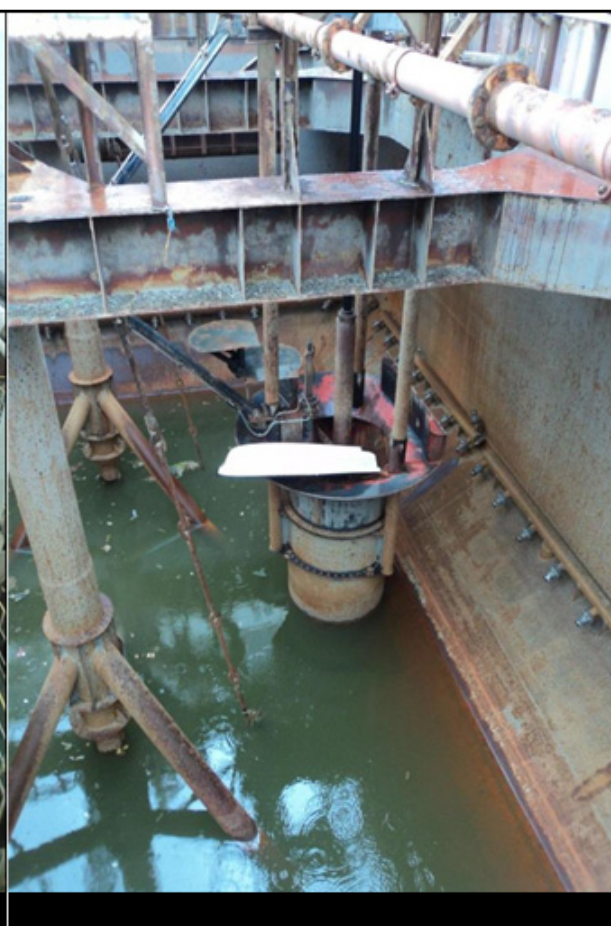
According to the 2nd Pipe Operator (day shift), the boat bumped into the overflow due to the strong current induced by the outflowing water. At that point, the Apprentice Pipe Operator stood up and tried to get a hold at a part of the overflow structure. It can be assumed that due to the weight shift, the boat became unstable and capsized. The two occupants subsequently fell overboard into the hopper and got sucked through the overflow.

Figure 3.12 - Overturned boat on fore overflow
(Source: Operator)

The event shows that the strength of the current induced by lowering the overflow too rapidly can be hazardous for a small unsecured boat or a person in the hopper. In general, lowering the water level in the hopper is likely to create a highly dynamic and uncontrollable environment and thus raise the risk for personnel working in that environment above ALARP. It should therefore be stressed that in order to control the increased risk, no person should be in the hopper and the boat should be secured during every water level change.

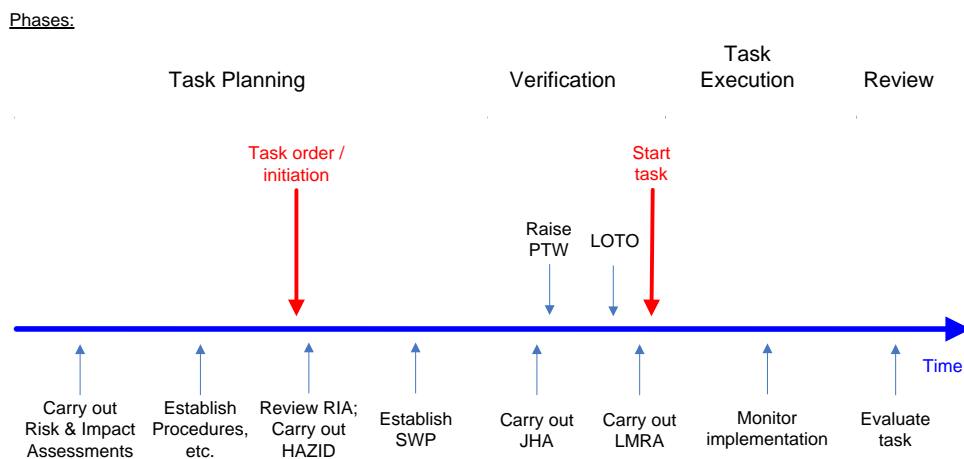
Figure 3.2.2.1.: Hazard Management Timeline (Source: Operator)

In accordance with the HM system, for tasks contained in the Risk and Impact Assessment register, a number of assessments shall be carried out before the start of the task (Fig. 3.2.2.1.: Hazard Management Timeline). Since the task was not part of the Risk and Impact Assessment register, neither the Job Hazard Analysis defined in the HM system, nor the associated Hazard Management (Risk Assessment Procedure) was available at the time of the occurrence and there was no operational Safe Work Practice for the performed task at the time.
