# **Final Report No. 2384**

## **by the Swiss Transportation Safety Investigation Board STSB**

concerning the serious incident involving  
the aircraft PA-28-181, LX-AVA,

on 19 July 2020

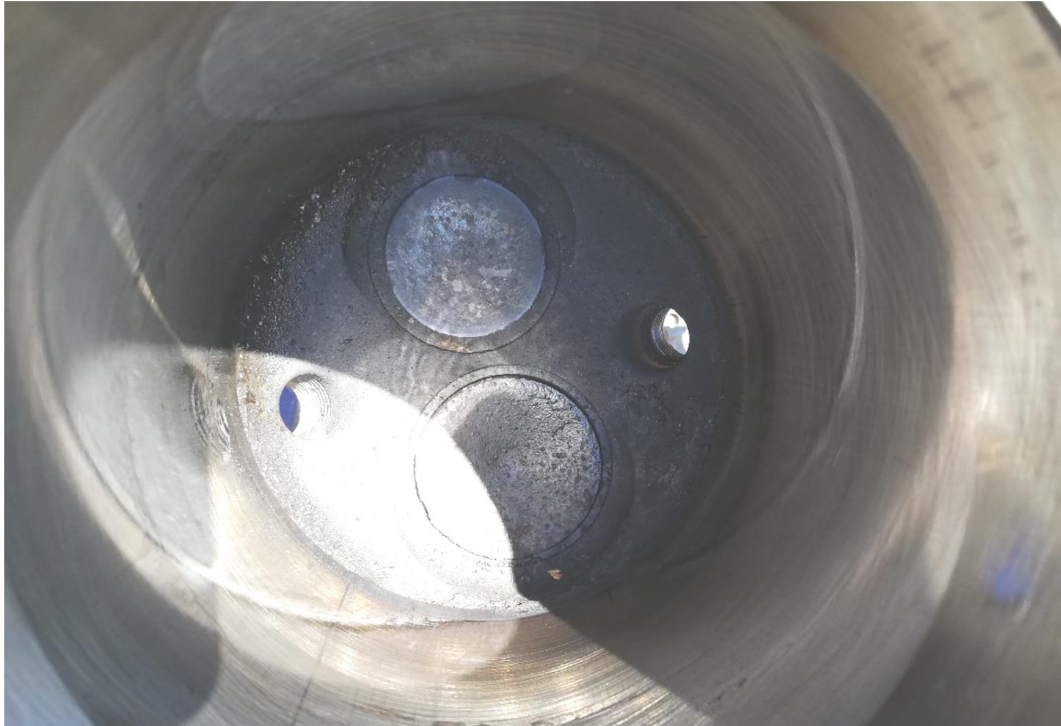
The inspection carried out on the aircraft on 30 July 2020 revealed that the compression on the No. 3 cylinder was very low. The piston and its associated piston rings showed no damage. The usual burn residues were visible on the intake and exhaust valves of cylinder No. 3 (cf. figure 2 on the following page).

**Figure 2:** Combustion residues on the intake and exhaust valves of cylinder no. 3.

The loss of compression on cylinder no. 3. was due to a leaking intake or exhaust valve. This is mainly caused by combustion residues such as carbon particles or lead from the use of aviation gasoline (AVGAS), which stick between the valve surface and the valve seat and thus can prevent the valves from closing completely. In exceptional cases, burnt or warped valves can also be responsible for a leak, but this can rather be excluded in the present case.

The loss of engine power during climb, resulting in the serious incident, is due to a loss of compression of cylinder No. 3 caused by a leaking intake or exhaust valve.

After the installation of a new cylinder as well as new valves, piston and piston rings, the engine then delivered the required power during the test run.
