Final Report No. 2384

concerning the serious incident involving
the aircraft PA-28-181, LX-AVA,

on 19 July 2020

approximately 2 km west of the airport
St. Gallen-Altenrhein (LSZR)

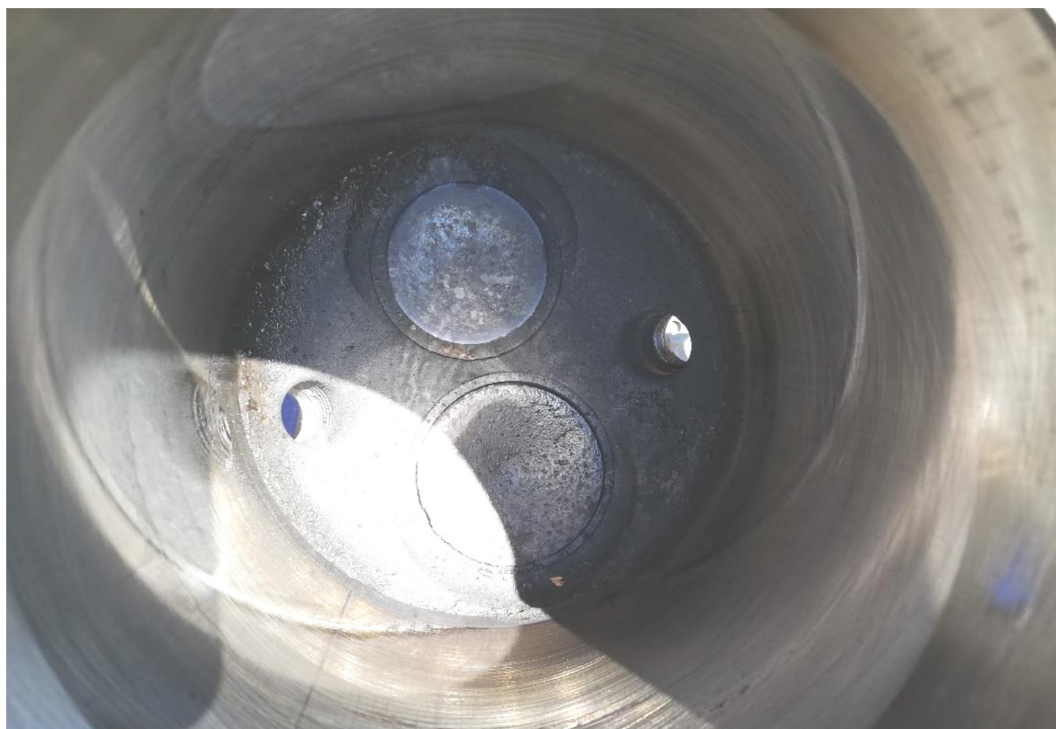
The inspection carried out on the aircraft on 30 July 2020 revealed that the compression on the No. 3 cylinder was very low. The piston and its associated piston rings showed no damage. The usual burn residues were visible on the intake and exhaust valves of cylinder No. 3 (cf. figure 2 on the following page).

Figure 2: Combustion residues on the intake and exhaust valves of cylinder no. 3.

The loss of compression on cylinder no. 3. was due to a leaking intake or exhaust valve. This is mainly caused by combustion residues such as carbon particles or lead from the use of aviation gasoline (AVGAS), which stick between the valve surface and the valve seat and thus can prevent the valves from closing completely. In exceptional cases, burnt or warped valves can also be responsible for a leak, but this can rather be excluded in the present case.

The loss of engine power during climb, resulting in the serious incident, is due to a loss of compression of cylinder No. 3 caused by a leaking intake or exhaust valve.

After the installation of a new cylinder as well as new valves, piston and piston rings, the engine then delivered the required power during the test run.
