## Accident to the Pilatus – PC-12 - 47E registered LX-JFD

on 30 March 2020

on approach to Nice-Côte-d'Azur airport (Alpes-Maritimes)

## In-flight lightning strike, structural damage observed on ground

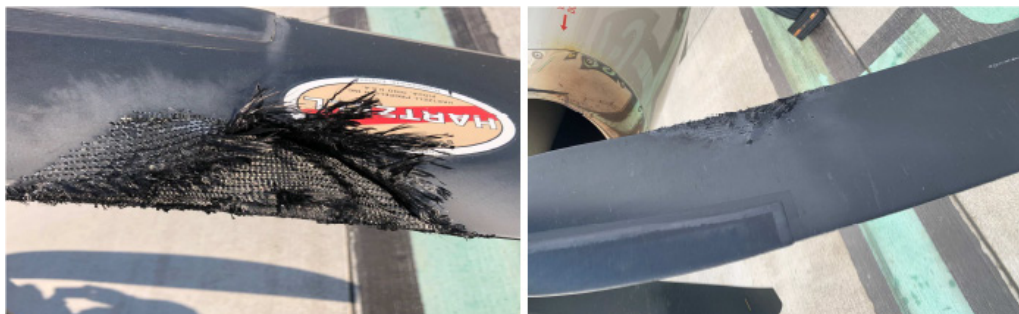
One of the propeller blades was damaged by the lightning (see Figure 2).

The main damage was located in the trailing edge area of the blade. This area is composed of foam and approximately 1 mm-thick carbon fabric ply. This area is not considered as structural. The blade was not repairable.

Figure 2: Damage observed on a propeller blade

The propeller manufacturer had never previously observed this type of damage in operation due to an in-flight lightning strike. In its experience, the damage occurs near the blade tips and several blades are generally affected. The particular nature of this damage could correspond to an exit point rather than an entry point, i.e. the lightning travelling through the aircraft airframe towards the blade and not from the air towards the blade. The severity of this lightning strike is similar to what can be observed in the laboratory during the propeller certification and corresponds to relatively high energy. The propeller manufacturer considered that the damaged blade was still structurally solid in the spar area and that the propeller could continue to operate without failure or rupture.

After replacing the blade, the propeller was overhauled and then reinstalled on the aircraft.

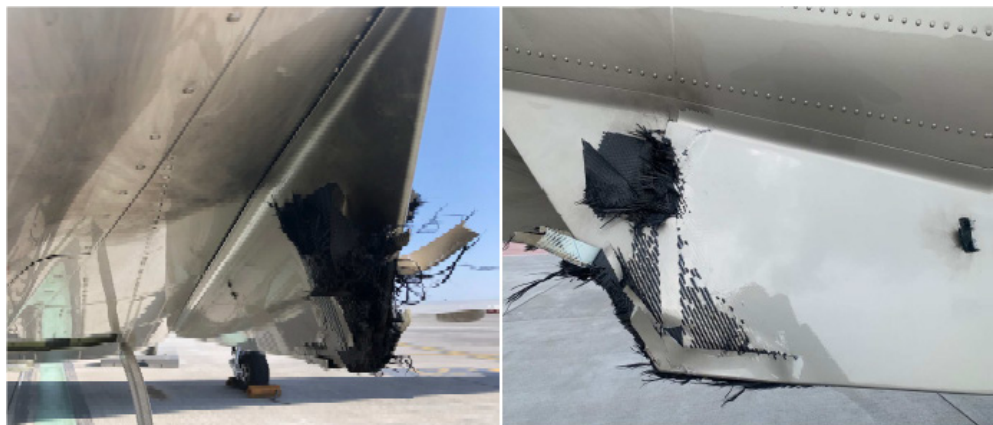
The right ventral fin was damaged by the lightning (see Figure 3).

Figure 3: Damage observed on right ventral fin

After repair, the ventral fin was reinstalled on the aircraft.

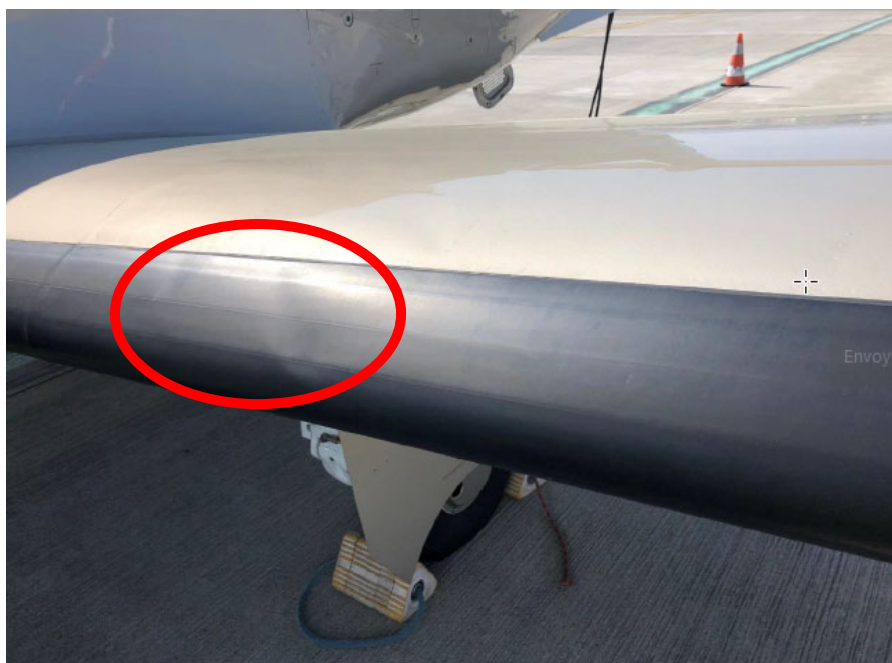
The damage observed by the maintenance personnel consisted of deformations of the left wing skin, at the leading edge and under the wing (see [Figures 5](#) and [6](#)).

Figure 5: Deformations observed on left wing leading edge

Signs of major structural damage were observed on the skin of the left wing in the form of diagonal folds/creases in several places. The arm of the outboard flap mechanism was permanently deformed.

The observations made on the aircraft seem to support the hypothesis of high loads in flight rather than a hard landing.

The left wing and certain parts of the trailing edge flap had to be replaced to return the aircraft to service.

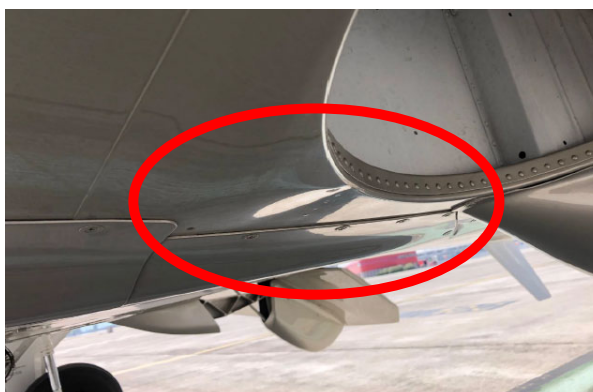
Figure 6: Deformations observed on lower surface of left wing
