EMERGENCY LANDING OF A CESSNA C177 NEAR STEGEN (L) ON 18 JANUARY 2015

DATE OF ISSUE: 14 DECEMBER 2018

Report N° AET/AC-2018/02

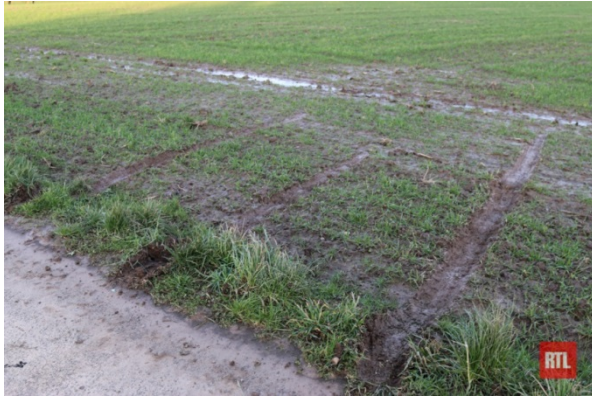
The selected field was bordered by a paved rural road on the east side, which was the side the pilot was approaching from. The aircraft first touched down in the adjoining field to the east of the rural road, approximately 3.5 m from the road, leaving visible marks in the muddy soil. It should be noted that the paved rural road is elevated by approximately 10 cm in relation to the adjoining fields. The tire marks continued for about 2 m across the rural road before disappearing. Small pieces of the nose wheel fairing could be found in close proximity to the rural road, leading to the conclusion that the nose wheel fairing had been damaged when impacting that road.

Tire marks from first touchdown

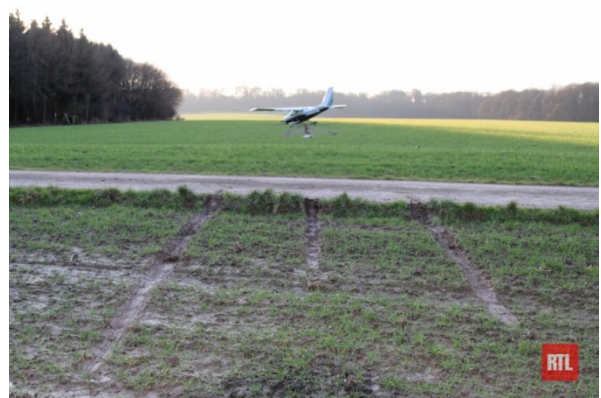
After the initial touch-down, while crossing the rural road, the aircraft became airborne again (absence of tire marks in the muddy soil). About 23 m further west, the tire marks reappeared. Based on the marks in the field, the aircraft's second touch-down was in a nose-down attitude. The nose wheel fairing then probably detached from the aircraft and came to rest in that area. Approximately 5 m after the second touchdown, the propeller impacted the muddy field several times, indicating that it was still turning. Approximately 10 m further down, the nose wheel broke off.

Elevated rural road crossing the fields

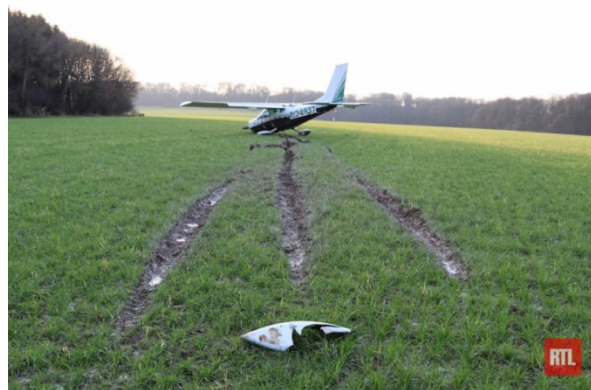
Tire marks from second touchdown

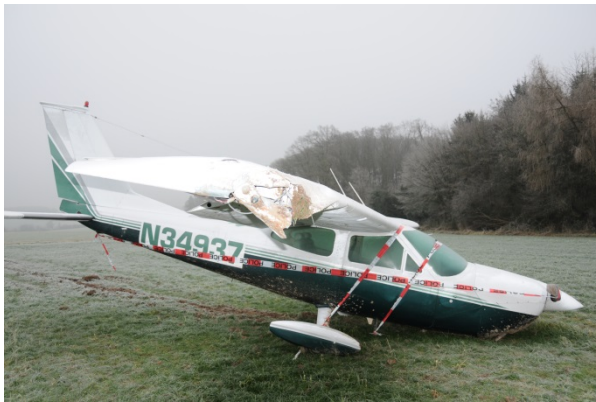
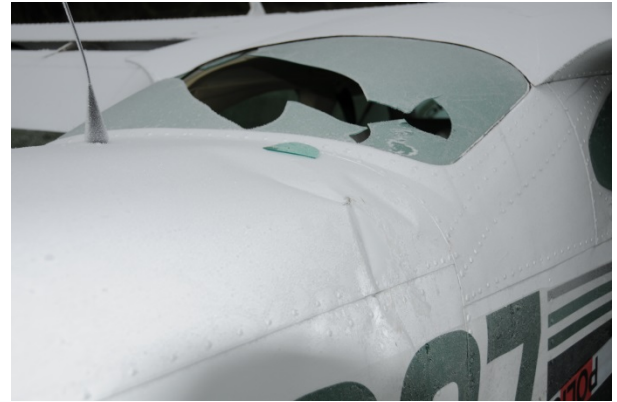
The aircraft sustained damage to the rear fuselage structure, the propeller, the nose and main landing gear, the right wing and the rear back window and was subsequently written off.
