SERIOUS INCIDENT

Aircraft Type and Registration:	Boeing 747-8R7F, LX-VCF	
No & Type of Engines:	4 x GEnx-2B67 turbofan engines	
Year of Manufacture:	2012	
Date & Time (UTC):	30 March 2017 at 1216 hrs	
Location:	En route from Houston to Prestwick	
Type of Flight:	Commercial Air Transport (Cargo)	
Persons on Board:	Crew - 3	Passengers - None
Injuries:	Crew - None	Passengers - N/A
Nature of Damage:	Extensive fuel contamination of aircraft interior and wiring	
Commander's Licence:	Airline Transport Pilot's Licence	
Commander's Age:	52 years	
Commander's Flying Experience:	12,900 hours (of which 9,200 were on type) Last 90 days - 164 hours Last 28 days - 47 hours	
Information Source:	AAIB Field Investigation

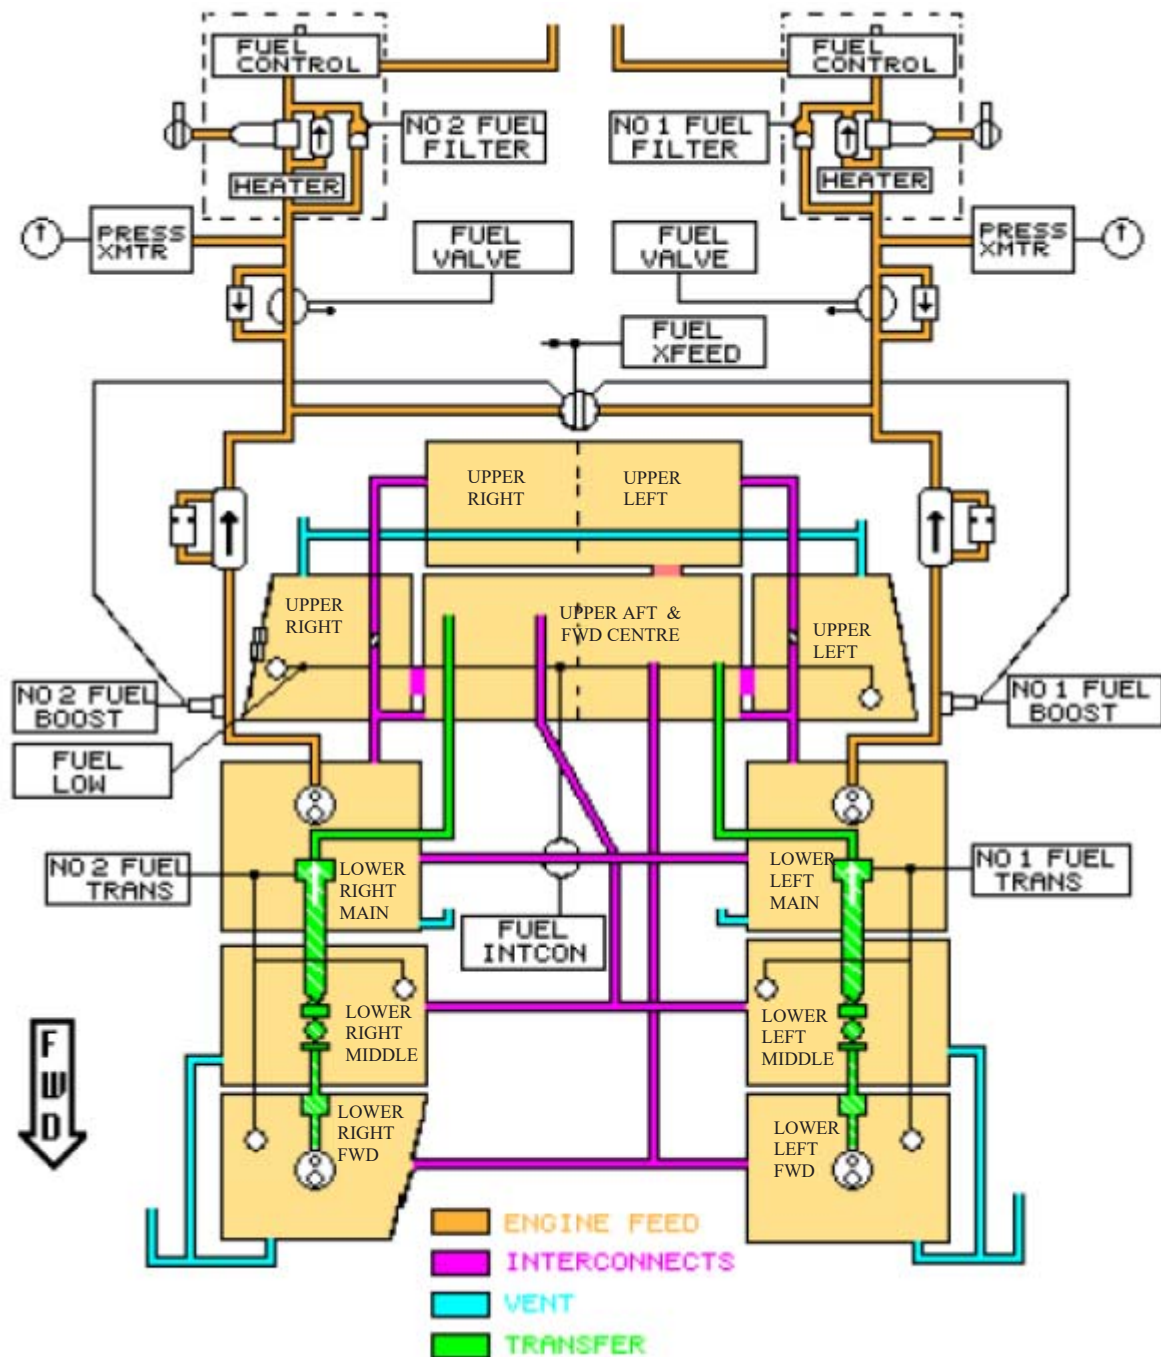
Figure 4

Bell 412EP Simplified fuel system schematic (Note: auxiliary tank not shown)

During the post-incident inspection at Prestwick, the helicopter battery was observed to be disconnected; therefore, none of the helicopter fuel pumps could have operated during the incident flight. The investigation considered that possible routes for fuel to escape from the helicopter could have included: via the sump drain valves, defuelling valves, the fuel vent lines or a loose connection in a fuel system interconnect line.
