SERIOUS INCIDENT

Aircraft Type and Registration:	Boeing 747-8R7F, LX-VCF	
No & Type of Engines:	4 x GEnx-2B67 turbofan engines	
Year of Manufacture:	2012	
Date & Time (UTC):	30 March 2017 at 1216 hrs	
Location:	En route from Houston to Prestwick	
Type of Flight:	Commercial Air Transport (Cargo)	
Persons on Board:	Crew - 3	Passengers - None
Injuries:	Crew - None	Passengers - N/A
Nature of Damage:	Extensive fuel contamination of aircraft interior and wiring	
Commander's Licence:	Airline Transport Pilot's Licence	
Commander's Age:	52 years	
Commander's Flying Experience:	12,900 hours (of which 9,200 were on type) Last 90 days - 164 hours Last 28 days - 47 hours	
Information Source:	AAIB Field Investigation

Synopsis

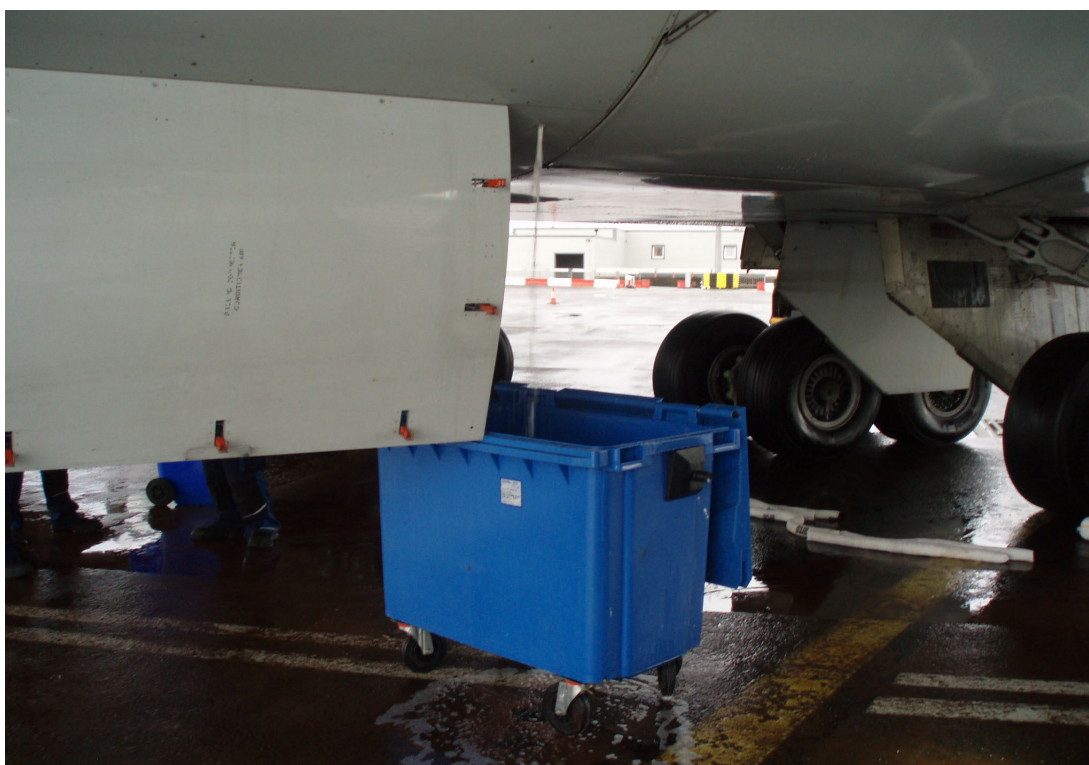
Figure 1

flight crew were shutting down the engines they smelled fuel. When the ground operations agent entered the aircraft via the main deck door to commence unloading operations, he too detected a strong smell of aviation fuel and heard the sound of running liquid. He identified the source as a Bell 412EP helicopter, which was being shipped as cargo on the main deck of the aircraft and noted that fuel appeared to be leaking from a vent on the forward right-hand side of the helicopter. The ground operations agent reported the situation to the flight crew. The Airport Authority and RFFS were notified and the airport emergency response plan was activated. The flight crew shut down the aircraft and opened the escape hatch and upper deck service door to ventilate the aircraft. Upon arrival at the aircraft the RFFS noted that fuel was coming out of the bottom of LX-VCF's fuselage, close to the left body landing gear, having leaked through the main deck, lower deck and avionics bay and was pooling on the apron beneath the aircraft (Figure 1). The aircraft was evacuated, electrically isolated and quarantined by the RFFS. The RFFS subsequently stated that the measured fuel vapour levels indicated a high risk of explosion and that the fuel flammability limits were potentially in range. After the aircraft had been made safe, all cargo, including the helicopter, was offloaded manually.

Fuel exiting lower fuselage of LX-VCF
