PRELIMINARY REPORT

Righthand Body Landing Gear separation during
landing of a Boeing B747-4R7F registered LX-OCV
and operated by Cargolux Airlines International
S.A. on runway 06 at Luxembourg Airport (ELLX)
on 14 May 2023

DATE OF ISSUE: 6 August 2024

Report N° AET/AC-2024/01

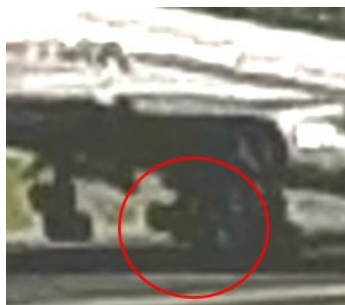
Fig. 1-1

Airport surveillance video footage showed that after becoming airborne, the RH BLG wheel truck initially rotated to a normal pitch-up position (Fig. 1-1) before an over-extension of the strut could be observed (Fig. 1-2). The over-extension was accompanied by a vapor release. During climb out, the RH BLG wheel truck could be observed in a pitch-down position (Fig. 1-3). The same pitch-down position could also be observed on a publicly available landing video⁴, up to the point of the RH BLG separation on touchdown.

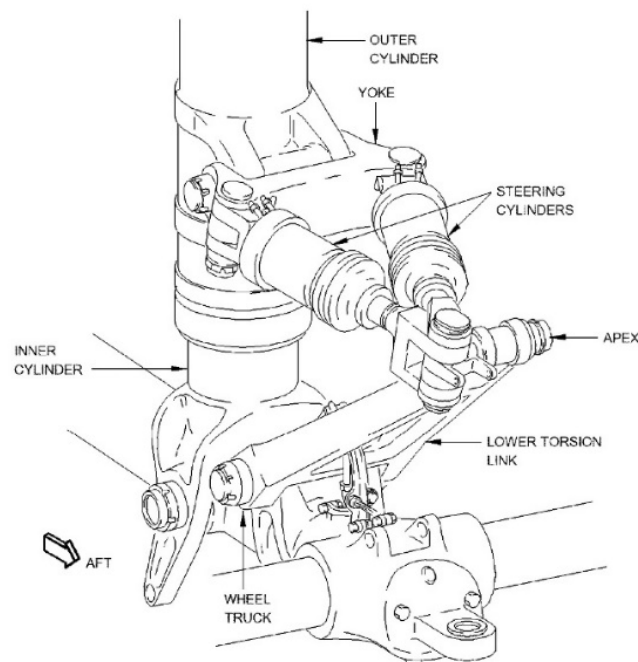
Fig. 2 (Source: The Boeing Company)

During normal operation of the BLG (Fig. 2), the Truck Positioning Actuator (TPA) tilts the wheel truck to a 7° pitch-up position to ensure the correct positioning for the gear retraction sequence. The piston rod of the TPA was found fractured near the actuator body after the occurrence. In case of failure of the TPA, the wheel truck would still pitch up due to the weight of the lower torsion link and the steering cylinders that attach aft of the gear truck pivot joint.

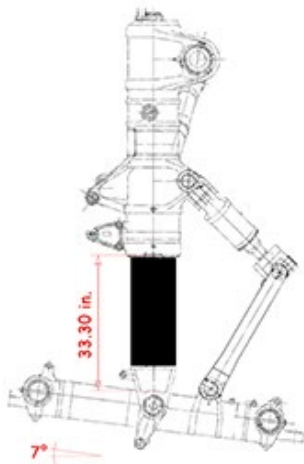
Fig. 3-1

The pitch-down position of the wheel truck after takeoff indicates an over-extension of the shock strut. According to the Aircraft Maintenance Manual (AMM)⁶, in fully extended condition with the Upper Bearing and Snubber Valve stopping against the Follower Tube, the Inner Cylinder extends to 33.30 inches (Fig. 3-1⁷). A kinematic diagram provided by the manufacturer showed that in case of an over-extension of the shock strut beyond the fully extended condition, the steering yoke contacts the outer cylinder steering yoke attach lugs at an angle of approximately 32° (Fig. 3-2), with an over-extension of approximately 7 inches. Based on the truck pivot and torsion linkage attachment geometry, any further over-extension beyond that position will induce a pitch-down movement of the gear truck and the TPA must expand (or fail) against its commanded pitch-up position.

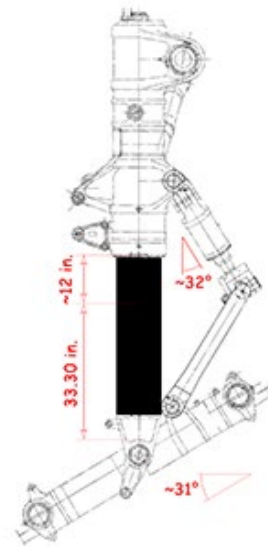
Fig. 3-3

The over-extension of the shock strut is limited by the steering mechanism assembly to a value of approximately 12 inches beyond the fully extended condition, where the lower torsion link to truck attach lugs contact the inner cylinder and the gear truck reaches a pitch-down angle of approximately 31° (Fig. 3-3). The lack of contact witness marks on the attach lugs or the inner cylinder seems to indicate that this maximum over-extension condition was not reached during the investigated event.
