Serious Incident

- Final Summary Report -

AAIS Case N° AIFN/0004/2021

Smoke/Fire from Windshield Window

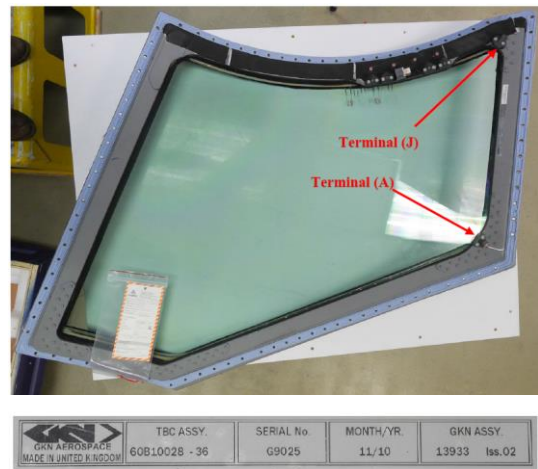
Figure 3. R1 Windshield s/n G9025 inside view and data tag

The windshield was removed from the shipment box and placed face down on the examination table. The windshield anti-ice power terminals (A) and (J) are identified in figure 3 below.

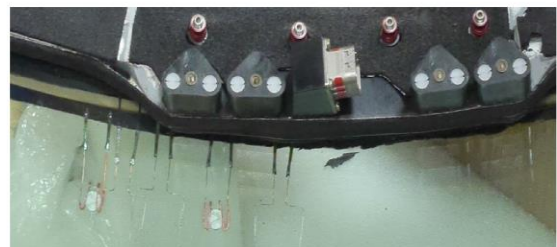
Figure 4. R1 Windshield s/n G9025 sense elements and connections

While conducting the physical examination, there were no defects noted with the sense elements and connections as shown in figure 4 below. There was no electrical testing performed at this time.

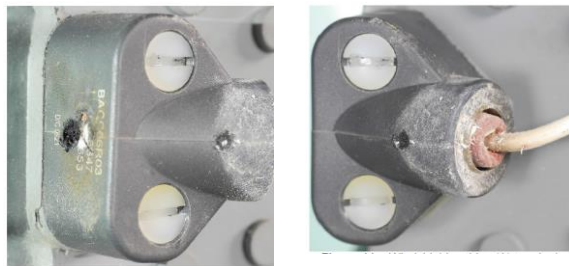
Figure 7. Windshield anti-ice terminal (A)

Evidence of heat damage was noted adjacent to the terminal (A) and deposited materials were noted on the transparency adjacent to (A). There were no defects noted on the terminal (J).

Evidence of discoloration due to heat was noted on the wire and case of the terminal (A) as shown in figures 7 and 8.

A hole was noted on the side of the terminal with evidence of heat damage. The windshield anti-ice terminals (A) and (J) were removed from the windshield assembly.

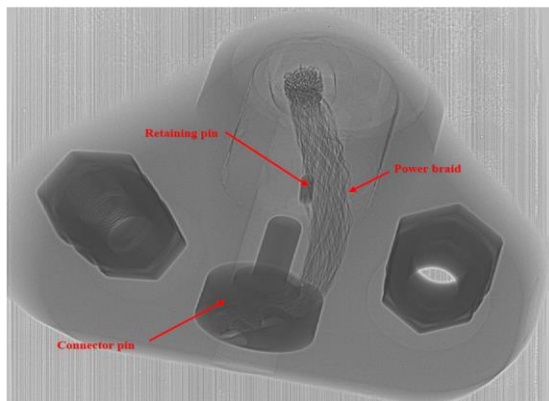
Figure 9. DR image of the terminal (J)

The X-ray digital radiography (DR) examinations were performed on windshield terminal (J) and (A) block assemblies as shown in figures 9 and 10. Parts inside the terminal (J) are the power braid wire, connector pin and retaining pin.

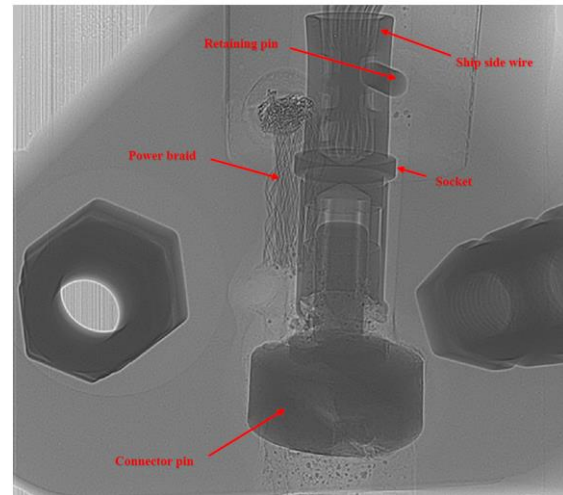
Figure 10. DR image of the terminal (A)

The part in the image of the terminal (A) shown in figure 10 are the power braid wire, connector pin, ship side wire and socket

The electrical arcing originated from the integrated power braid wire joint crimped at the connector base leading to degraded electrical conductivity within this terminal. The results from the CT scan images revealed that fractures of wire strands at a crimp point within the pin base caused the electrical resistance and heat buildup which generated electrical sparks and smoke.

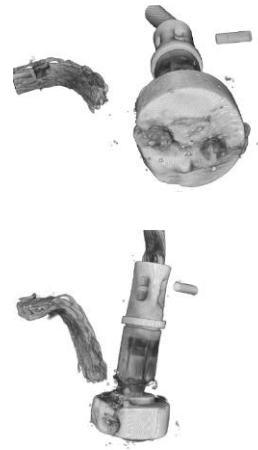
Figure 12. terminal (A) CT cross-section

The Air Accident Investigation Sector determines that the cause of the smoke and fire in the R1 window terminal block was the defective windshield thermal (anti-ice) heating electrical pin/socket terminal block consisting of a power braid wire crimped at the base pin.
