**SERIOUS INCIDENT**

<b>Aircraft Type and Registration:</b>	Bombardier Global 6000, LX-NST	
<b>No &amp; Type of Engines:</b>	2 Rolls Royce BR700 engines	
<b>Year of Manufacture:</b>	2017 (Serial no: 9814)	
<b>Date &amp; Time (UTC):</b>	7 April 2022 at 1625 hrs	
<b>Location:</b>	London Luton Airport	
<b>Type of Flight:</b>	Commercial	
<b>Persons on Board:</b>	Crew - 2	Passengers - None
<b>Injuries:</b>	Crew - None	Passengers - N/A
<b>Nature of Damage:</b>	Damage to right wing tip, flap fairing, leading edge slat and aileron	
<b>Commander's Licence:</b>	Airline Transport Pilot's Licence	
<b>Commander's Age:</b>	51 years	
<b>Commander's Flying Experience:</b>	7,200 hours (of which 1,350 were on type) Last 90 days - 34 hours Last 28 days - 0 hours	
<b>Information Source:</b>	AAIB Field Investigation

**Synopsis**

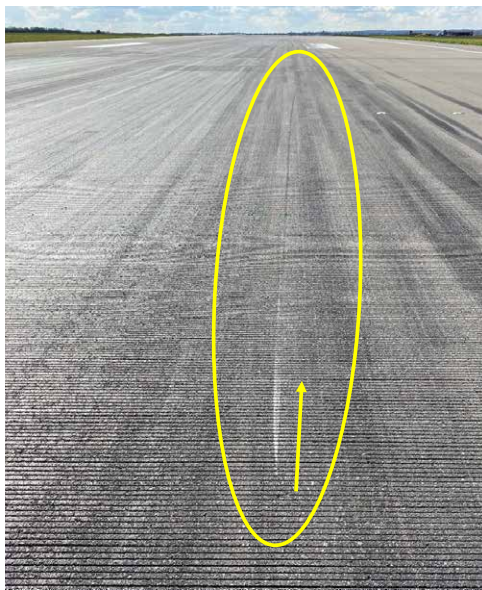
**Figure 1**

The aircraft had touched down on Runway 25 at Luton around the normal touchdown markers. There were marks visible from the right wing contacting the ground from around 390 m from the threshold of the runway for 18 m as shown in Figure 1.

Markings on Runway 25 with the arrow indicating the direction of landing

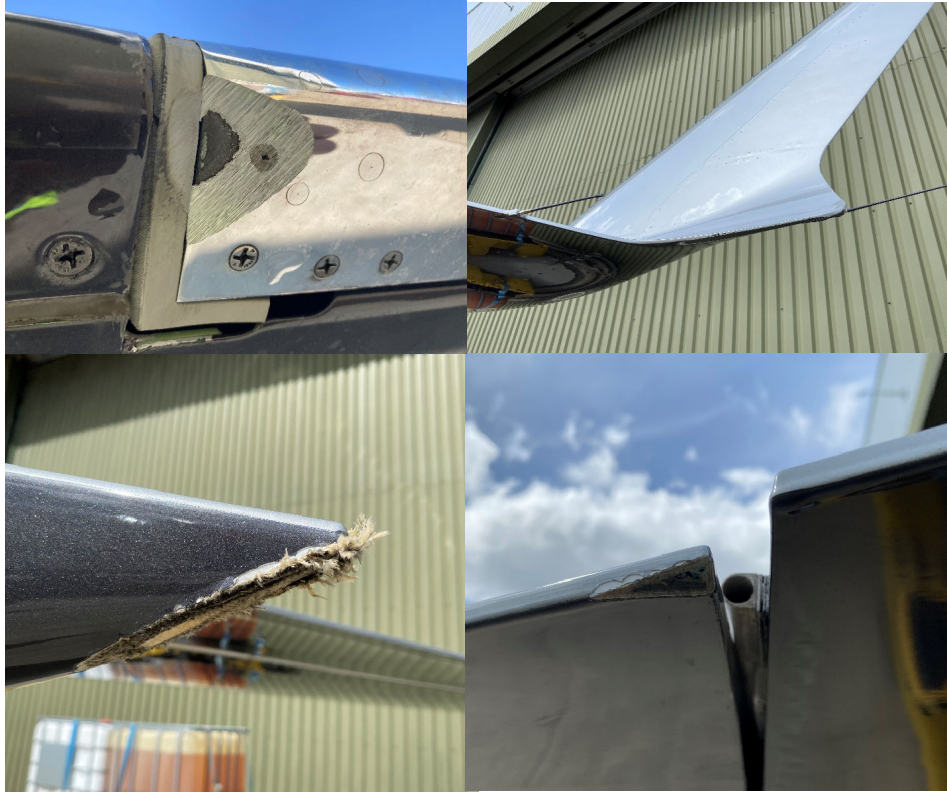
**Figure 2**

The winglet damage consisted of trailing edge and outboard skin damage. The flap fairing, which was composite construction, had been partly worn away. The outboard leading edge slat outer skin was damaged down to the second inner skin layer, and the aileron trailing edge lower outboard skin had been shaved off. Three of the static discharge wicks on the right aileron also required replacement. The damage is shown in Figure 2.

Damage to LX-NST Clockwise from top left – slat, winglet, aileron, flap fairing

The following parts were replaced:

- Right hand slat assembly
- Right hand aileron including three static dischargers
- Access panel

Repairs were made to the flap fairing and winglet trailing edge.

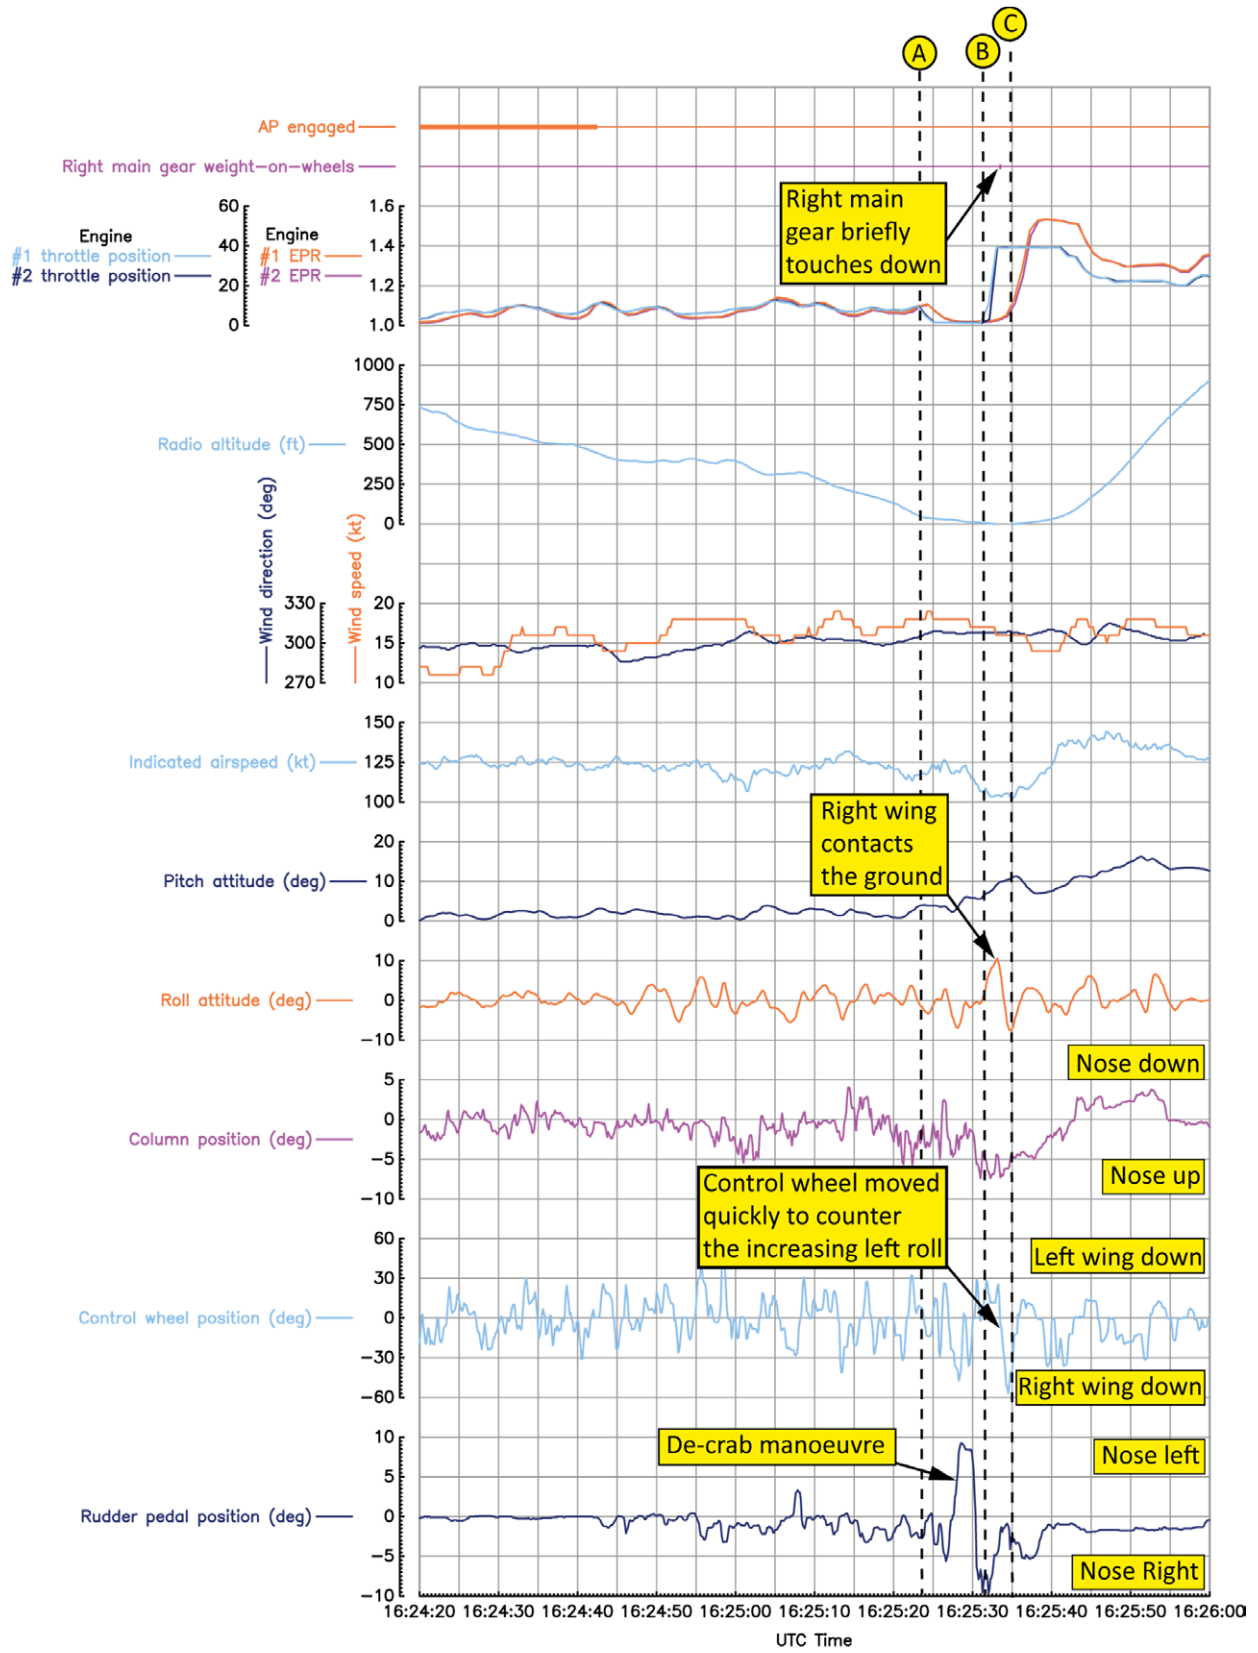
Figure 4

The recorded data, downloaded from the solid-state FDR fitted to LX-NST, showed that the autopilot was disengaged at 450 ft RA. In the windy conditions, significant activity was recorded on the controls, especially the control wheel position, and, after the autopilot was disengaged, on the rudder pedals. This resulted in larger roll perturbations, but the aircraft's flight path was generally well controlled. At point 'A' on Figure 4, at 50 ft RA, the ATS retarded the throttles towards idle. The wind, sampled four times a second and recorded by the anemometer situated near to the touchdown point of Runway 25, was from 308° at between 17 and 19 kt and varied little over the next 10 seconds – between point 'A' and point 'C'. Three seconds after the ATS had retarded the throttles, at approximately 25 ft RA, a significant nose-left rudder pedal demand and corresponding right-wing-down wheel input was made to de-crab the aircraft and align it with the runway. At approximately 10 ft RA, during the de-crab manoeuvre, the rudder and wheel position were reversed to demand a nose-right and left-wing-down correction, but almost immediately afterwards, at point 'B', the landing was aborted and the throttles were selected to full thrust. However, the aircraft rolled to the right and, before the engines had developed a substantial increase in thrust, reached 10.5° right angle of bank with a pitch attitude of 9.5°. At this point, the right main gear briefly touched down and the wing contacted the ground. The aircraft then began to roll rapidly left to 7.5° angle of bank, which was countered by a large, swift right-wing-down wheel input. Shortly afterwards, at point 'C' – three seconds after the selection of TOGA, the engine thrust began to increase significantly and the aircraft began to climb away.

Flight data from LX-NST's approach and bailed landing

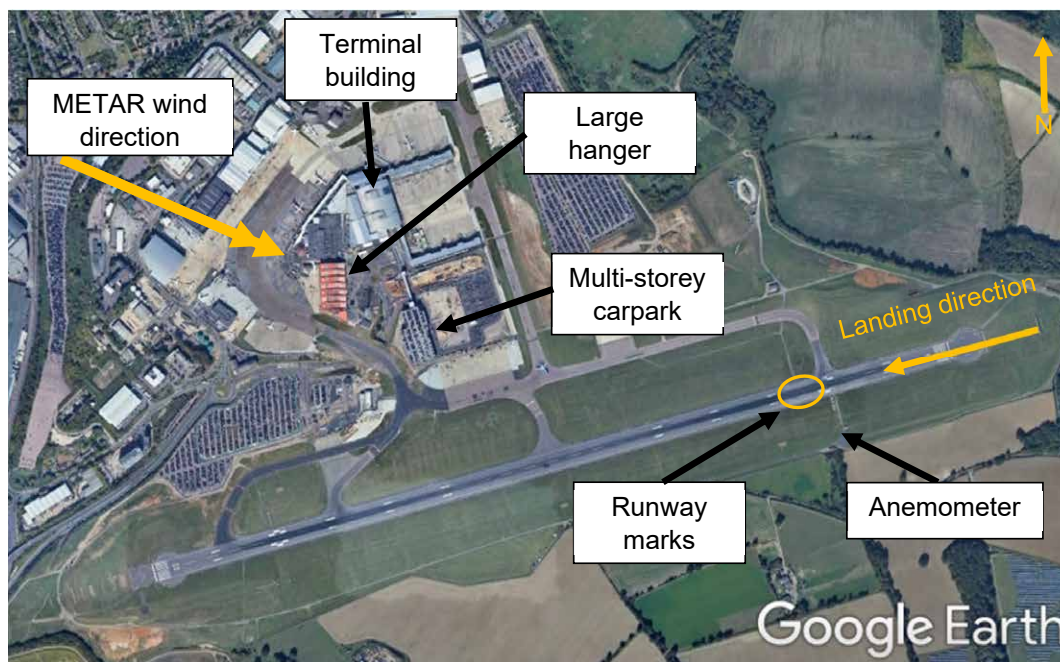
**Figure 6**  
Luton Airport layout

Luton Airport has a single runway orientated 07/25. The airfield sits on a hill at 526 ft amsl. The terminal and associated buildings are to the north of the runway and include a multistorey carpark which is 325 m from the centreline. Figure 6 shows these buildings in relation to the wind from the METAR and area in which the aircraft wing made contact with the runway.

The layout of Luton Airport has a large multistorey car park, hangars and the terminal building to the northwest of the touchdown zone. This can mean that with a strong north-westerly wind, there can be turbulence and variations in the wind as aircraft land on Runway 25. Although the wind data from Luton does not show a large shift in wind direction or strength during the baulked landing, it is possible that the aircraft was affected by low-level turbulence or wind changes that did not reach the airport anemometer position and therefore are not recorded.
