FINAL REPORT

FATAL OCCUPATIONAL ACCIDENT ON BOARD OF THE VESSEL MV MEDI ZUOZ ON 4 APRIL 2019

Report N° AET/TM-2020/01

**Fatal occupational accident on board of the vessel MV Medi Zuoz
on 4 April 2019**

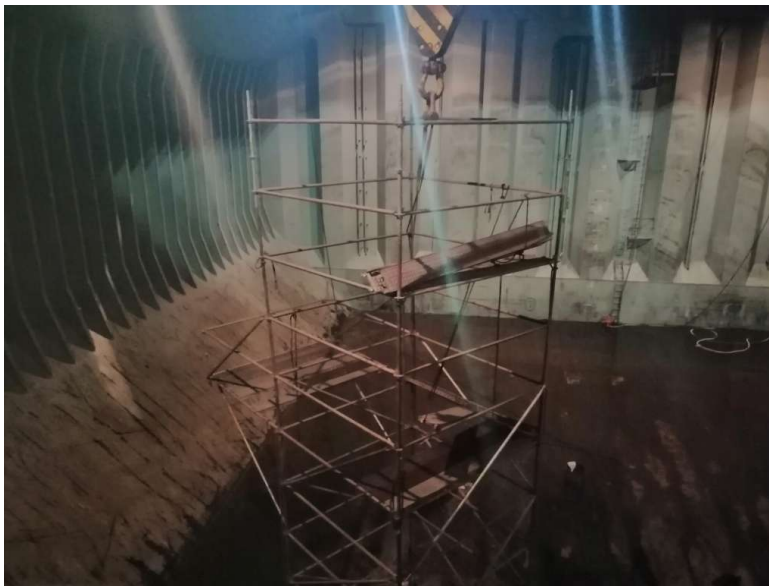
A shore contract worker climbed up the scaffolding tower to properly attach the ropes to the crane so that the tower could eventually be moved to the next hold. While climbing up the scaffolding tower, the unsecured contract worker lost balance, fell on the tank top and was seriously injured. It was later established that one of the two ropes used to connect the tower to the crane hook had broken.

Figure 1.1 - Picture taken on scene after the accident

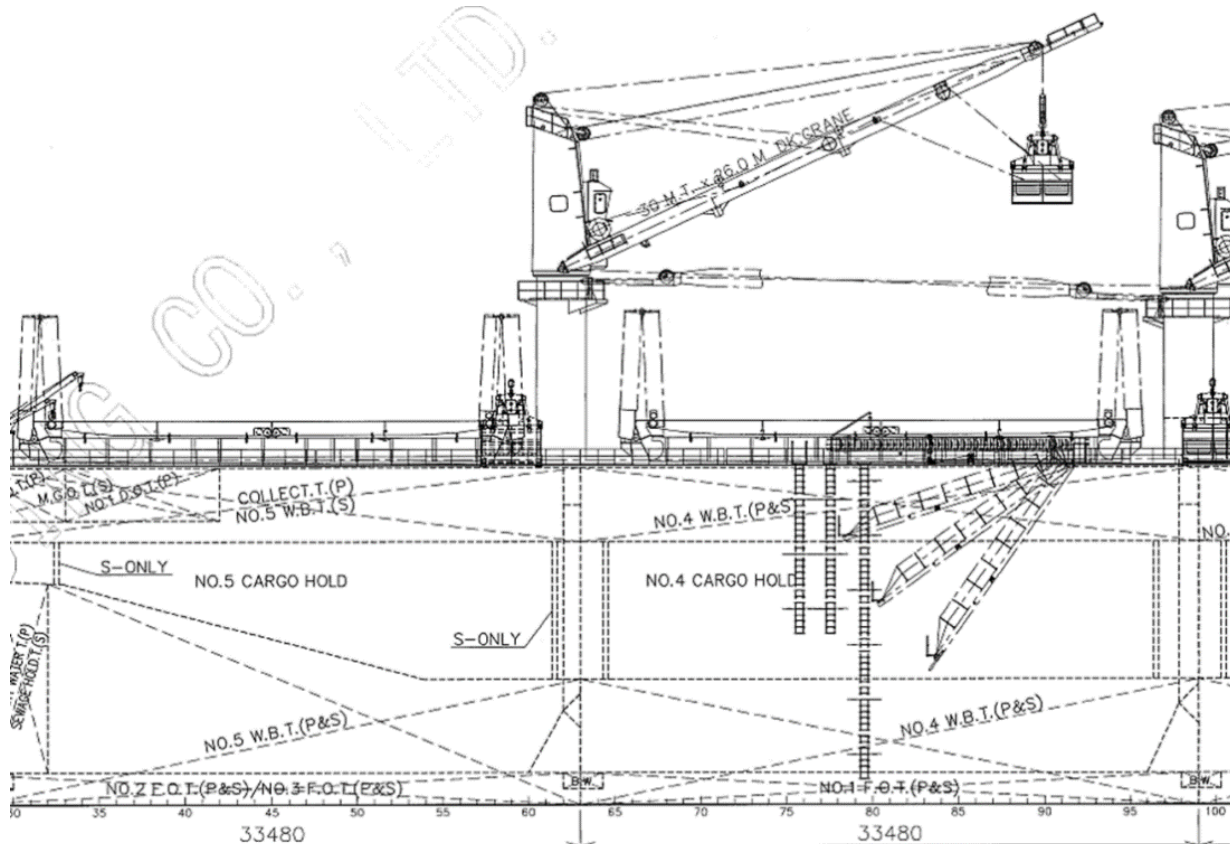
At 23:00, the cleaning of cargo hold number 4 was completed and the scaffolding tower was due to be transferred from cargo hold number 4 to the cargo hold number 5, in the same way as the transfer of the other scaffolding tower from cargo hold number 2 to cargo hold number 1.

Figure 3.3 - General arrangement plan, cargo holds number 4 and number 5
(Source: operator)

During lifting, the Chief Officer noticed that the construction was vibrating abnormally. At that time the scaffolding tower was lifted to about 30 cm below deck level. The Chief Officer instructed the crane operator to lower the scaffolding tower back down onto the cargo hold tank top.

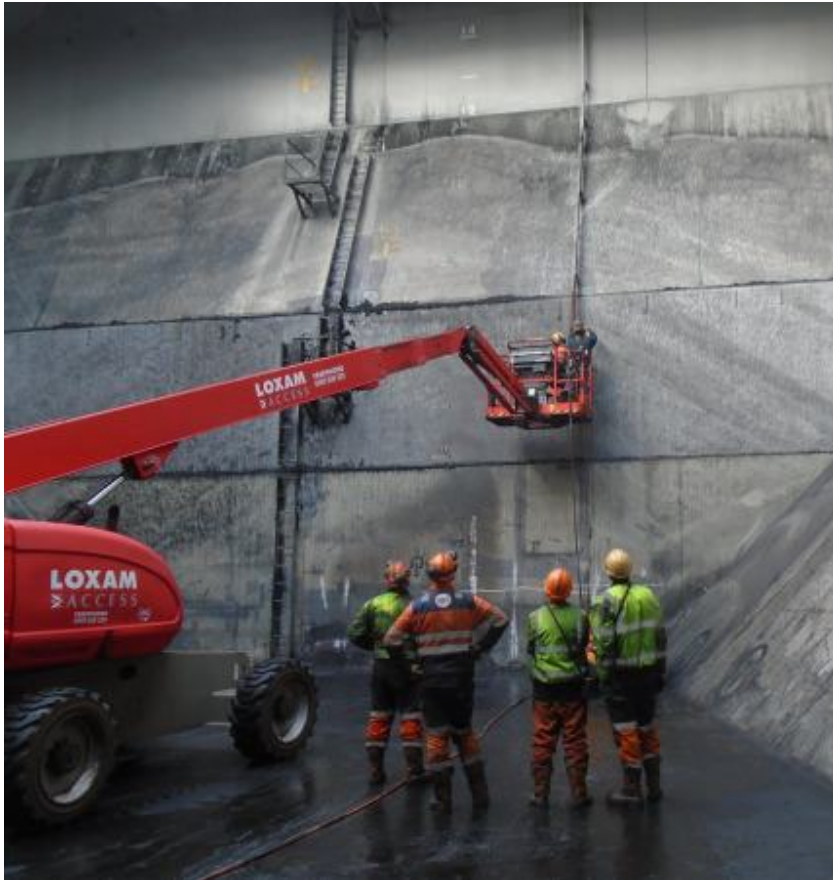
The operator provided a picture showing an alternative means of working at height used by another contractor to execute the cleaning of cargo holds on MV Medi Zuoz in a different port, by using a multidirectional mobile elevating work platform (MMEWP, also known as cherry pickers) instead of a scaffolding tower.

Figure 3.6 - Cleaning of a cargo hold
(Source: operator)
