# FINAL REPORT

## FATAL OCCUPATIONAL ACCIDENT ON BOARD OF THE VESSEL MV MEDI ZUOZ ON 4 APRIL 2019

**Report N° AET/TM-2020/01**

**Fatal occupational accident on board of the vessel MV Medi Zuoz  
on 4 April 2019**

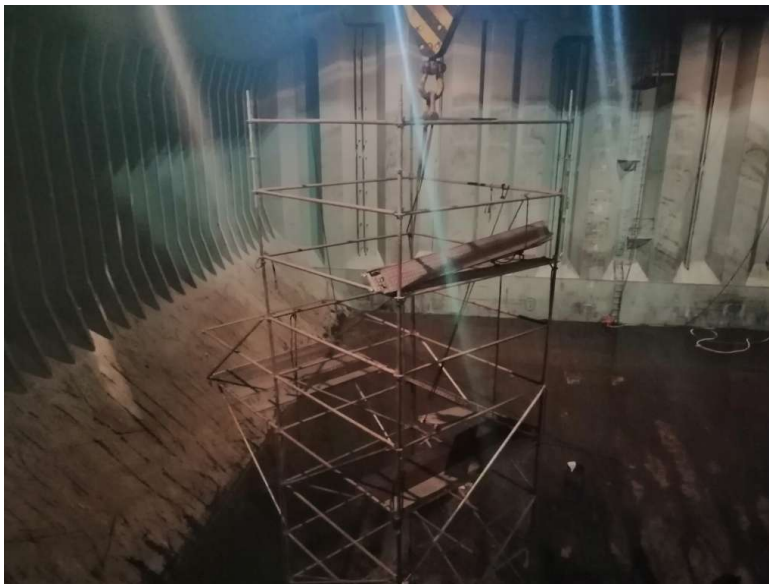
**Figure 1.1** - Picture taken on scene after the accident

A shore contract worker climbed up the scaffolding tower to properly attach the ropes to the crane so that the tower could eventually be moved to the next hold. While climbing up the scaffolding tower, the unsecured contract worker lost balance, fell on the tank top and was seriously injured. It was later established that one of the two ropes used to connect the tower to the crane hook had broken.

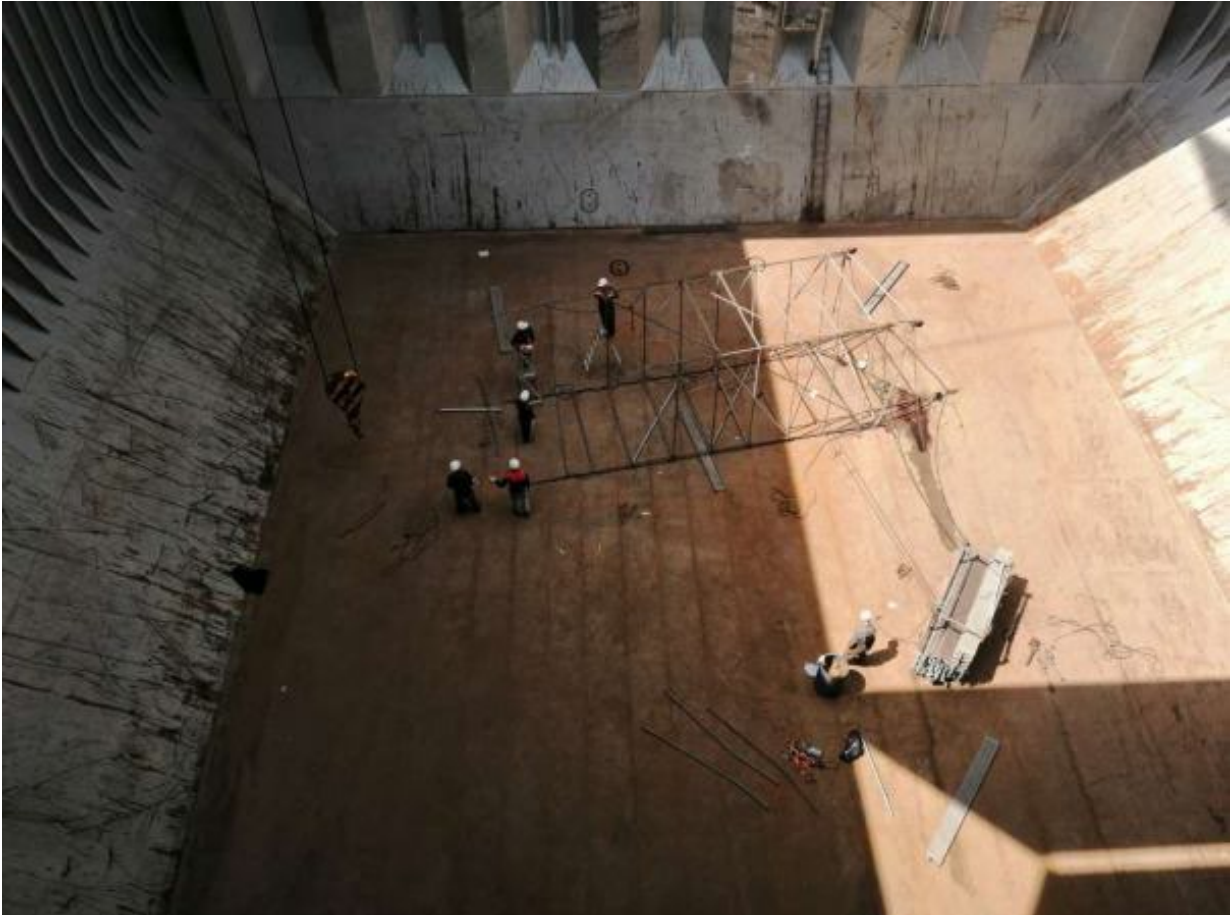
**Figure 2.3** - Cargo hold number 4  
(Source: operator)

Location of the victim: Cargo hold number 4

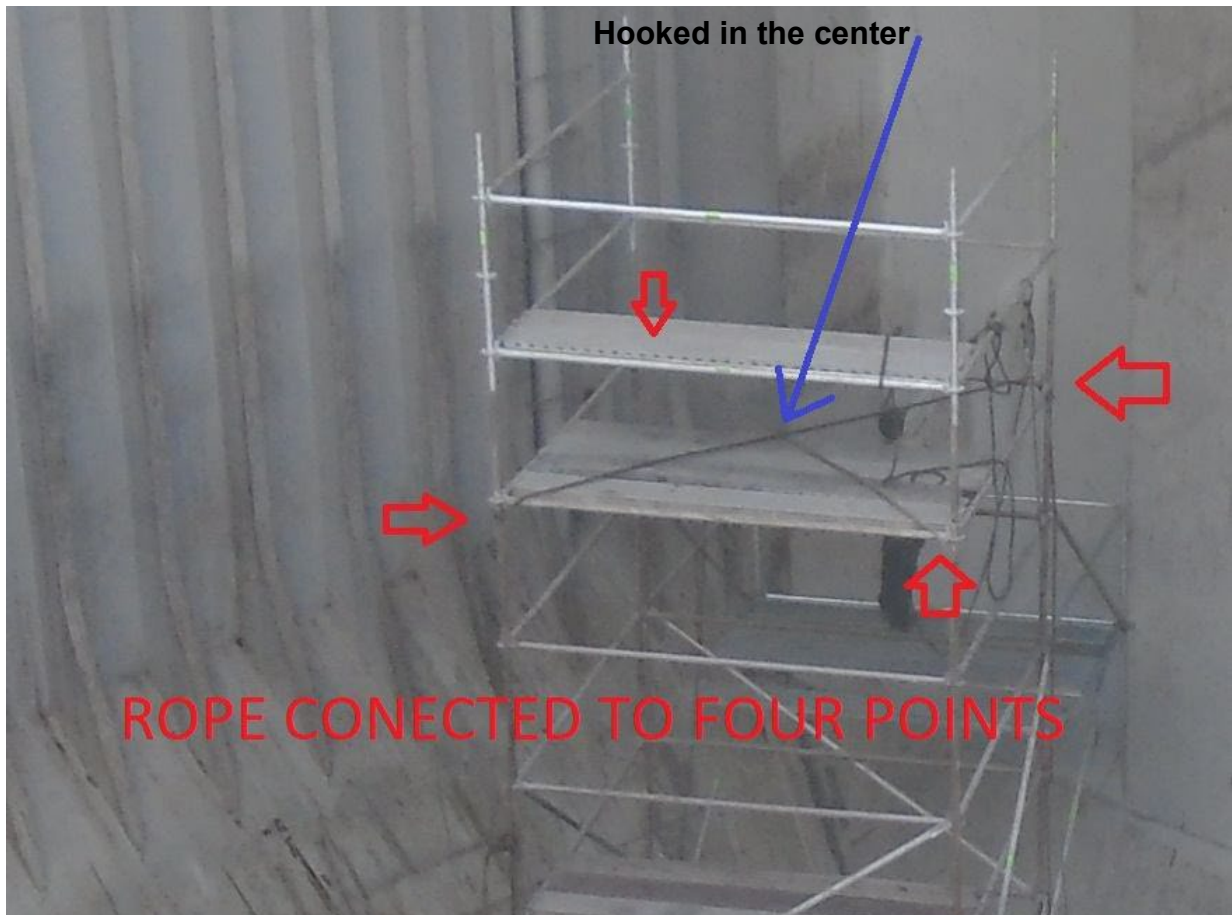
**Figure 3.2** – Lifting arrangement of the scaffolding tower  
(Source: operator)

The whole construction was hooked to the ship's crane by two fibre ropes attached diagonally to four corners and transferred from cargo hold number 2 to cargo hold number 1.

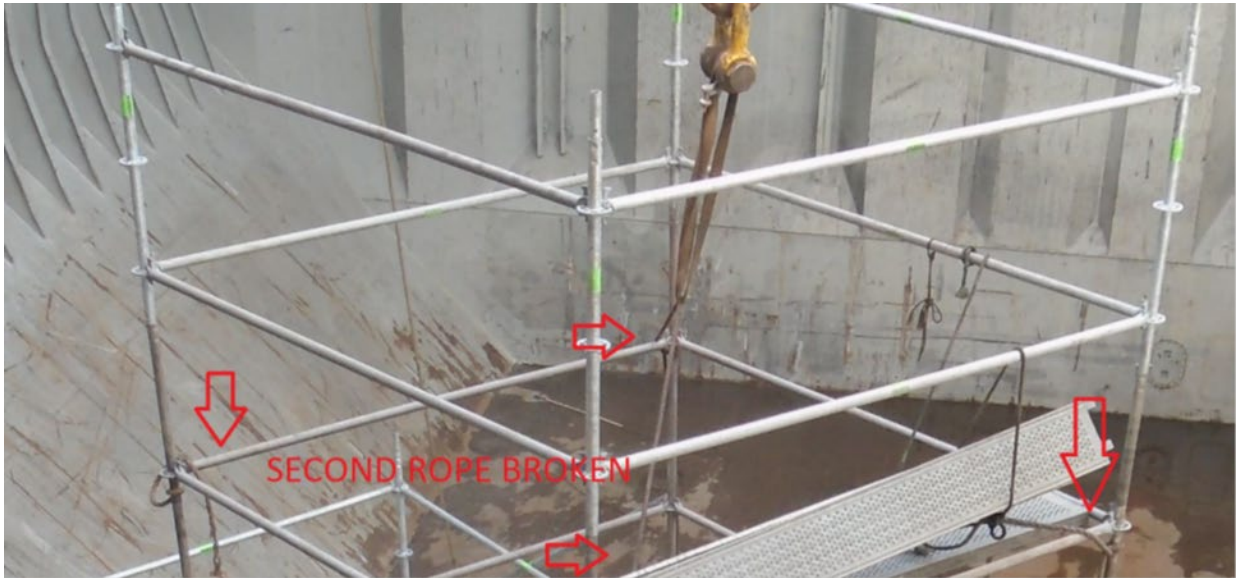
**Figure 3.4** - Attachment of the scaffolding tower, with one detached rope  
(Source: operator)

At the accident scene, one of the two fibre ropes was found to be broken and the scaffolding tower in hold number 4 was hooked to one rope only (connected to two corners of the top 'lift' of the tower). This resulted in an unstable configuration during lifting.

The cleaning task required the use of the contractor's equipment and related PPE to work at height. One of the contractor's ropes used to attach the scaffolding tower to the crane broke during the lifting and transfer process. This led to an unstable platform on the scaffolding tower, which finally contributed to the accident. This highlights the importance to use safe and appropriate equipment, but it also shows the difficulties for the vessel's crew to properly evaluate the condition of such equipment.

<ul style="list-style-type: none"> <li>➤ In situation, when certificates are not available or conditions of contractor's equipment found in poor/unsafe condition, vessel must cancel the job and inform DPA.</li> <li>➤ When contractor's lifting equipment are without certificate or found in poor/unsafe condition, Master must inform DPA. In consultation with DPA and, as applicable, crew must consider providing vessel's lifting equipment to contractor for usage after a suitable briefing on usage and safety precautions. This will ensure control over the good working condition of these equipment through vessel's continued maintenance and regular quality control.</li> </ul>	
--	--
