FINAL REPORT

FATAL OCCUPATIONAL ACCIDENT ON BOARD OF THE VESSEL *NABUCCO* ON 26 JUNE 2017

DATE OF ISSUE: 15 February 2019

Report N° AET/TM-2019/01

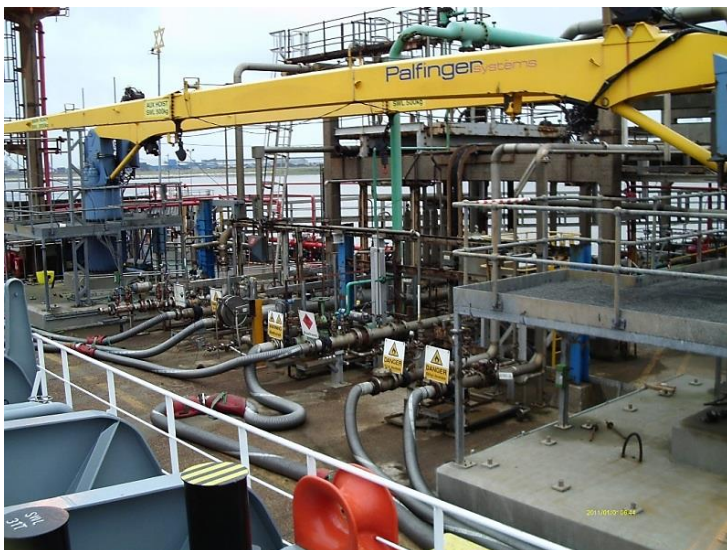
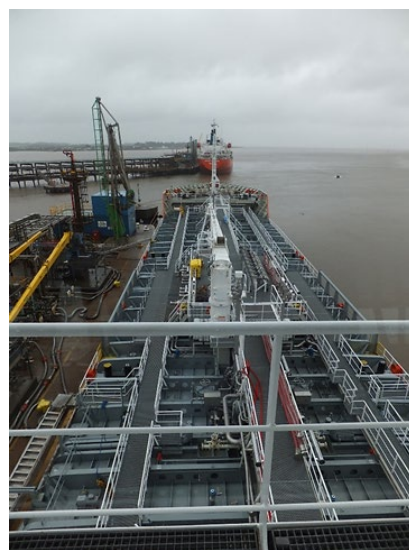
Figure 2.4 - Saltend number 1 jetty - Cranage
(Source: MAIB)

Due to repair scheduled for 27 June 2017, both cranes were not operational on the day of the occurrence.

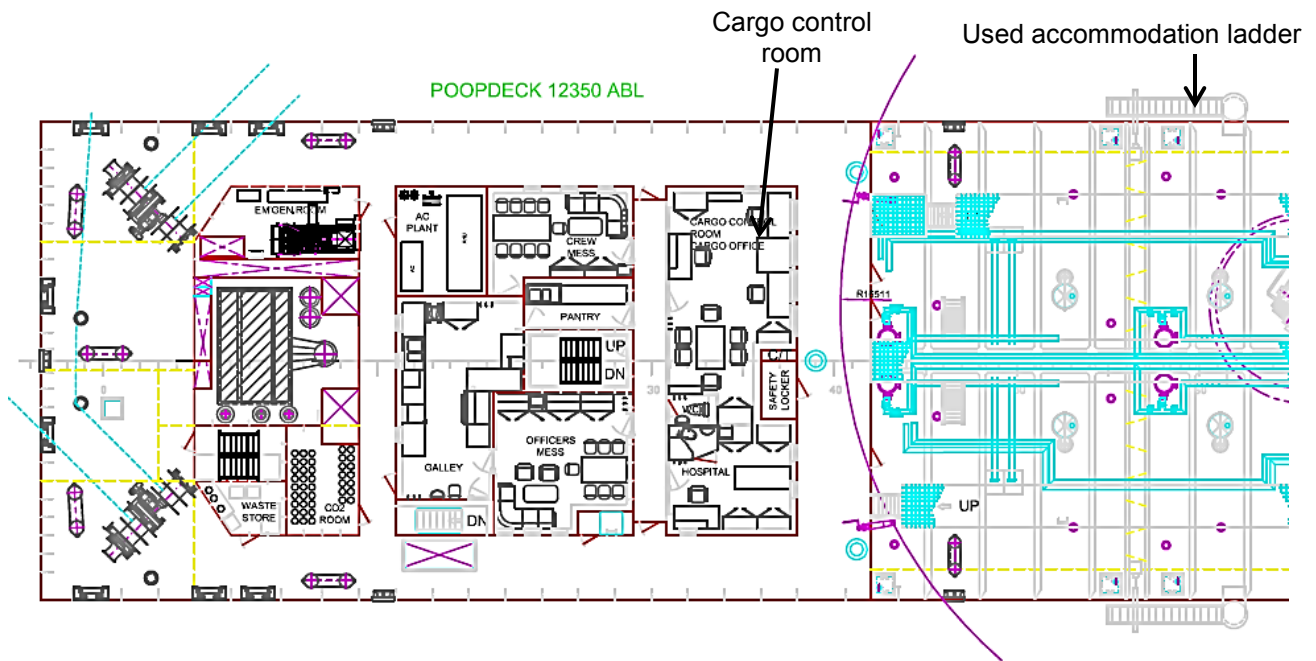
Figure 3.2 - Top view Main Deck; Cargo Control Room and accommodation ladder
(Source Operator)

The C/O, noticing that the A/B had not yet started with stowing away the accommodation ladder, changed into his boiler suit and headed out of the CCR on deck to do that task himself.

The C/O ordered the 3rd Officer to return to the CCR and to ballast slightly to starboard to list the ship away from the jetty to free the jammed hand rail.

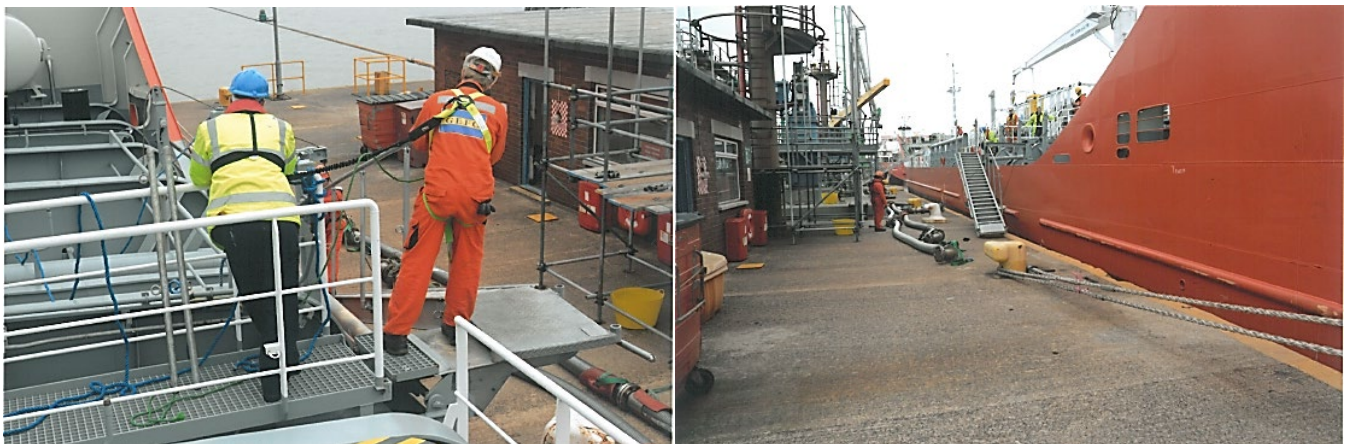
Figure 3.3 – Testing of the accommodation ladder
(Source Police)

- Tests performed after the accident found that the accommodation ladder worked as per design.
- Safety procedures defined in the operator's SMS were not adhered to by the crew at different levels of responsibility, impeding the safety on board the Nabucco and weakening the safety culture.

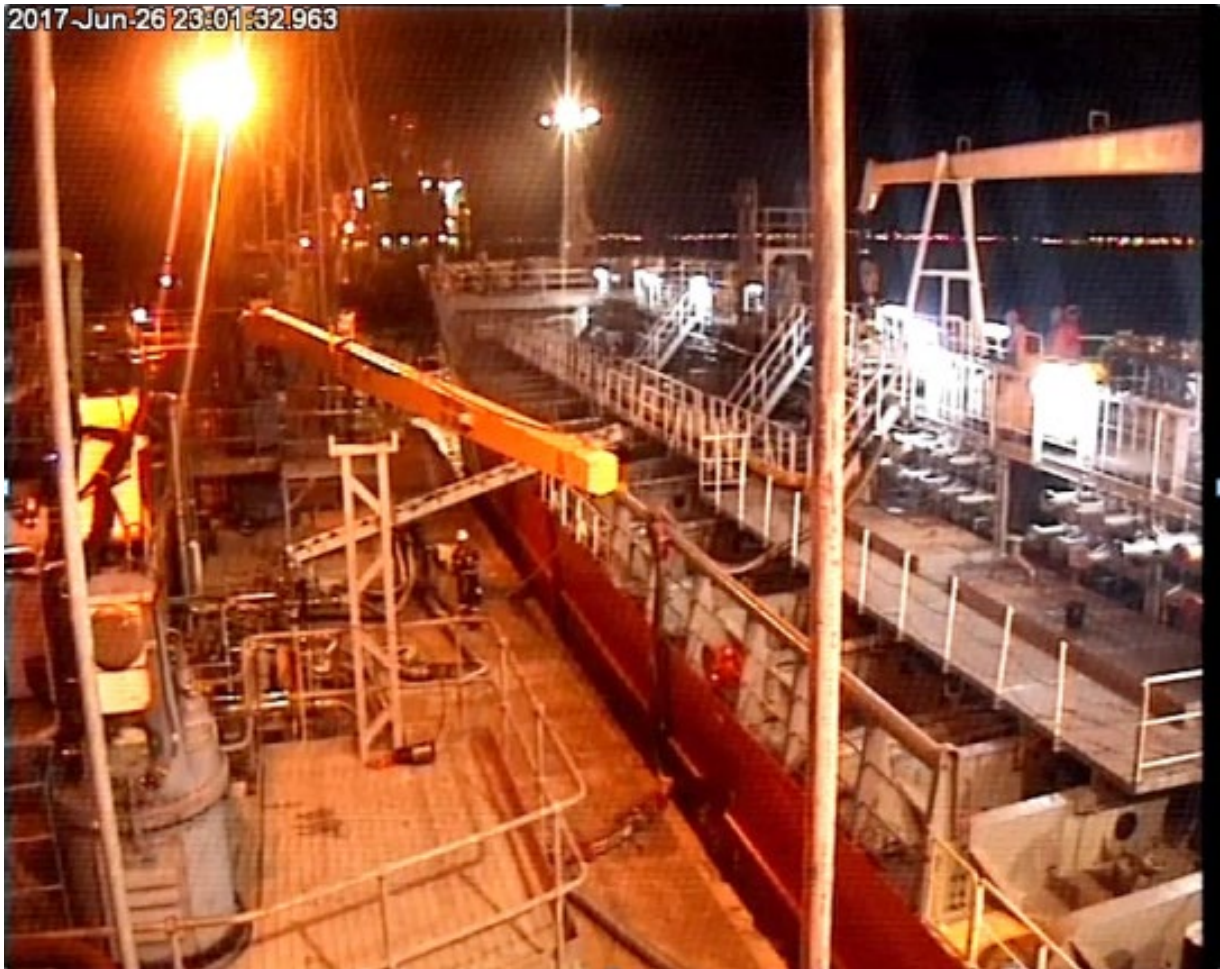
Figure 3.4 - Excerpt of the jetty number 1 CCTV
(Source ABP)

At 23:03, the Pier Master saw the Cargo Surveyor running towards the west part of the jetty. He swung the camera around to the accommodation ladder and captured the shore team and ship’s crew attempting to rescue the C/O.

The C/O was not visible on the jetty’s CCTV prior to the accident. The exact moment of the accident when the C/O fell into the water was not captured on the jetty’s CCTV.
