## FATAL OCCUPATIONAL ACCIDENT ON BOARD OF THE VESSEL *NABUCCO* ON 26 JUNE 2017

DATE OF ISSUE: 15 February 2019

**Report N° AET/TM-2019/01**

**Fatal occupational accident on board of the vessel Nabucco  
on 26 June 2017**

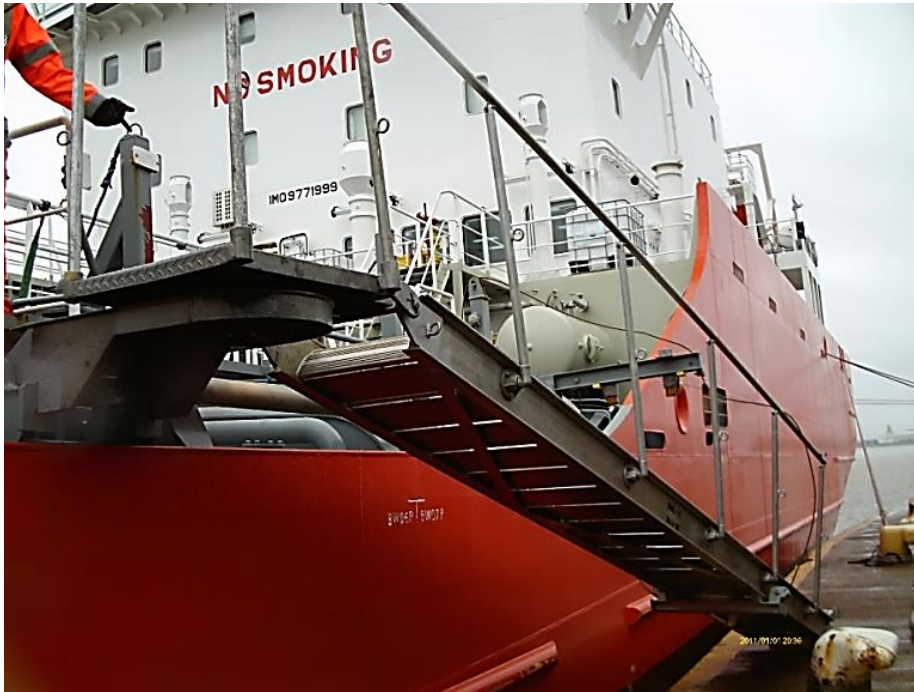
**Figure 2.3** - Port side accommodation ladder

Gap between the vessel and the quay: 0.62 m

Height (time of the occurrence): About 5.3 m from the platform to the water  
About 2.5 m from the platform to the quay

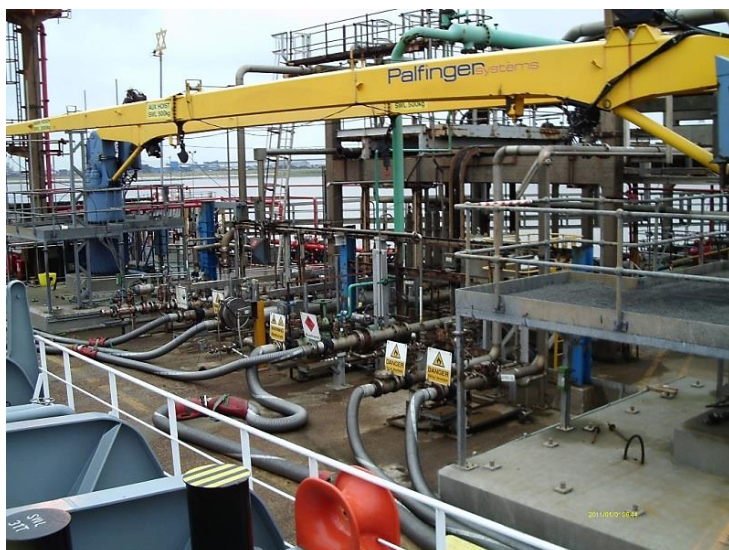
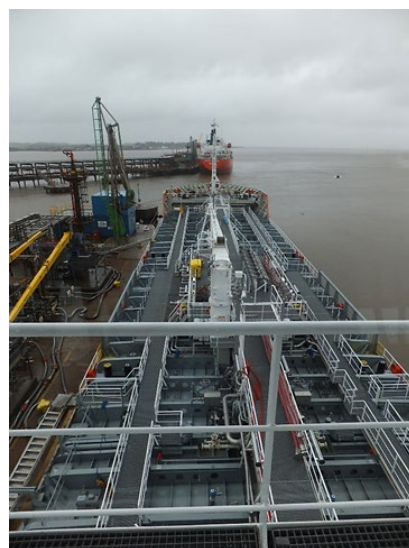
**Figure 2.4** - Saltend number 1 jetty - Cranage  
(Source: MAIB)

Due to repair scheduled for 27 June 2017, both cranes were not operational on the day of the occurrence.

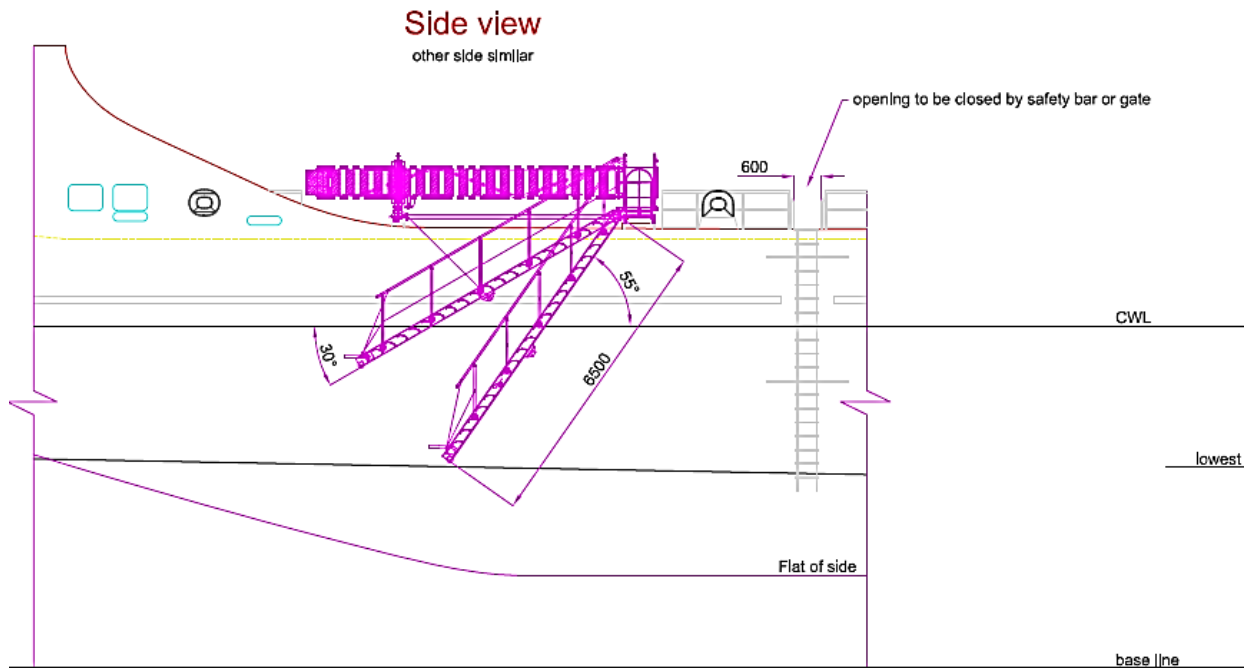
**Figure 3.1** - accommodation ladder  
(Source Operator)

After discussions between the C/O, the 3<sup>rd</sup> Officer and the ABP Loading Master, it was agreed that the accommodation ladder would be deployed for use as safe means of access at High-water period, when the gangway was deemed too steep for safe access to the ship. The accommodation ladder was rigged from the aft end of the main deck. It should be noted that the accommodation ladder was rarely used in Saltend. As tide would ebb, the accommodation ladder would have to be stowed and the gangway would again be used as safe means of access.

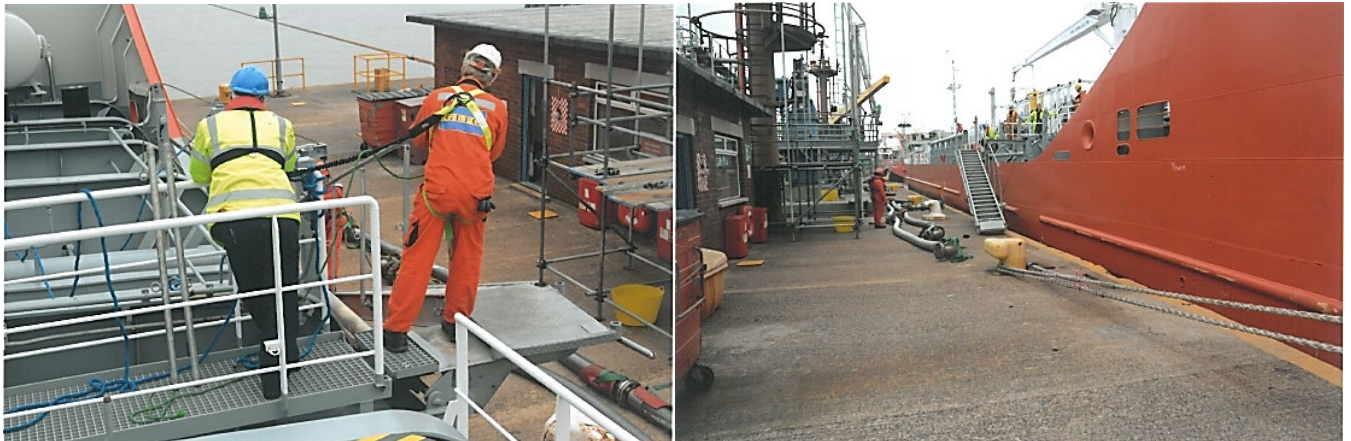
**Figure 3.3** – Testing of the accommodation ladder  
(Source Police)

- Tests performed after the accident found that the accommodation ladder worked as per design.
- Safety procedures defined in the operator's SMS were not adhered to by the crew at different levels of responsibility, impeding the safety on board the Nabucco and weakening the safety culture.

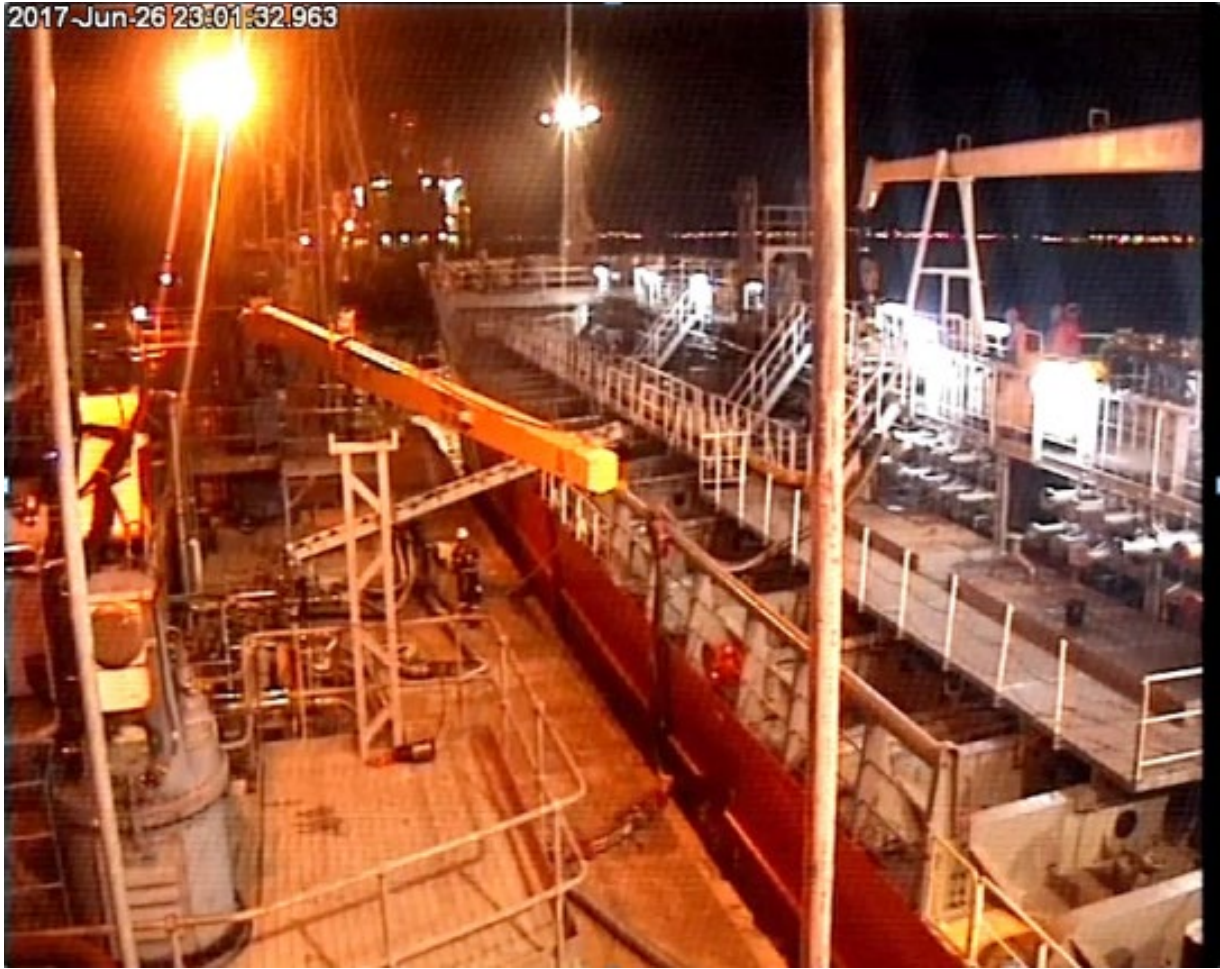
**Figure 3.4** - Excerpt of the jetty number 1 CCTV  
(Source ABP)

At 23:03, the Pier Master saw the Cargo Surveyor running towards the west part of the jetty. He swung the camera around to the accommodation ladder and captured the shore team and ship’s crew attempting to rescue the C/O.

The C/O was not visible on the jetty’s CCTV prior to the accident. The exact moment of the accident when the C/O fell into the water was not captured on the jetty’s CCTV.
