Report on the collision between  
fv Z.575 – HEIN SENIOR and mv ACEROMAR  
on August 3<sup>rd</sup> 2020

in the traffic separation scheme Terschelling - German Bight  
near Schiermonnikoog  
with material and structural damage to the vessels.

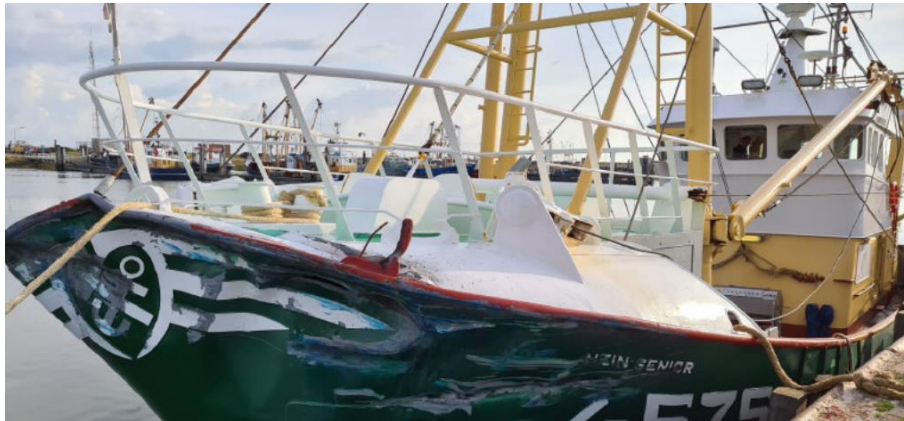
Fv Z.575 HEIN SENIOR ran with her PS bow into mv ACEROMAR and hit her on PS, from midships up to the aft.

The derrick of fv Z.575 HEIN SENIOR hit the railing and hatch cover gantry of the mv ACEROMAR where after the derrick turned over against the wheelhouse of fv Z.575-HEIN SENIOR.

*Figure 7 - Fv Z.575-HEIN SENIOR damaged after collision*

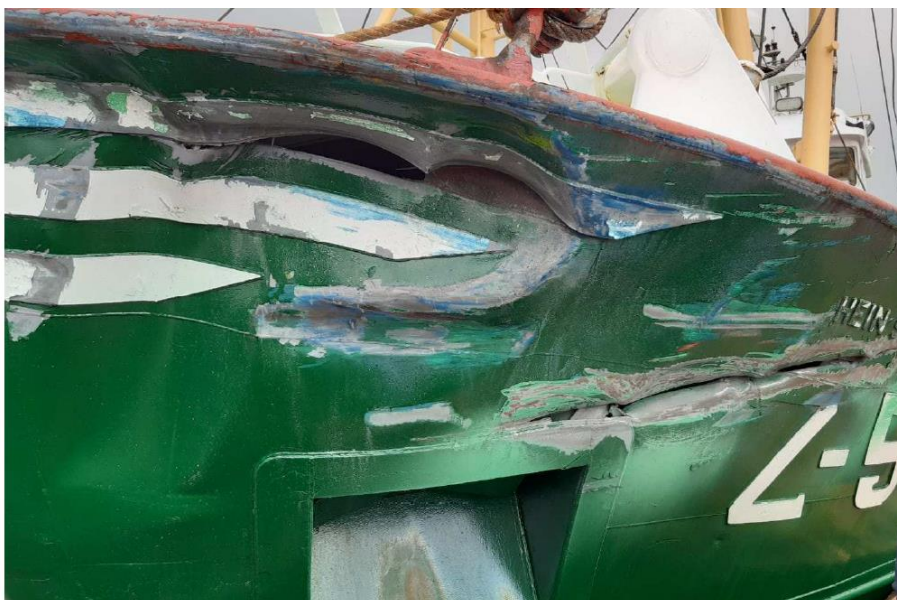
Fv Z.575-HEIN SENIOR was heavily damaged on her PS bow, in front of the collision bulkhead. The ship's hull was ripped open in two positions above the PS anchor lock, as indicated in Figure 11.

*Figure 11 - Ruptured hull of Z.575-HEIN SENIOR*

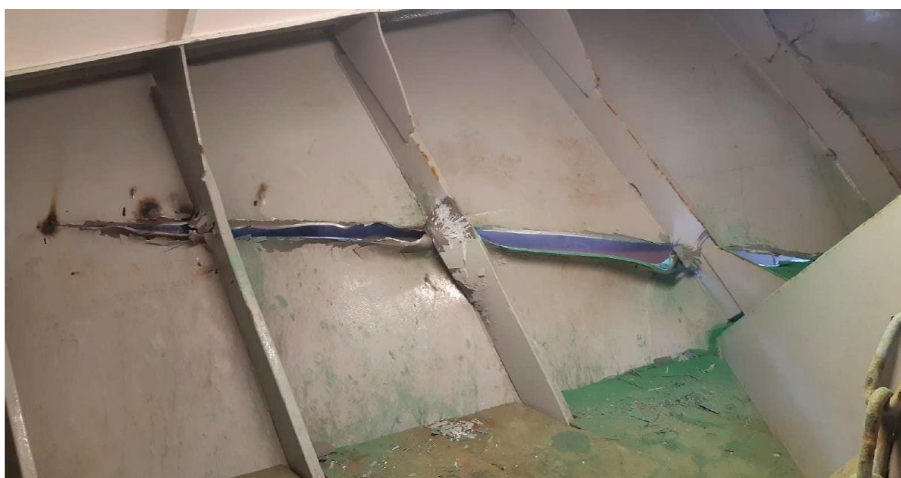
Figure 12 shows the lower rupture from inside the vessel. Three stiffeners were partially teared through.

*Figure 12 – Lower rupture in the hull of fv Z.575-HEIN SENIOR*

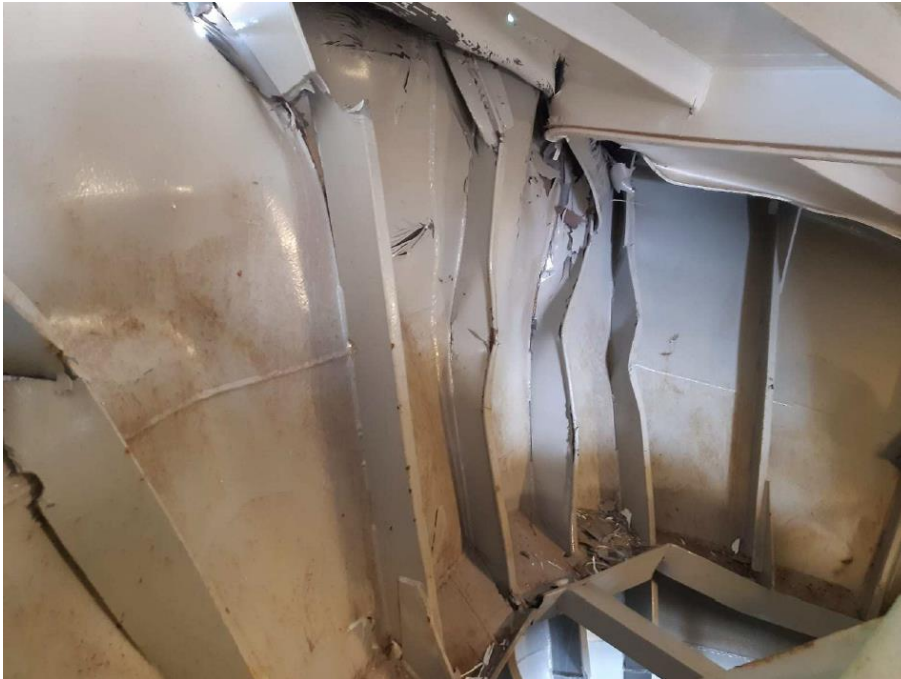
Figure 14 shows the damage at the stem of fv Z.575-HEIN SENIOR. The central deck beam and the stiffeners below were bent. The knee joint of the second stiffener on PS was completely torn through.

*Figure 14 - Damaged stiffened plate structure at the stem of fv Z.575-HEIN SENIOR*

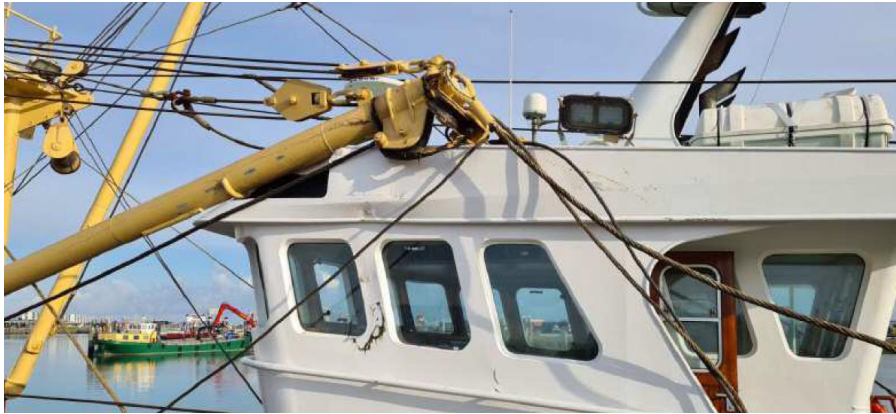
The derricks of fv Z.575-HEIN SENIOR were put at 45° during the sea passage. The PS derrick hit mv ACEROMAR and damaged the hatch cover gantry crane of the mv ACEROMAR. After hitting mv ACEROMAR, the derrick was swung against the wheelhouse of fv Z.575-HEIN SENIOR, as indicated in Figure 15.

*Figure 15 - PS derrick hit the wheelhouse of fv Z.575-HEIN SENIOR*

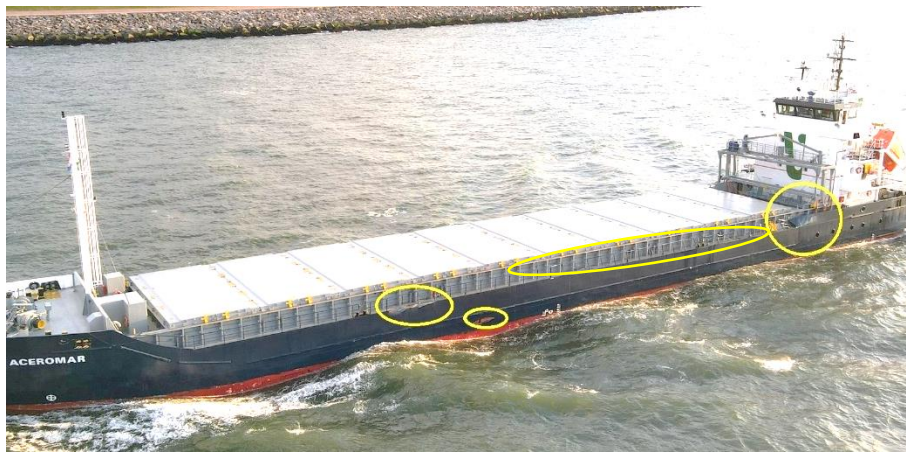
Mv ACEROMAR had some material damages on PS, as indicated in Figure 16.

*Figure 16 – Impact of the collision on PS of mv ACEROMAR*

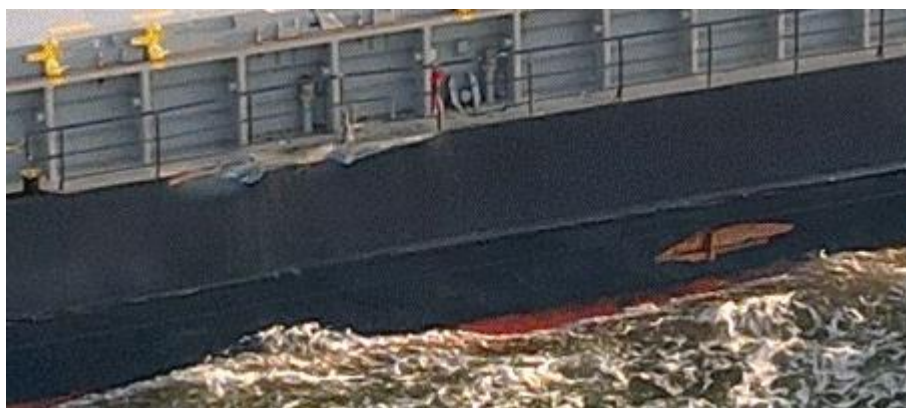
The PS side shell plate was also damaged between frames 79-83.

Figure 17 shows a more detailed view of the PS side shell damages.

*Figure 17 - Detail of damage on PS side plate of mv ACEROMAR*

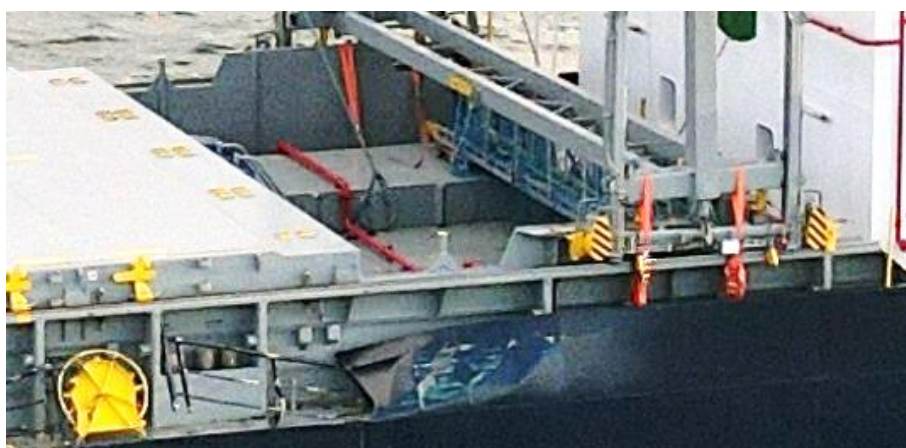
PS bulwark and PS railings were found contact damaged from the midship section up to the aft, between frames 19 and 95. The PS aft fairlead was found with the rollers blocked.

The hatch cover gantry crane was hit by the PS derrick of fv Z.575-HEIN SENIOR and was found contact damaged. It needed to be dismantled for repairs.

*Figure 18 - Damaged railing, bulwark and gantry crane on board mv ACEROMAR*

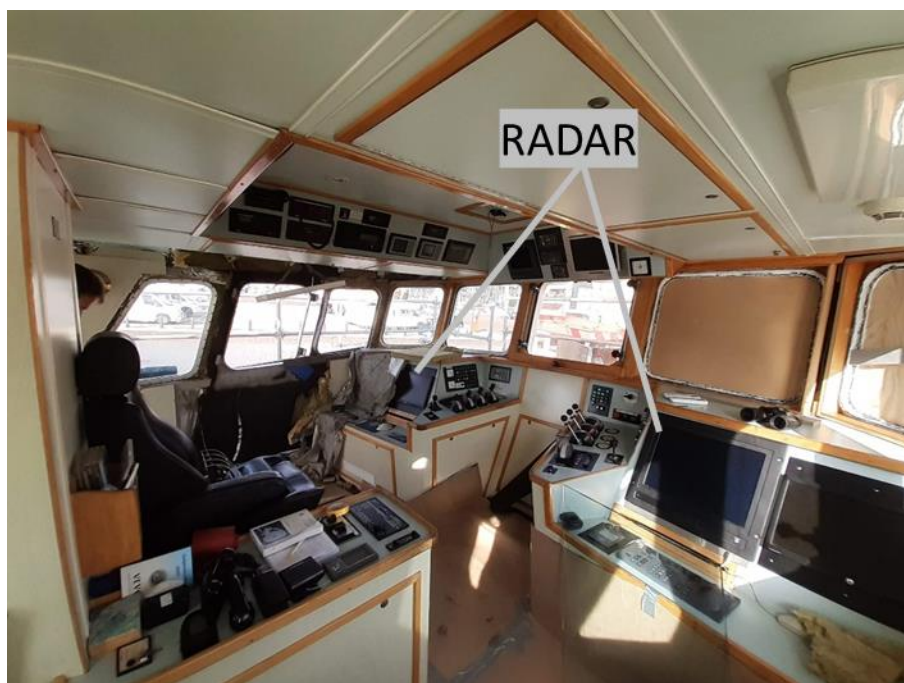
The wheelhouse was fitted with 11 windows that were divided by near vertical posts.

*Figure 19 - Overview wheelhouse fv Z.575-HEIN SENIOR*

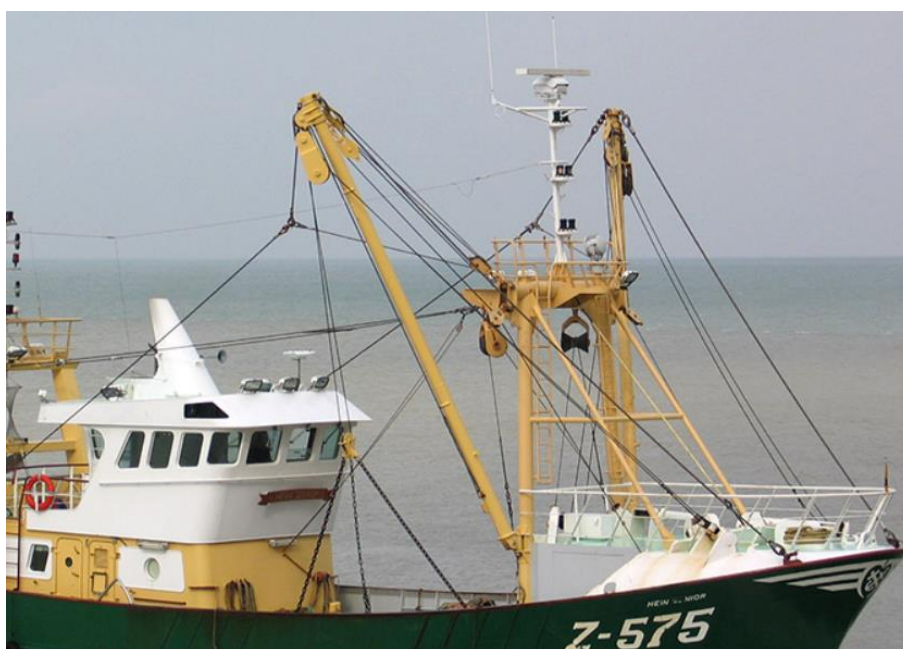
The position of the radar antenna on board did not cause any blind sectors.

*Figure 25 - Position of radar antenna on board*
