FINAL REPORT

FATAL ACCIDENT ON BOARD *IBN BATTUTA* ON 29 SEPTEMBER 2011

Report N° AET/TM-2018/01

**Fatal accident on board *IBN Battuta*
on 29 September 2011**

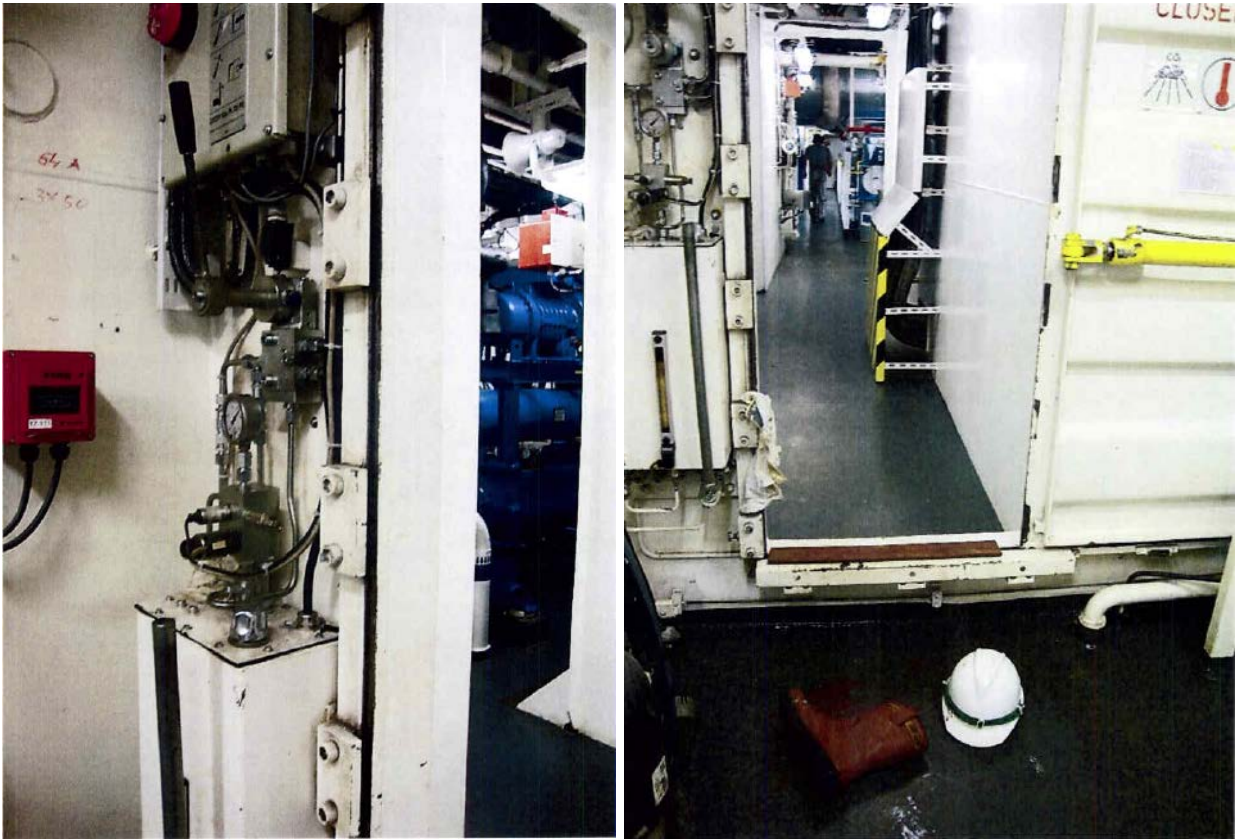
Figure 3.3 – Accident scene
(Source: Operator)

According to the Voyage Data Recorder (VDR) logs, at 10:04:11 AM, the control handle of WTD 3 (door between the pump room and the engine room) was moved to 'open' position. The VDR logs show that WTD 3 was not fully opened during that operation, as the proximity switch 'Door fully open' has not been triggered.

At 10:07:51 AM, the WTD 3 was completely opened and secured in the open position with a steel bar. The power supply of the pump motor was subsequently switched off. The Chief Mate arrived on the scene of the occurrence and found the Apprentice Dredge Operator lying on the floor in a stable position. The Chief Engineer checked the Apprentice Dredge Operator for vital signs.

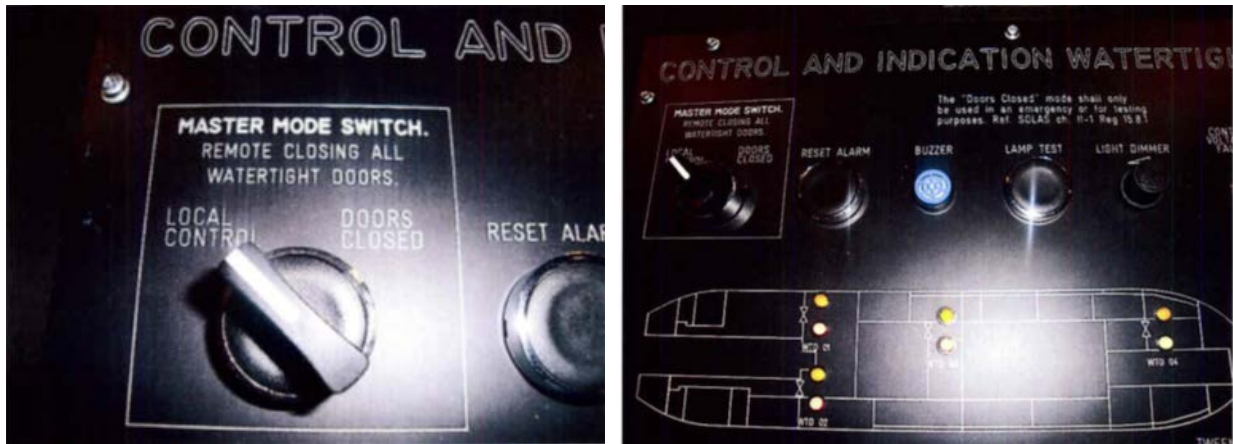
Figure 3.6 – Control and indication panel of the WTDs' system
(Source: Schoenrock Hydraulik Marine Systeme GmbH)

- The indications of the mimic panel on the bridge were checked: all doors were displayed as out of service and closed. The power had been switched off and the pressure had dropped down. WTD 3 was in 'open' position, the remaining doors were indicated as closed. Additional yellow LED's indicated the following alarms: 'loss of power', 'loss of pressure' and 'low oil level'.

- The alarm horn of WTD 3 was inoperative.
- The warning lights (yellow flashing lights) on both sides of the WTD 3 were operational.
- The WTD 3 needed 28 seconds to completely close and 15 seconds to fully open, which is within prevailing SOLAS provisions requiring a minimum of twenty seconds and a maximum of forty seconds to close a WTD.
- The remaining parts and parameters of the WTD 3 were in accordance with the design specifications and prevailing regulations.

- Occurrence was communicated during a daily crew-meeting;
- Training was given to all personnel on board with regard to the safe operation of the WTDs;
- Audible alarm of WTD 3 was repaired.

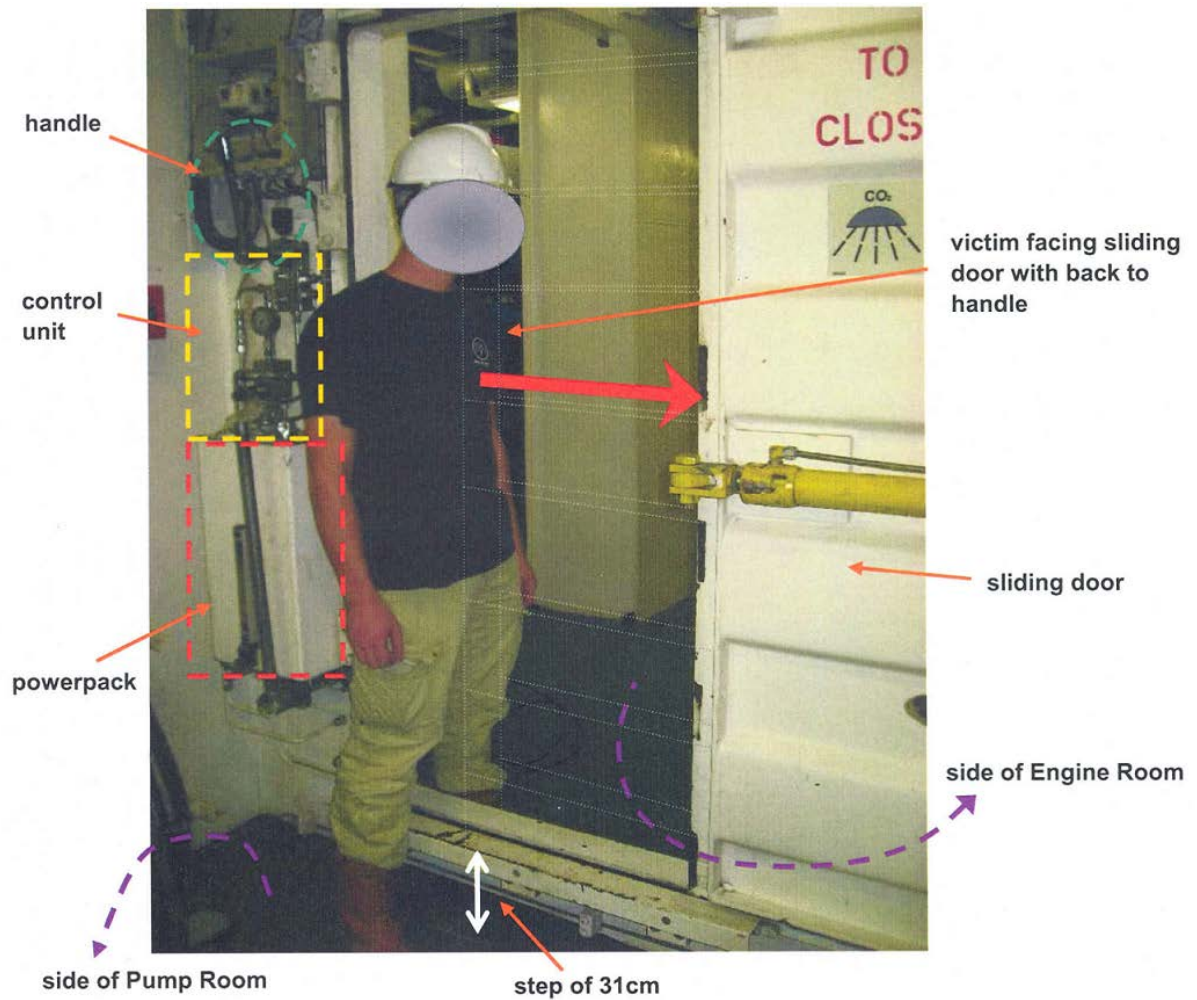
Figure 4.1 – Simulation of the Apprentice Dredge Operator's position
(Source: Operator)

It is unlikely that the Apprentice Dredge Operator has been trapped in the position he was found in on his passing of the doorway to the engine room. The opening of the door would require the operation of the control handle located at shoulder level, which would be hardly achievable with the back of the body facing the handle. The most probable scenario is that the Apprentice Dredge Operator stepped through the opening doorway while holding the handle located in the pump room in 'open' position and then reversed his path to get back to the pump room while or after releasing the handle. Based on the previously observed WTD 3 openings, it is probable that the door has only been opened by as much as to allow the quick passage of the doorway. Due to the selected 'doors closed' mode, WTD 3 started to close when the handle was released to neutral position. The Apprentice Dredge Operator then got trapped in the door with his back towards the operating panel, hence unable to operate the control handle on either side of the door to stop or reverse the movement of the sliding door.

At 10:06:02 AM, the WTD 3 was completely opened by the crewmembers providing assistance to the Apprentice Dredge Operator. The elapsed time from the moment the control handle was supposedly moved by the Apprentice Dredge Operator to the 'open' position, until the door was fully opened by the crewmembers assisting the victim onsite, was 111 seconds.

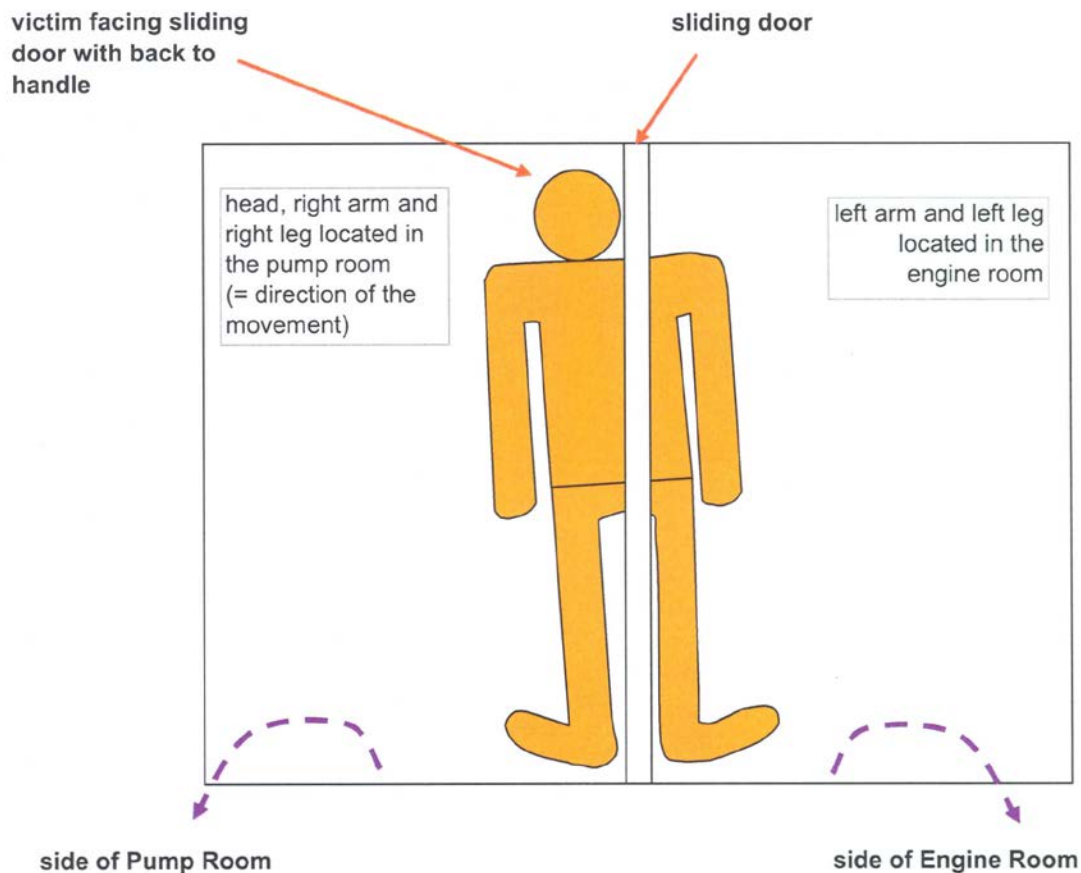
Figure 4.2 – Apprentice Dredge Operator's position

It can be assumed that WTD 3 was opened wide enough to allow a normal passage of the Apprentice Dredge Operator from the pump room to the engine room. For comparison, the three cycles of WTD 3 prior to the occurrence took respectively 22 s, 18 s and 20 s for the door to open and close. Based on the measured opening and closing speeds of WTD 3, it can be evaluated that the door had been opened by respectively 41 cm, 34 cm and 37 cm during those three cycles.

It can be estimated that the Apprentice Dredge Operator's body, while trapped in WTD 3, was exposed to a force of 40 kN for at least eighty seconds.
