FATAL ACCIDENT ON BOARD <u>IBN BATTUTA</u> ON 29 SEPTEMBER 2011

DATE OF ISSUE: 2 Mai 2018

Administration of Technical Investigations

Report N° AET/TM-2018/01

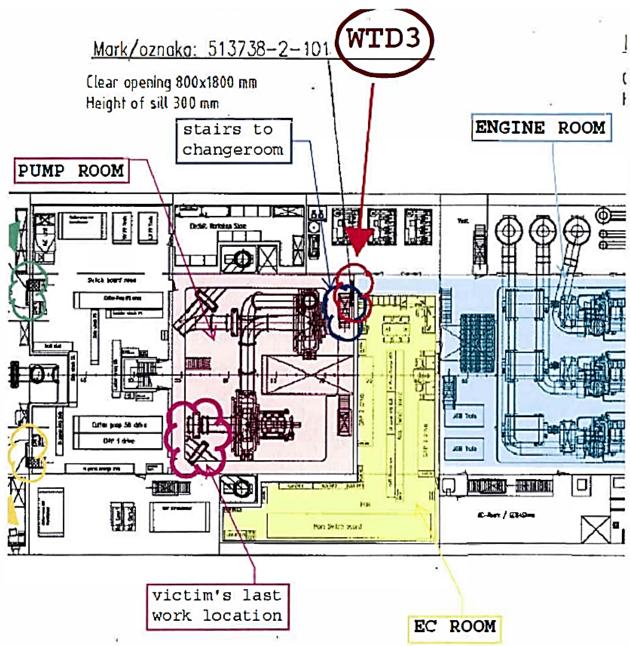
Figure 3.2 – Hydraulic doors layout of IBN Battuta (Source: Operator)

According to the Voyage Data Recorder (VDR) logs, at 10:04:11 AM, the control handle of WTD 3 (door between the pump room and the engine room) was moved to 'open' position. The VDR logs show that WTD 3 was not fully opened during that operation, as the proximity switch 'Door fully open' has not been triggered.

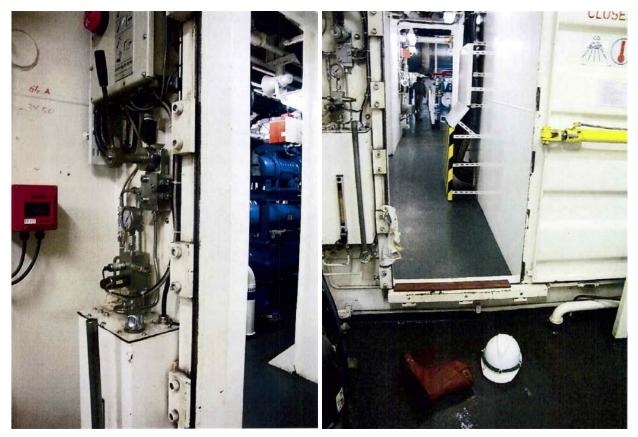
Figure 3.3 – Accident scene (Source: Operator)

At approximately 10:05 AM, the 2nd and 3rd Engineer went to check an overboard valve on the platform situated near the engine control room (ECR) and WTD 3. When they approached WTD 3 from the ECR, they saw that the Apprentice Dredge Operator was stuck in the WTD 3. His body faced the closing part of the sliding door, with the left leg and the left arm located on the side of the engine room and his head, the right leg and the right arm located on the side of pump room. WTD 3 was fully opened at 10:06:02 AM and the Apprentice Dredge Operator was laid down on the floor in the pump room. The Chief Engineer, who was in the ECR with the 2nd and 3rd Engineer, was also informed about the occurrence. In the meantime, an electrician called the bridge via portable radio and notified the occurrence.

At 10:07:51 AM, the WTD 3 was completely opened and secured in the open position with a steel bar. The power supply of the pump motor was subsequently switched off. The Chief Mate arrived on the scene of the occurrence and found the Apprentice Dredge Operator lying on the floor in a stable position. The Chief Engineer checked the Apprentice Dredge Operator for vital signs.

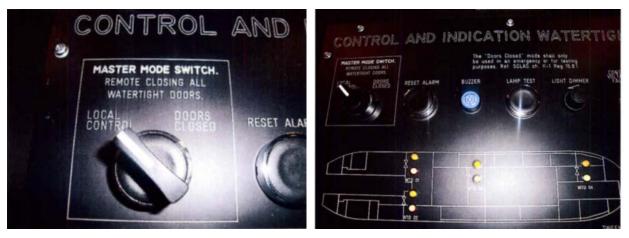
Figure 3.6 – Control and indication panel of the WTDs' system (Source: Schoenrock Hydraulik Marine Systeme GmbH)

- The indications of the mimic panel on the bridge were checked: all doors were displayed as out of service and closed. The power had been switched off and the pressure had dropped down. WTD 3 was in 'open' position, the remaining doors were indicated as closed. Additional yellow LED's indicated the following alarms: 'loss of power', 'loss of pressure' and 'low oil level'.

- The alarm horn of WTD 3 was inoperative.
- The warning lights (yellow flashing lights) on both sides of the WTD 3 were operational.
- The WTD 3 needed 28 seconds to completely close and 15 seconds to fully open, which is within prevailing SOLAS provisions requiring a minimum of twenty seconds and a maximum of forty seconds to close a WTD.
- The remaining parts and parameters of the WTD 3 were in accordance with the design specifications and prevailing regulations.

- Occurrence was communicated during a daily crew-meeting;
- Training was given to all personnel on board with regard to the safe operation of the WTDs;
- Audible alarm of WTD 3 was repaired.

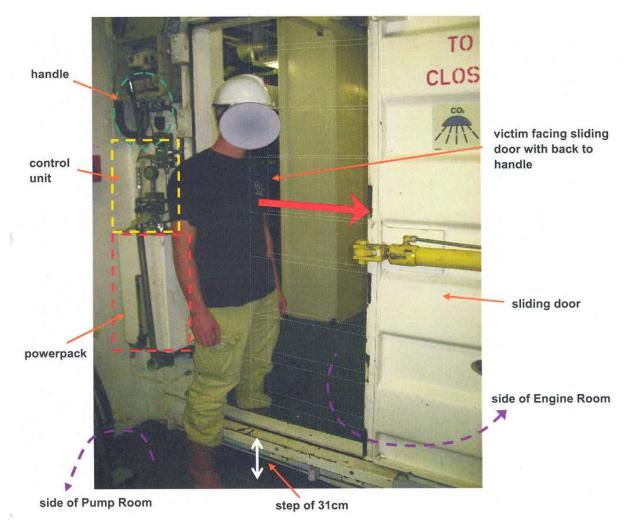
Figure 4.1 – Simulation of the Apprentice Dredge Operator's position (Source: Operator)

It is unlikely that the Apprentice Dredge Operator has been trapped in the position he was found in on his passing of the doorway to the engine room. The opening of the door would require the operation of the control handle located at shoulder level, which would be hardly achievable with the back of the body facing the handle. The most probable scenario is that the Apprentice Dredge Operator stepped through the opening doorway while holding the handle located in the pump room in 'open' position and then reversed his path to get back to the pump room while or after releasing the handle. Based on the previously observed WTD 3 openings, it is probable that the door has only been opened by as much as to allow the quick passage of the doorway. Due to the selected 'doors closed' mode, WTD 3 started to close when the handle was released to neutral position. The Apprentice Dredge Operator then got trapped in the door with his back towards the operating panel, hence unable to operate the control handle on either side of the door to stop or reverse the movement of the sliding door.

At 10:06:02 AM, the WTD 3 was completely opened by the crewmembers providing assistance to the Apprentice Dredge Operator. The elapsed time from the moment the control handle was supposedly moved by the Apprentice Dredge Operator to the 'open' position, until the door was fully opened by the crewmembers assisting the victim onsite, was 111 seconds.

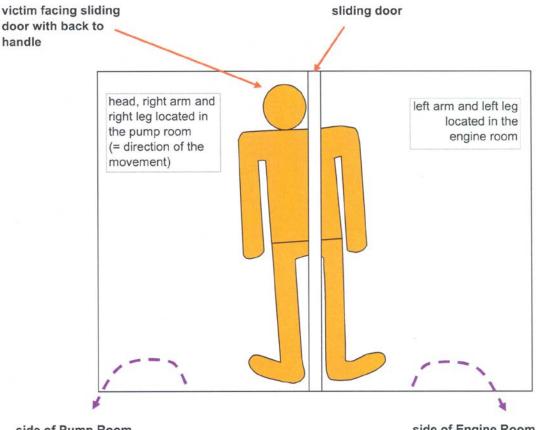
It can be assumed that WTD 3 was opened wide enough to allow a normal passage of the Apprentice Dredge Operator from the pump room to the engine room. For comparison, the three cycles of WTD 3 prior to the occurrence took respectively 22 s, 18 s and 20 s for the door to open and close. Based on the measured opening and closing speeds of WTD 3, it can be evaluated that the door had been opened by respectively 41 cm, 34 cm and 37 cm during those three cycles.

It can be estimated that the Apprentice Dredge Operator's body, while trapped in WTD 3, was exposed to a force of 40 kN for at least eighty seconds.
