INTERIM REPORT

SINKING OF THE VESSEL BOURBON RHODE ON 26 SEPTEMBER 2019

DATE OF ISSUE: 15 April 2021

Report N° AET/TM-2021/01

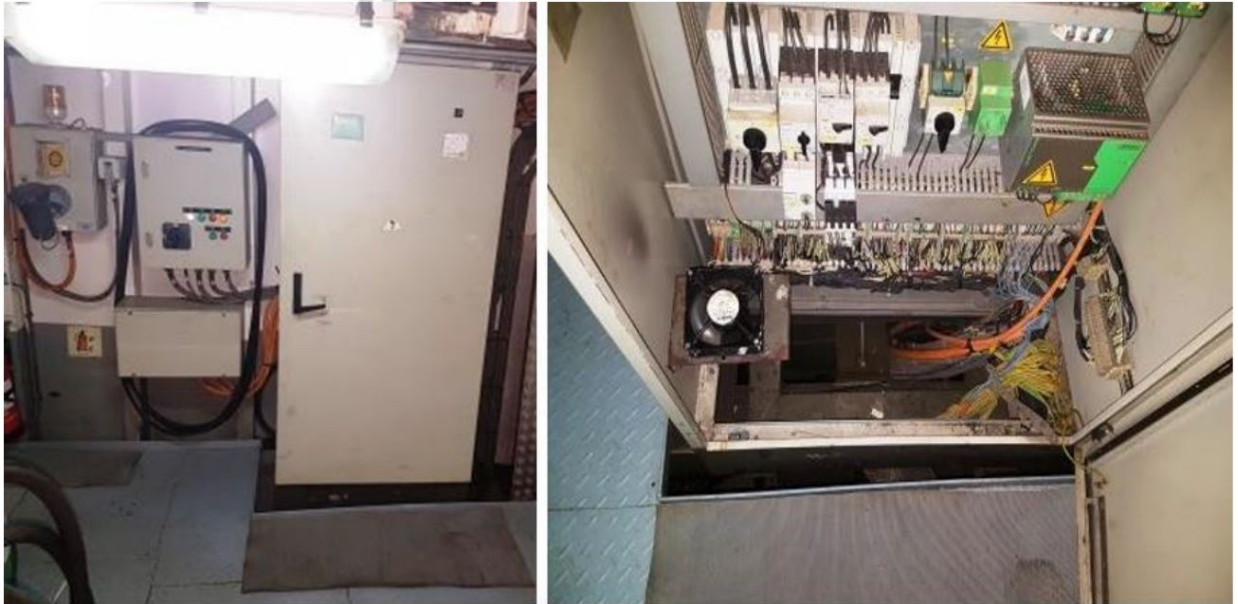
The steering system and electrical cabinets were positioned on floor plate level. The cabinets were open at the base and thus left the electrical components unprotected against water in case of flooding.

Figure 3.7 – Electrical Cabinets in Z-Drive compartment (*Bourbon Rhesos*, 2019)
(Source: Bourbon Marine & Logistics)

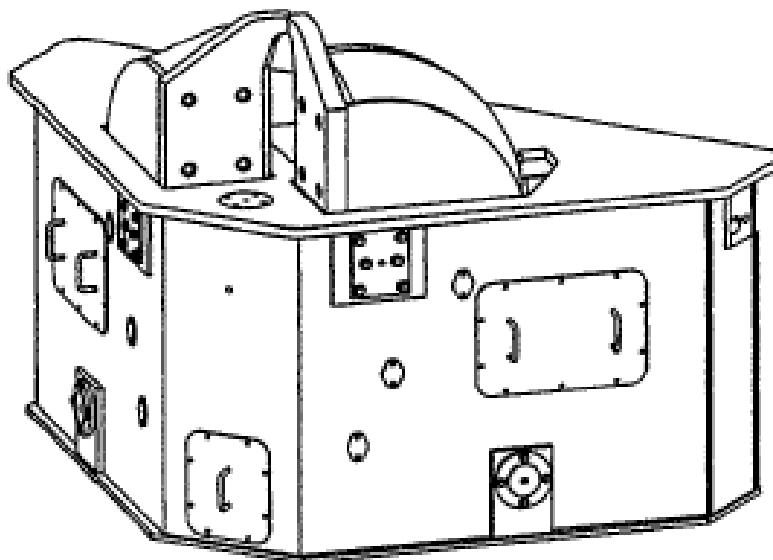
Figure 3.18 – *Bourbon Rhode*, Shark Jaw housing frame
(Source: Bourbon Marine & Logistics)

During operation, water from the deck can enter the watertight housing frames. When not in use, the Shark Jaws and the towing pins are lowered into their housing frames and are flush with the deck. In lowered position, gaps around the shark jaws also allow water to enter the housing frame. This issue is of lesser importance regarding the towing pins, due to smaller gaps.

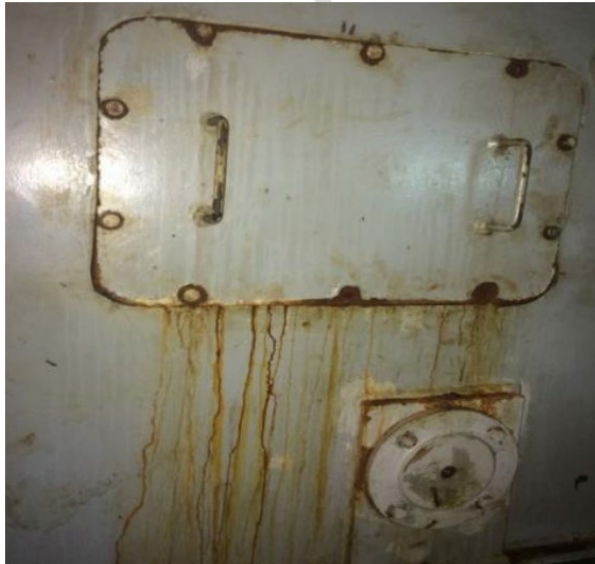
The *Bourbon Rhode* technical inspections report from 19 May 2019 identified the inspection covers to be leaking, with evidence of staining on the housing frame.

In addition to the technical inspection report, Bourbon Marine & Logistics provided the following two pictures showing the Shark Jaws inspection covers in May and August 2019. Both pictures show stains on the shark jaws housing frame suspected to come from leaking inspection covers.

Figure 3.28 – Starboard Inspection Cover, May 2019
(Source: Bourbon Marine & Logistics)

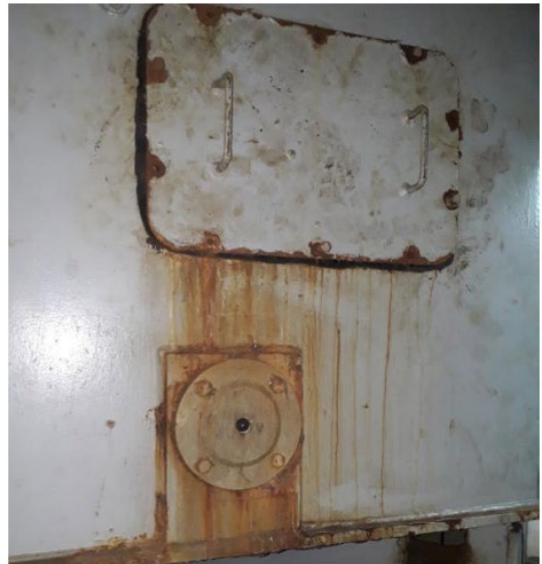
Figure 3.29 – Port Inspection Cover, August 2019
(Source: Bourbon Marine & Logistics)

According to statements of the previous crew operating the voyage from Onne (Nigeria) to Las Palmas (Spain), the leakage of the inspection covers had been identified and the replacement of these covers was entered into the Task Assistant to be completed during the upcoming maintenance works (PMP) at the shipyard in Las Palmas. It was further stated that with the jaw plate covers installed and sealed, water was still leaking through the inspection covers during times of heavy rainfall.

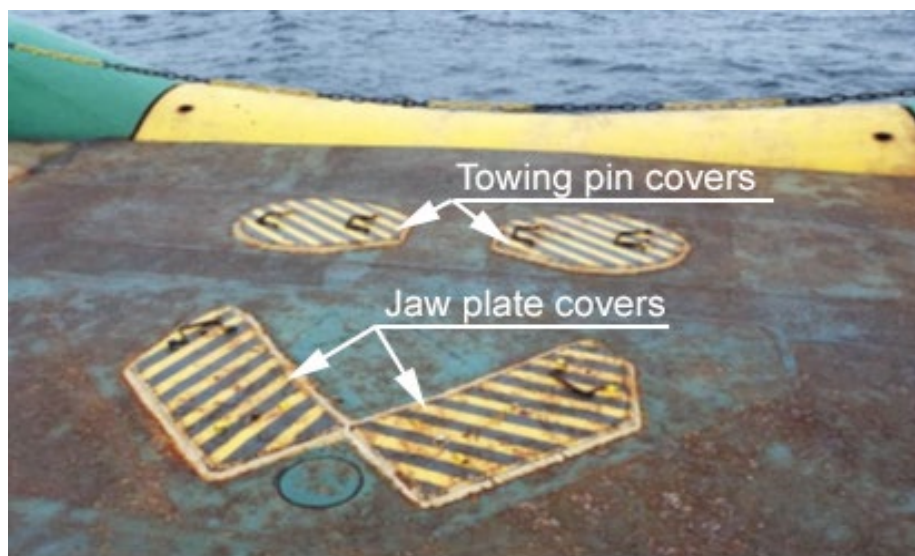
According to the manufacturer's '*Operation Manual of Deck Machinery*', jaw plate covers are not part of the supply list and can hence be considered as optional (unless mandated by the operator of the vessel). They can be installed to cover the retracted Shark Jaws when they are not in use. When fastened to the securing bolts of the Shark Jaws, they provide a flat and even surface, thereby reducing the risk of injury to crewmembers working on deck. Furthermore, when installed with appropriate sealing, they can prevent or reduce water ingress into the watertight housing frame of the Shark Jaws.

Figure 3.30 – *Bourbon Rhesos*, sister vessel, Shark Jaws in retracted position with jaw plate covers fitted and cemented to the working deck
(Source: Bourbon Marine & Logistics)
