Luxembourg, 19 August 2020

SAFETY BULLETIN LU-MA-SB/2020-001

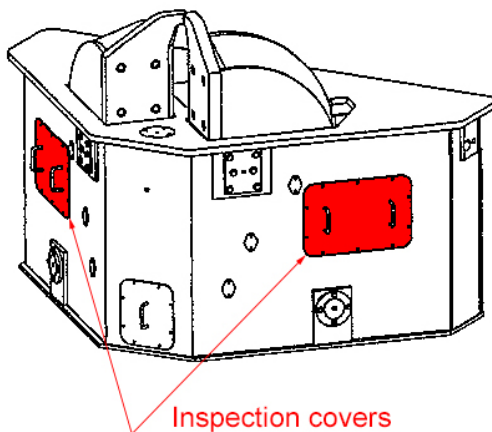
The Bourbon Rhode, an oceangoing anchor handling tug, was equipped with a system called shark jaws¹, installed in the aft Z-Drive compartment, to secure chains or wires during anchor handling operations. During operation, water from the deck can enter the watertight housing frame, which has three drain fittings at the bottom plate. When not in use, the shark jaws are lowered into the housing frame and are flush with the deck. In lowered position, gaps around the shark jaws allow water to enter the housing frame.

Figure 1. - Shark jaws housing frame²

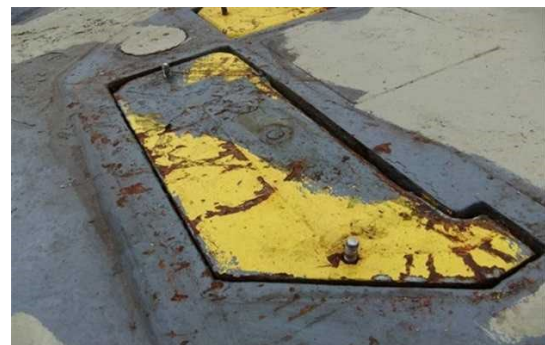
Figure 2. - Retracted shark jaws on Bourbon Rhesos³

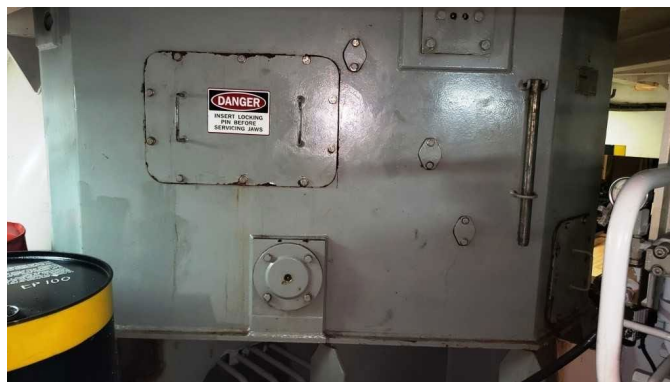
Figure 3. – Shark jaws inspection cover on Bourbon Rhesos⁴

Over time, the inspection covers of the shark jaws housing frame on the Bourbon Rhode have lost their watertight properties. The water leaking through the gaps between the housing frame and the inspection covers was collected in the bilge well at the bottom of the Z-Drive compartment and could be pumped out by activating the bilge pump system.

The investigation has shown that under unfavorable circumstances and in combination with other safety-related factors that will be developed in the final report, the water quantity penetrating the compartment is likely to increase up to a point where, when unnoticed or unattended for a certain period of time, an unsafe condition may develop and lead to a major flooding with subsequent foundering.

The Administration of technical investigations advises all operators of vessels equipped with the Plimsoll Smith Berger Hydraulic Shark Jaw system P3679-350MTTA or anchor handling systems with similar designs of the inspection covers to implement in the vessel operator's Safety Management System a standard procedure for tasks requiring the opening of the inspection covers of the anchor handling system housing frame.

- Preventive actions to mitigate the risk of water ingress through the inspection openings during maintenance tasks on the anchor handling systems (e.g. sea state limitations, installation of anchor handling system deck cover plates);

- Instructions for the appropriate sealing method when installing the inspection covers to ensure the watertightness of the anchor handling system housing (e.g. application of silicone sealant, installation of gasket);

- Instructions for testing the watertightness of the anchor handling system after completion of the works and installation of the inspection covers (e.g. flooding of anchor handling system housing frame with closed drainage by use of fire hose).

- Maintenance actions to prevent a degradation of the inspection covers and securing devices, which could compromise the watertightness of the anchor handling system;
