SAFETY RECOMMENDATION LU-MA-SR/2020-003

The ongoing investigation of the sinking of the vessel Bourbon Rhode on 26 September 2019 in the Atlantic Ocean during a transit voyage from Las Palmas to Guyana has highlighted a safety issue that requires an immediate safety action. In accordance with the provisions laid down in Art. 9., paragraph 2, of the national amended law dated 30 April 2008 establishing the Administration of technical investigations (AET), safety recommendations may be issued at any time during the investigation, when such an action is deemed necessary.

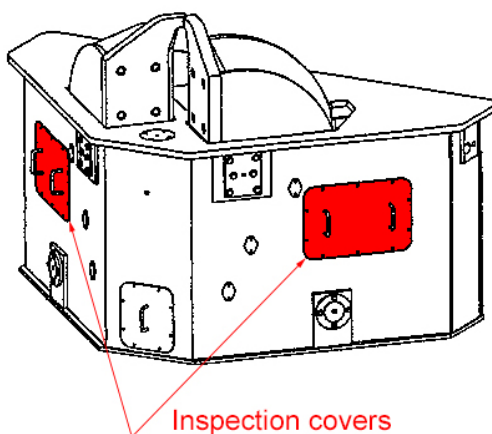
Figure 1. - Shark jaws housing frame²

The Bourbon Rhode, an oceangoing anchor handling tug, was equipped with a system called shark jaws¹, installed in the aft Z-Drive compartment, to secure chains or wires during anchor handling operations. During operation, water from the deck can enter the watertight housing frame, which has three drain fittings at the bottom plate. When not in use, the shark jaws are lowered into the housing frame and are flush with the deck. In lowered position, gaps around the shark jaws allow water to enter the housing frame.

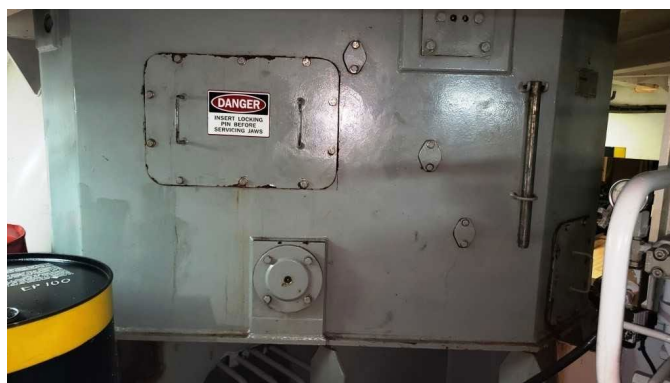
Figure 3. – Shark jaws inspection cover on Bourbon Rhesos⁴

Over time, the inspection covers of the shark jaws housing frame on the Bourbon Rhode have lost their watertight properties. The water leaking through the gaps between the housing frame and the inspection covers was collected in the bilge well at the bottom of the Z-Drive compartment and could be pumped out by activating the bilge pump system.

The investigation has shown that under unfavorable circumstances and in combination with other safety-related factors that will be developed in the final report, the water quantity penetrating the compartment is likely to increase up to a point where, when unnoticed or unattended for a certain period of time, an unsafe condition may develop and lead to a major flooding with subsequent foundering.

During the investigation, further analysis by the operator has identified other anchor handling vessels in his fleet with leaking inspection covers of the anchor handling systems⁵. This shows that the compromised watertightness of the anchor handling systems equipped with this type of inspection covers is not an isolated safety issue, but is likely to be encountered at a systemic level. This latent condition led to the issuance of the present safety recommendation.

To require all owners of vessels equipped with the Plimsoll Smith Berger Hydraulic Shark Jaw system P3679-350MTTA or anchor handling systems with similar designs of the inspection covers and registered on the Luxembourg Merchant Fleet register, to implement in the vessel operator's Safety Management System a standard procedure for tasks requiring the opening of the inspection covers of the anchor handling system housing frame.

- Instructions for the appropriate sealing method when installing the inspection covers to ensure the watertightness of the anchor handling system housing (e.g. application of silicone sealant, installation of gasket);

- Instructions for testing the watertightness of the anchor handling system after completion of the works and installation of the inspection covers (e.g. flooding of anchor handling system housing frame with closed drainage by use of fire hose).

- Maintenance actions to prevent a degradation of the inspection covers and securing devices, which could compromise the watertightness of the anchor handling system;
