# Contact with wharf by livestock carrier *Angus Express*

Berths 4 and 5, Broome, Western Australia, on 20 April 2018

**ATSB Transport Safety Report**  
Marine Occurrence Investigation  
343-MO-2018-006  
Final – 20 March 2019

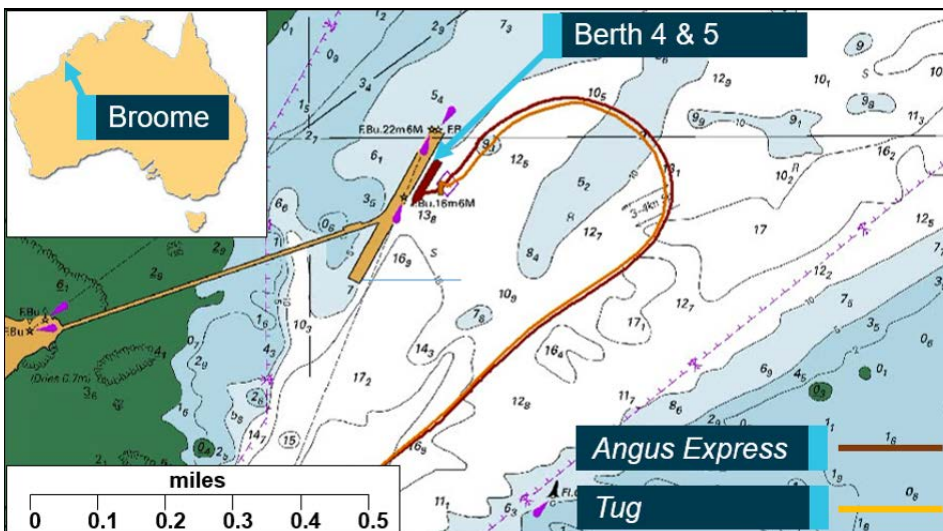
**Figure 1: *Angus Express*'s arrival into Broome and the approach to berth 4 & 5**

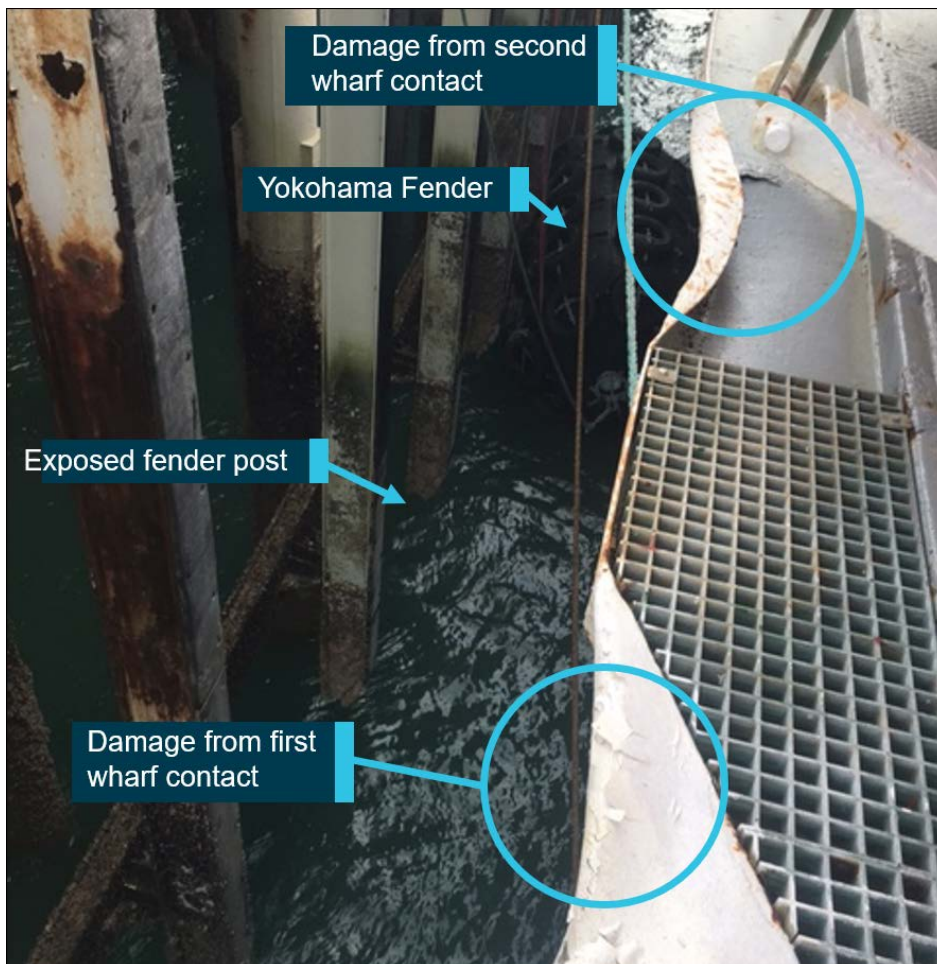
At 0712, the weight of the ship against the forward Yokohama fender forced it to pass under the fender posts, which resulted in the ship's bow moving towards the wharf (Figure 2). Shortly after, an overhanging scupper<sup>5</sup> protrusion made contact with the fender post (about 30 m from the ship's bow).

**Figure 2: Damage to the *Angus Express*'s starboard scupper protrusion**

towards the wharf, and the scupper protrusion again made contact with the fender post (Figure 2). The pilot instructed the tug to stop, and the ship came away from the vertical fender posts.

The pilot reported the incident to the harbour master who subsequently attended the ship and found minor damage to the ship's superstructure.

The height of tide at the time of the incident was 1.62 m, which was low enough to expose the base of the fender posts (Figure 3). When the pilot attempted to manoeuvre *Angus Express* forward using the tug, the force exerted on the Yokohama fender by the ship, allowed it squish and roll under the fender post. Consequently, the ship moved closer to the wharf and the scupper protrusion contacted the post.

- The height of tide when *Angus Express* was berthing was low enough to expose the base of the wharf's fender posts. Consequently, when the tug pushed to move the ship, the forward Yokohama fender was forced under the post, which allowed the ship's starboard scupper protrusion to contact the post with resulting damage.
- The harbour master and pilot were unaware of any height of tide limitations associated with berthing ships alongside Yokohama fenders at berths 4 and 5. Therefore, the risk assessment did not include any mitigating factors for berthing alongside at a height of tide less than 2.5 m.

Guidelines for berthing and being alongside when using Yokohama style fenders have been implemented for times of limiting low water levels. Also, the risk evaluation process between harbour master and pilot has been extended to include focussed quick risk assessment for circumstances such as tug shortages, vessel manoeuvring issues and tidal levels.

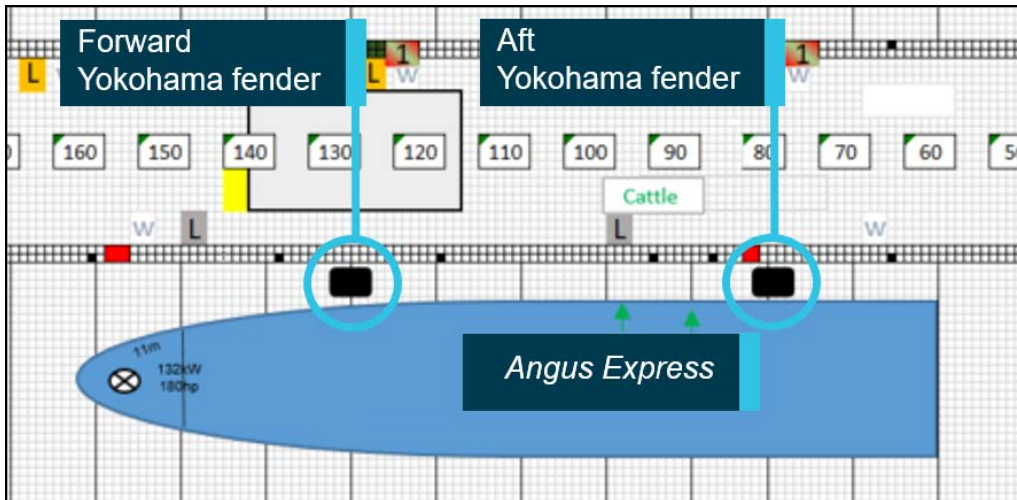
**Figure 3: Berthing plan showing the position of the Yokohama fenders at berth 4 & 5**

Post-incident investigations by Kimberley Ports Authority (KPA) and the pilotage provider, West Coast Pilots (WCP) confirmed that the fender posts at berths 4 and 5 were shorter than at others. No evidence was found to indicate that these shorter posts or the potential for fenders to be forced under them when water levels fell had been documented or otherwise promulgated to pilots through training or instruction.
