Contact with wharf by livestock carrier *Angus Express*

Berths 4 and 5, Broome, Western Australia, on 20 April 2018

ATSB Transport Safety Report

343-MO-2018-006

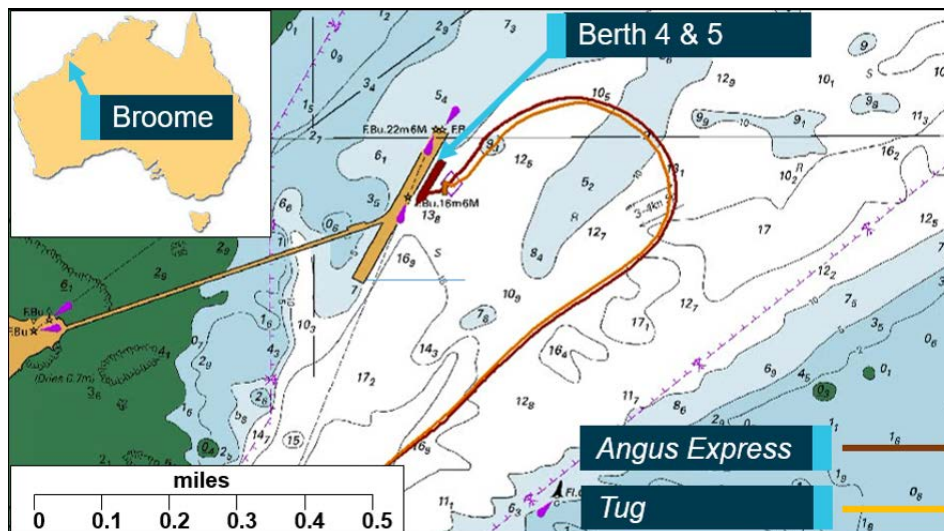
Figure 1: *Angus Express*'s arrival into Broome and the approach to berth 4 & 5

The pilot explained the plan to the ship's chief mate and master during the MPX and they agreed with the plan. The pilotage into Broome continued with a tug in attendance from 0636 (Figure 1), and went as planned and without incident.

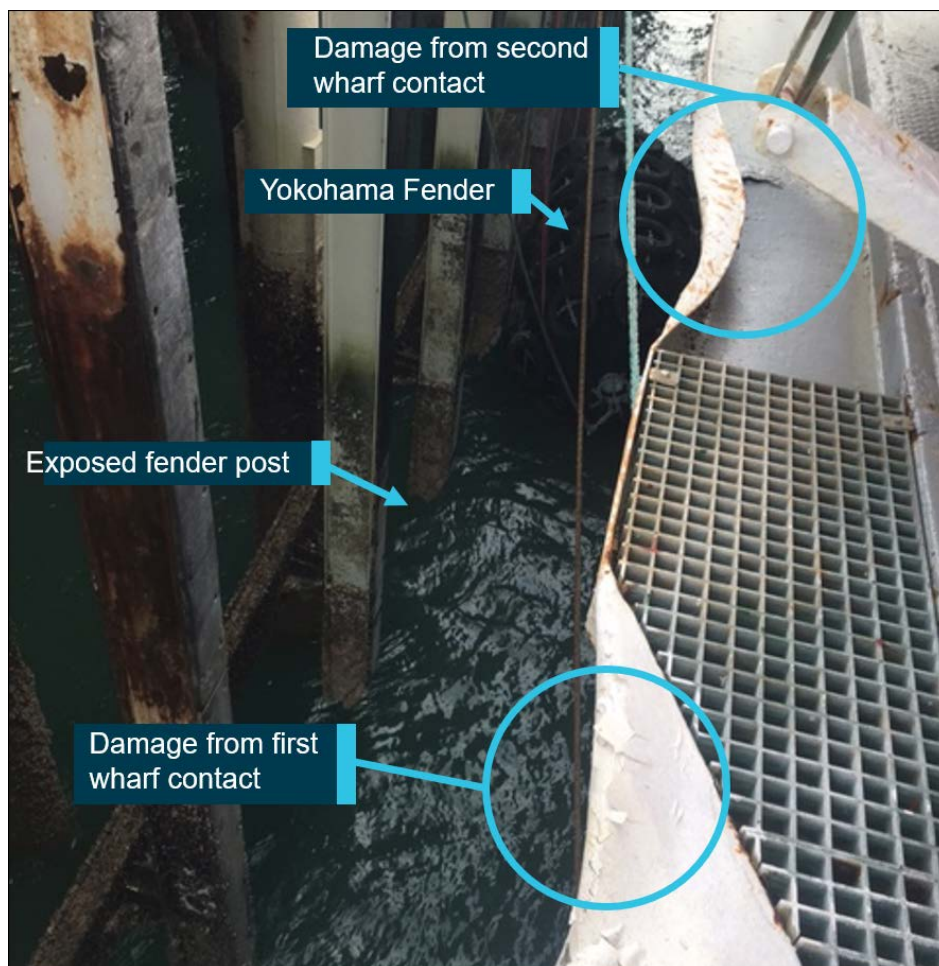
Figure 2: Damage to the *Angus Express*'s starboard scupper protrusion

At 0712, the weight of the ship against the forward Yokohama fender forced it to pass under the fender posts, which resulted in the ship's bow moving towards the wharf (Figure 2). Shortly after, an overhanging scupper⁵ protrusion made contact with the fender post (about 30 m from the ship's bow).

towards the wharf, and the scupper protrusion again made contact with the fender post (Figure 2). The pilot instructed the tug to stop, and the ship came away from the vertical fender posts.

The pilot reported the incident to the harbour master who subsequently attended the ship and found minor damage to the ship's superstructure.

The height of tide at the time of the incident was 1.62 m, which was low enough to expose the base of the fender posts (Figure 3). When the pilot attempted to manoeuvre *Angus Express* forward using the tug, the force exerted on the Yokohama fender by the ship, allowed it squash and roll under the fender post. Consequently, the ship moved closer to the wharf and the scupper protrusion contacted the post.

- The height of tide when *Angus Express* was berthing was low enough to expose the base of the wharf's fender posts. Consequently, when the tug pushed to move the ship, the forward Yokohama fender was forced under the post, which allowed the ship's starboard scupper protrusion to contact the post with resulting damage.
- The harbour master and pilot were unaware of any height of tide limitations associated with berthing ships alongside Yokohama fenders at berths 4 and 5. Therefore, the risk assessment did not include any mitigating factors for berthing alongside at a height of tide less than 2.5 m.

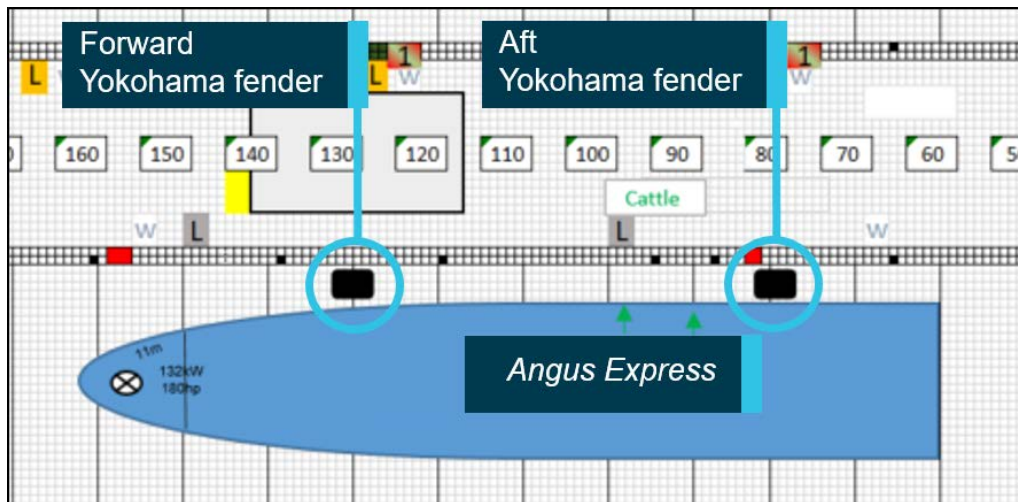
Figure 3: Berthing plan showing the position of the Yokohama fenders at berth 4 & 5

The Yokohama fender system in the Port of Broome consisted of large floating cylindrical rubber fenders, secured to vertical fender posts, which allowed vertical movement as the tide changed. The tyres fitted with chain to the outside of the fenders for protection also increased their width. The use of fenders kept the ship's side clear of the wharf, protecting both, and allowed longer loading windows (Figure 3). The added clearance from the wharf also reduced the steepness of the gangway in the large tidal range at Broome.

After the incident, inquiries by *Angus Express*'s pilot resulted in a pilot who had worked in the port until 2015 providing relevant information about the Yokohama fender system. That pilot's personal pilotage log indicated that a height of tide of less than 2.5 m was considered a significant factor with respect to the fenders at berth 5. When the water level fell below this height, the fenders could be forced under the vertical fender posts by a ship.

Post-incident investigations by Kimberley Ports Authority (KPA) and the pilotage provider, West Coast Pilots (WCP) confirmed that the fender posts at berths 4 and 5 were shorter than at others. No evidence was found to indicate that these shorter posts or the potential for fenders to be forced under them when water levels fell had been documented or otherwise promulgated to pilots through training or instruction.

Guidelines for berthing and being alongside when using Yokohama style fenders have been implemented for times of limiting low water levels. Also, the risk evaluation process between harbour master and pilot has been extended to include focussed quick risk assessment for circumstances such as tug shortages, vessel manoeuvring issues and tidal levels.
