## Report on the fatal accident on board mv SIMON STEVIN on 28 January 2019

The subsea rock installation vessel mv SIMON STEVIN was moored alongside at the Port of Zeebrugge for overhauling purposes. Most of the crew, except a few watchmen, were working in dayshifts, from 06.00 to 18.00.

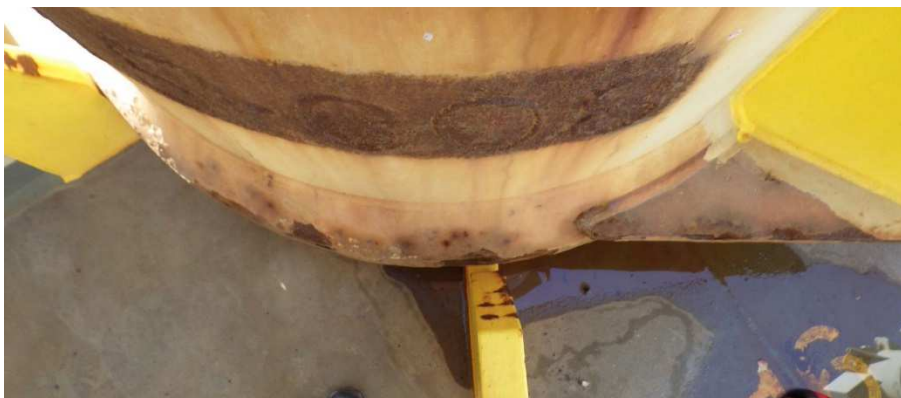
The use of the remote control was not exceptional as, for example, the steel pipes sometimes collided with the guide brackets welded on deck.

*Figure 10 - Detail of steel pipe in storage position with yellow guide brackets*
