## Report on the fatal accident on board mv SIMON STEVIN on 28 January 2019

#### 3.2 Accident Details

Time and Date	28 January 2019
Location	moored alongside at the Port of Zeebrugge (Belgium)
Deceased	1

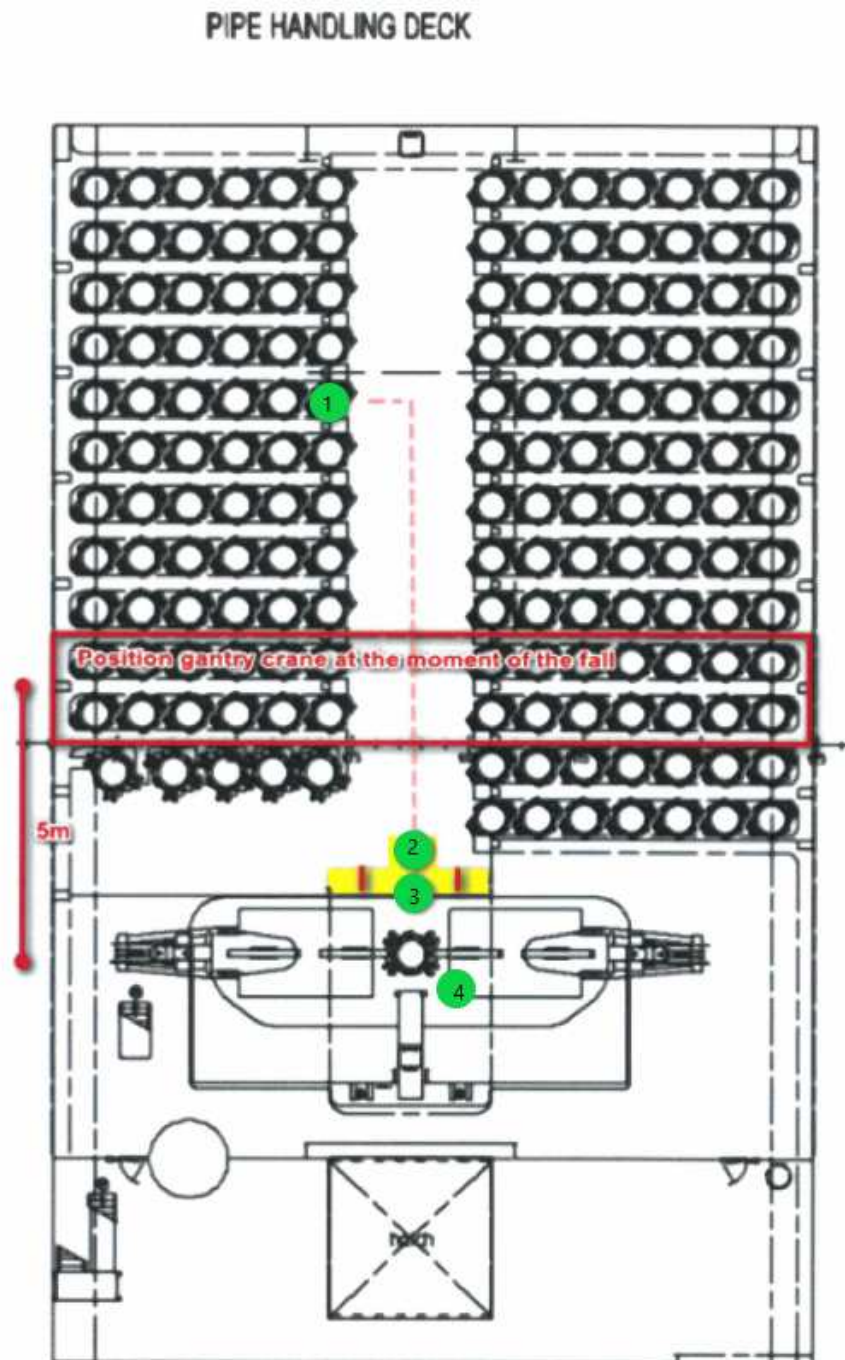
Figure 3 – Pipe handling deck

1. Pipe racks, where steel pipe sections are stored
2. Waiting position of the gantry crane (manipulator)
3. Railing that needs to be opened to transfer the pipes from the manipulator to the gripper
4. Gripper operating above the moon pool

As shown in Figure 3 on page 13, steel pipe sections had a storage position on the fall pipe deck. A manipulator (gantry crane) installed on this fall pipe deck could handle the pipes and transfer them to the gripper. The gripper could lower the pipe sections, so they could be connected to each other forming one long fall pipe through the moon pool in the ship's hull. The moon pool hatch was at main deck level, the fall pipe deck is some 12 metres higher. There was a railing between both deck levels that needed to be opened to allow for the transfer of steel pipe sections. The two gates in the railing needed to be opened manually. Both gates allow for a 90° opening, creating a safety barrier for any person that wanted to cross the pipe transfer area.

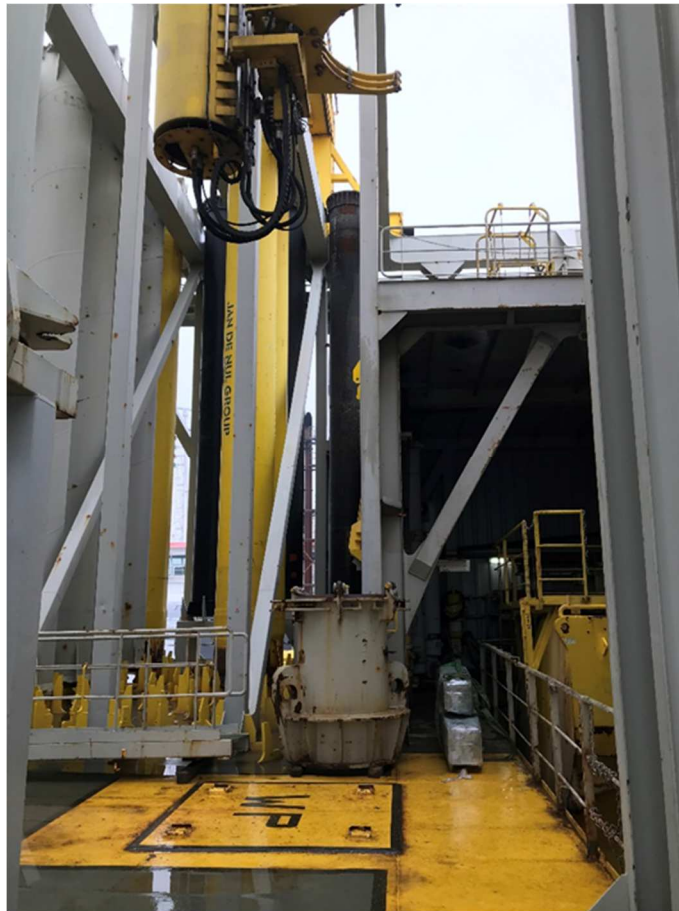
To reset the manipulator back to automatic mode, it was necessary to bring it to the waiting position, in front of the opened gates. From the position of the operator, the waiting position was located behind his back.

*Figure 6 - Manipulator at waiting position in caution area*

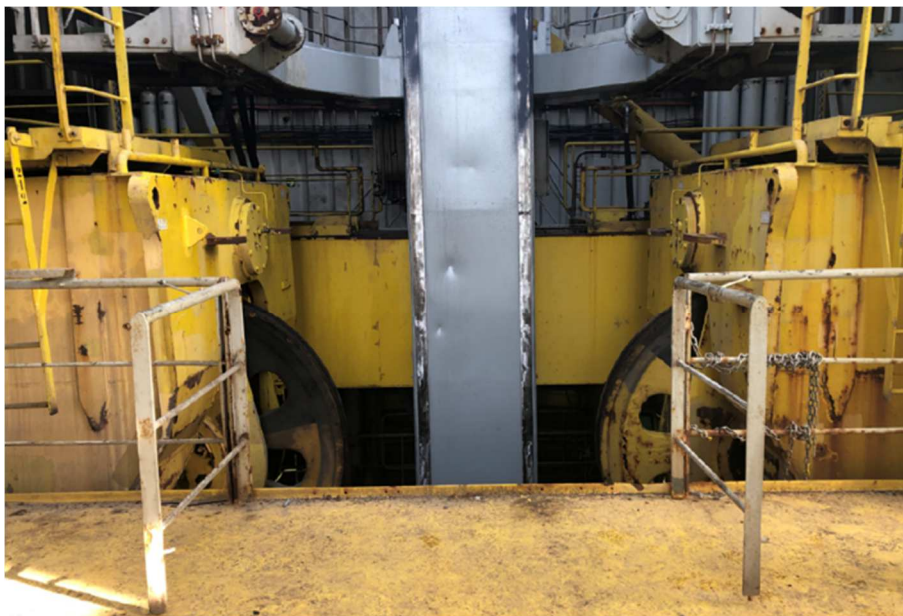
*Figure 7 - Open railing, gates turned 90°*

During pipe transfers between manipulator and gripper, the two gates in the railing were opened. These two gates and the yellow painted caution area were two barriers to prevent any passage during pipe transfers. When pipe transfers were finished, the gates were closed again.

1. The gates in the railing were open.
2. The FPO walked backwards, observing a gantry crane at a height of some 12 metres in front of him. He was not aware that he entered the caution area and that he was approaching the open gates.

As the gates in the railing were left open until the complete pipe transfer process had been completed, there was a possibility to fall from heights.

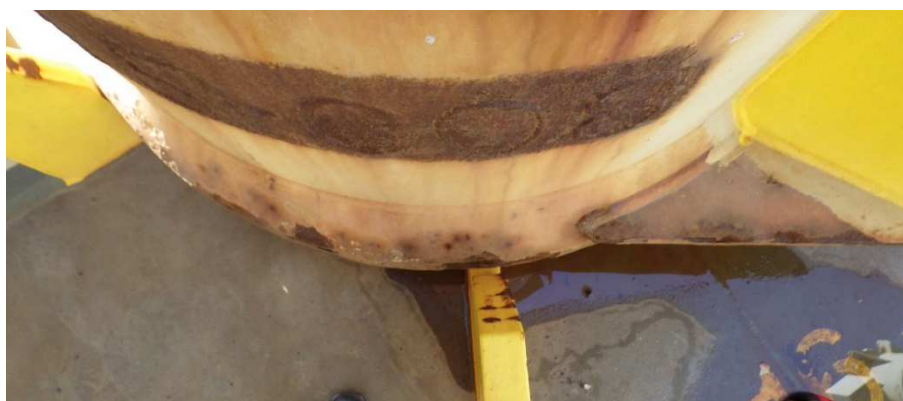
The use of the remote control was not exceptional as, for example, the steel pipes sometimes collided with the guide brackets welded on deck.

*Figure 10 - Detail of steel pipe in storage position with yellow guide brackets*

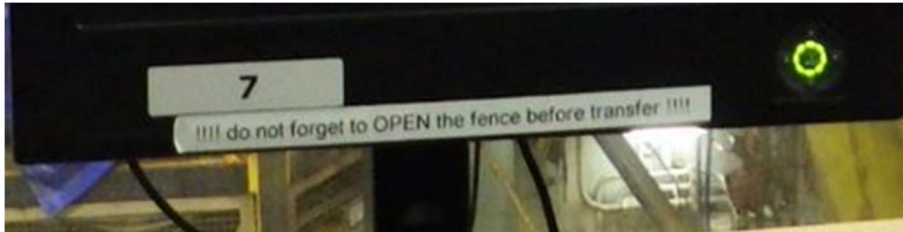
*Figure 11- Indication on screen in control room*

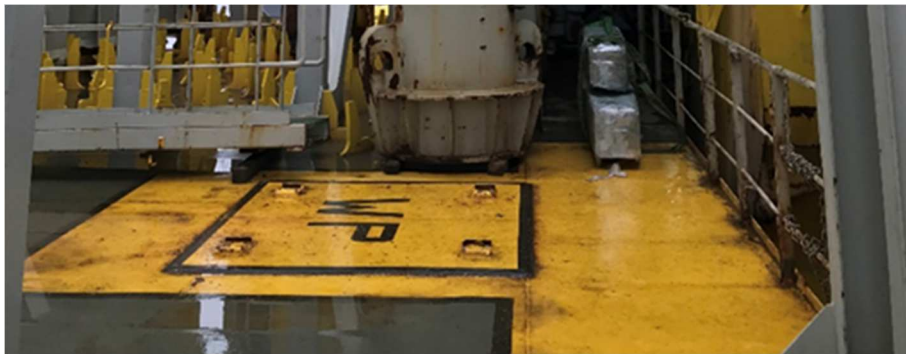
In case remote controlled intervention was needed by the FPO in the working area of the manipulator, only the caution area indicated the presence of the (opened) gates in the railing. It was not necessary to enter the caution area during remote controlled operations, but accidental entering was not excluded.

*Figure 12 – Caution area*

The caution area, a zone painted yellow, had not been observed during the manoeuvring with the gantry crane.

Entrance in the caution area can only be visually observed and had not been noticed. There is no auditory or kinaesthetic barrier.

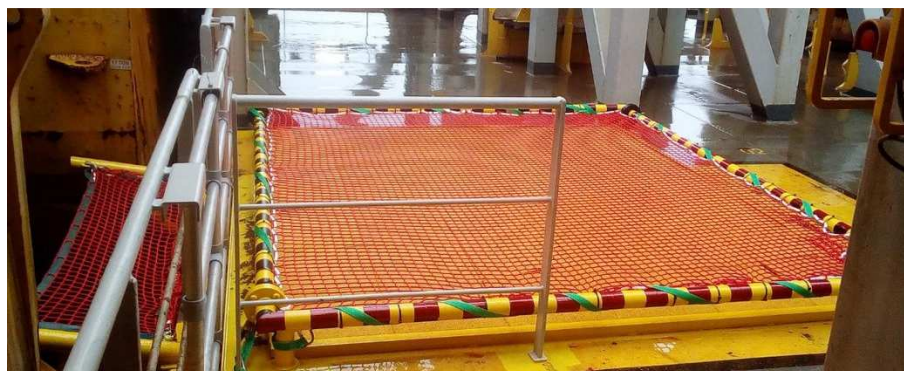
*Figure 13 – Sliding gate and permanent railing*

1. The gates in the railing have been replaced by a sliding gate that can be operated without entering the caution area as seen in Figure 13 on page 23.

2. A railing was installed to prevent the entrance of the caution area. Standing behind this railing, the sliding gate can be operated manually.
3. A safety net had been installed behind the sliding gate as seen in Figure 16 on page 24.

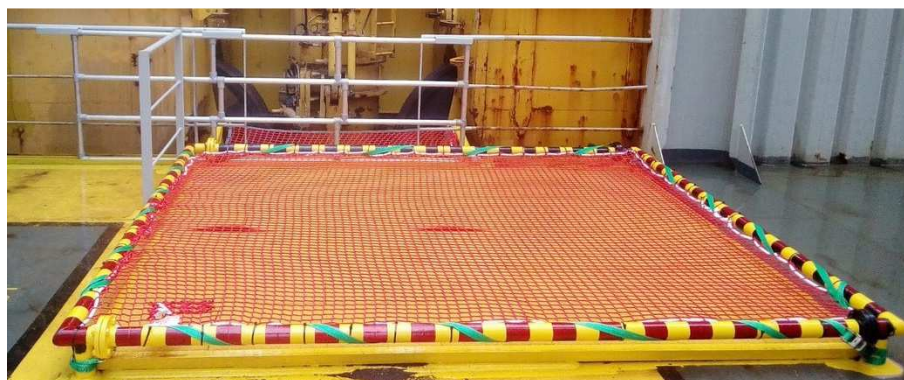
*Figure 14 - Kinaesthetic barrier*

4. A kinaesthetic barrier with a net and rubber mats had been installed to provoke a safe stumble in case of an unobserved entrance of the caution area. This barrier also prevented any passage in the caution area as seen in Figure 14 on page 23.

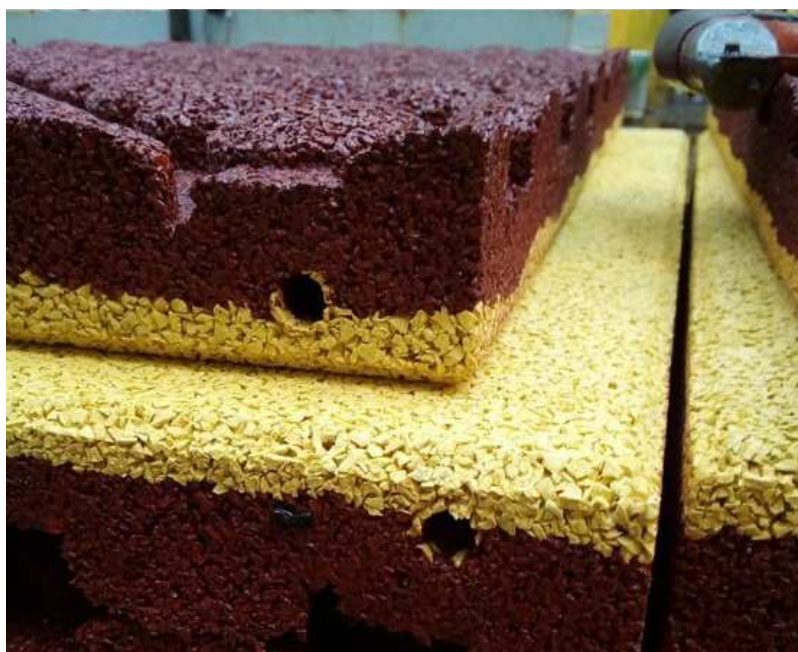
*Figure 15 – Rubber under the net of the barrier for a safe stumble*

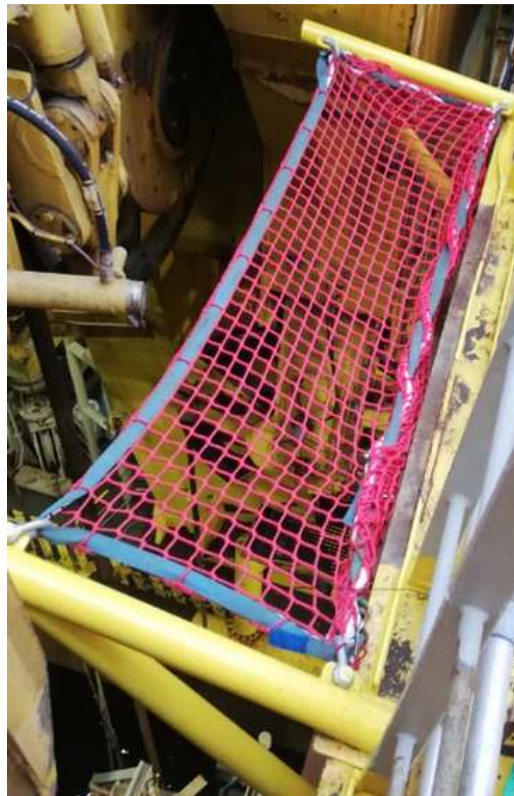
Figure 16 - Safety net behind sliding gate

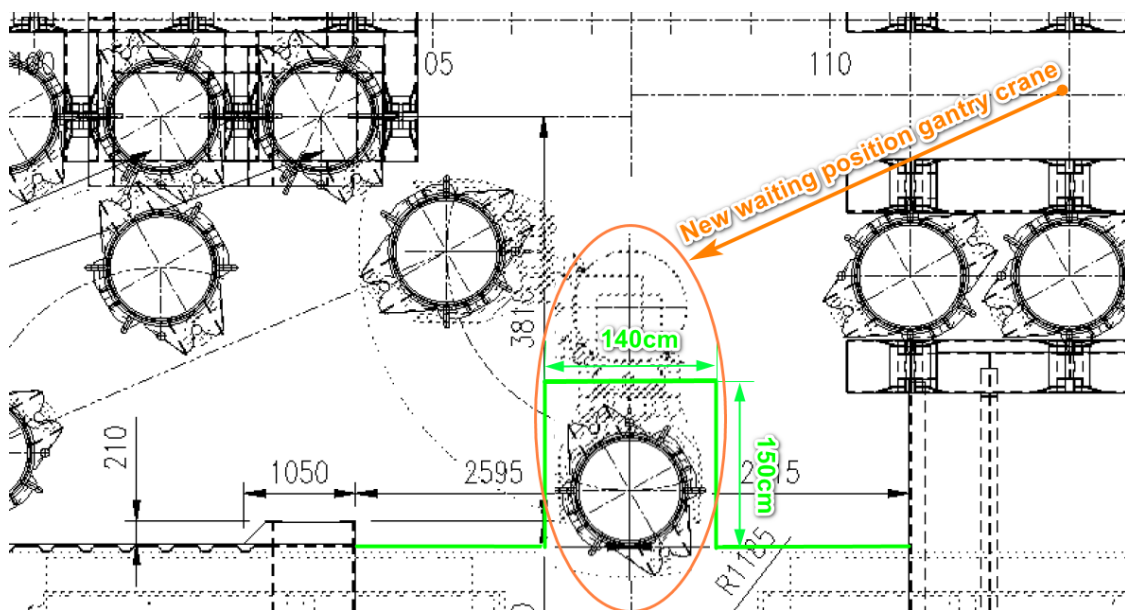
Figure 17 - Impression of final and permanent railing

5. A study was started to construct a final and permanent railing around the whole caution area in way of the manipulator as seen in Figure 17 on page 24. The manipulator should lift the pipe over the railing, but needed reprogramming. The study included the height and position of the railing and the limitations of the manipulator.
