# EMERGENCY LANDING OF A CESSNA C177 NEAR STEGEN (L) ON 18 JANUARY 2015

Report N° AET/AC-2018/02

## FACTUAL REPORT

Emergency landing of a Cessna C177 near Stegen (L) on 18 January 2015

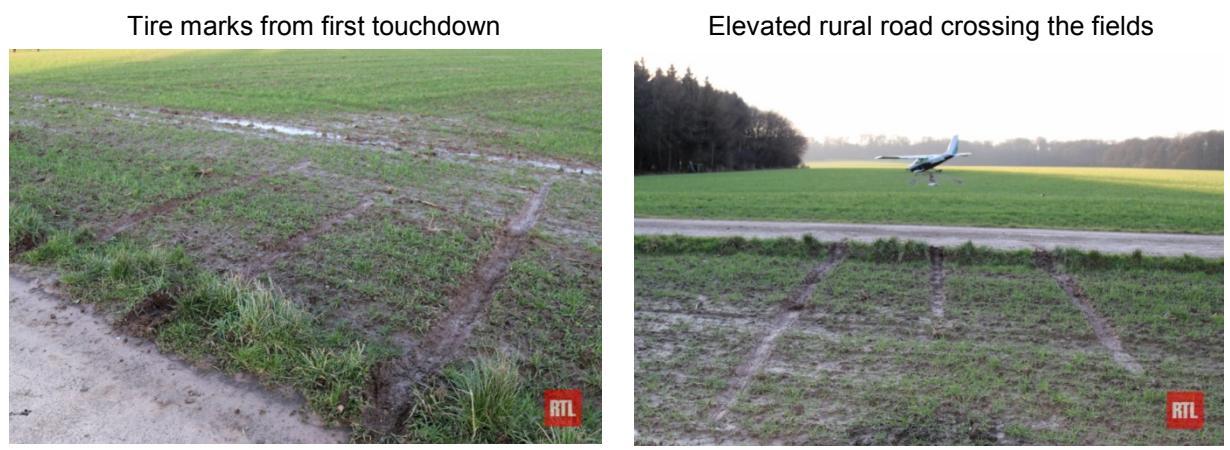
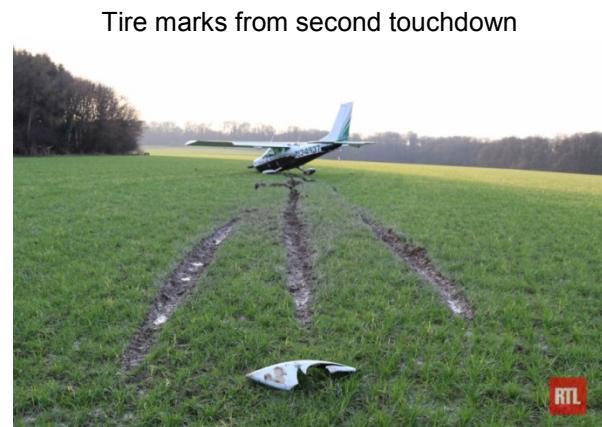
The selected field was bordered by a paved rural road on the east side, which was the side the pilot was approaching from. The aircraft first touched down in the adjoining field to the east of the rural road, approximately 3.5 m from the road, leaving visible marks in the muddy soil. It should be noted that he paved rural road is elevated by approximately 10 cm in relation to the adjoining fields. The tire marks continued for about 2 m across the rural road before disappearing. Small pieces of the nose wheel fairing could be found in close proximity to the rural road, leading to the conclusion that the nose wheel fairing had been damaged when impacting that road.

After the initial touch-down, while crossing the rural road, the aircraft became airborne again (absence of tire marks in the muddy soil). About 23 m further west, the tire marks reappeared. Based on the marks in the field, the aircraft's second touch-down was in a nose-down attitude. The nose wheel fairing then probably detached from the aircraft and came to rest in that area. Approximately 5 m after the second touchdown, the propeller impacted the muddy field several times, indicating that it was still turning. Approximately 10 m further down, the nose wheel broke off.

Shortly before coming to a stop and with the nose wheel detached, the aircraft veered to the left and the right hand wing tip impacted the field, damaging the outer portion of the leading edge.

During the landing sequence, the aircraft suffered damage to the rear fuselage structure, the propeller, the nose and main landing gear, the right wing and the rear back window.

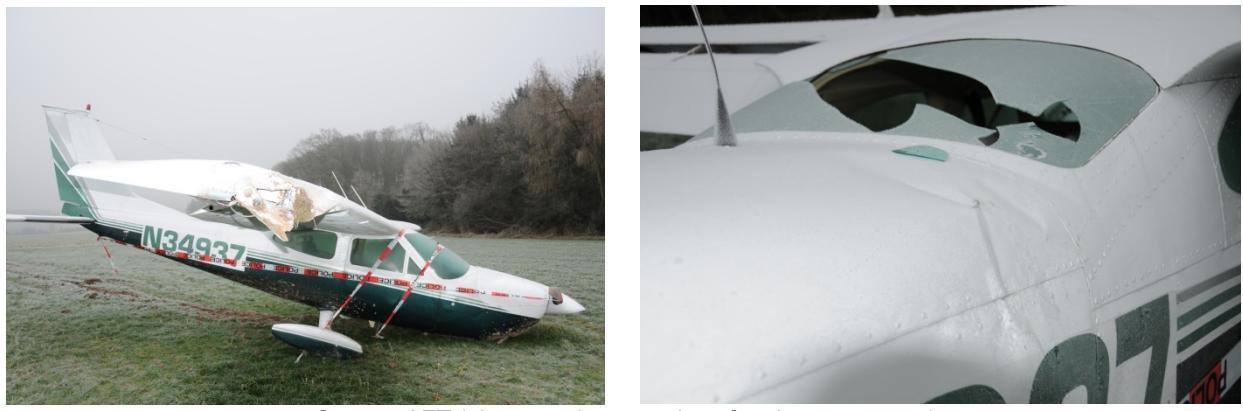
The aircraft sustained damage to the rear fuselage structure, the propeller, the nose and main landing gear, the right wing and the rear back window and was subsequently written off.
