FINAL REPORT
ON THE ACCIDENT OF 24 SEPTEMBER 2003
IN LUXEMBOURG
TO THE LUXAIR EMBRAER E145
REGISTERED LX-LGZ

Final issue: December 2010

Report N° AET-2010/AC-01

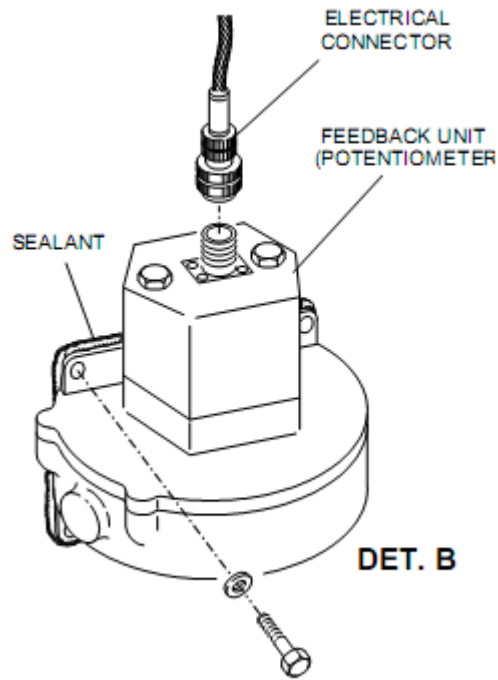
Figure 13. Feedback Unit located on the nose gear

Due to the mechanical working method of the Feedback Unit Sensor, no functional test was necessary. Visual inspection was performed to make sure that the unit was complete and not damaged.

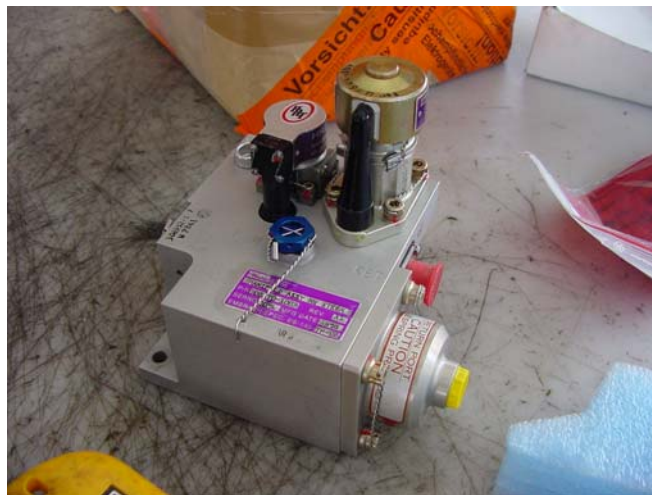
Figure 16. NW steering hydraulic manifold SN 0096

During the internal leakage test it was noted that the Electronic Hydraulic Servo Valve (EHSV) P/N 22253282-103 S/N 102 pressure was fluctuating ± 100 psi around neutral. This has been considered to be an anomaly and was specified in the test record. A first reaction was that the EHSV would get an unstable flow which might result in an oscillating nose gear.

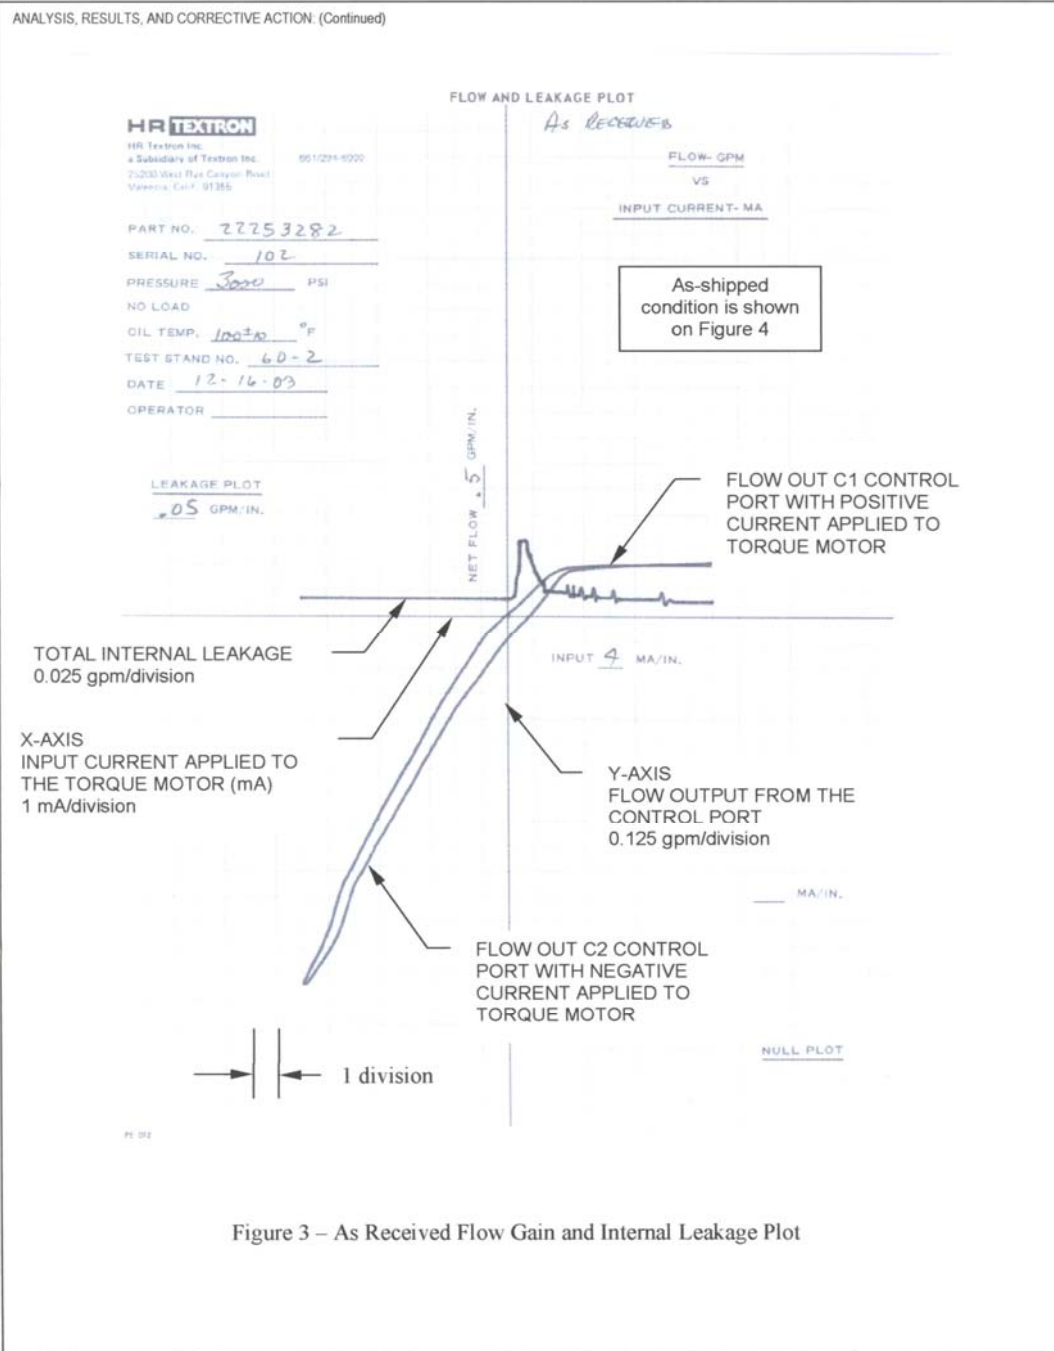
Figure 3 – As Received Flow Gain and Internal Leakage Plot

If contamination was present in the C1 nozzle, the C1 end chamber pressure could not decrease enough to allow the spool to travel to its commanded position and the first stage flow was restricted. In the case of the subject unit, the reduced second stage flow output observed in Figure 3 is evidence that the spool did not travel far enough to the left to fully open supply pressure to cylinder 1 and the low internal leakage is further evidence that the first stage was restricted.

1. Visually examined unit for external damage – No anomalies were noted.
2. Ran flow gain, internal leakage and pressure gain – Flow gain and pressure gain did not meet specification, see Figures 3 and 4. Figures 5 and 6 show the as shipped functional test plots for comparison.

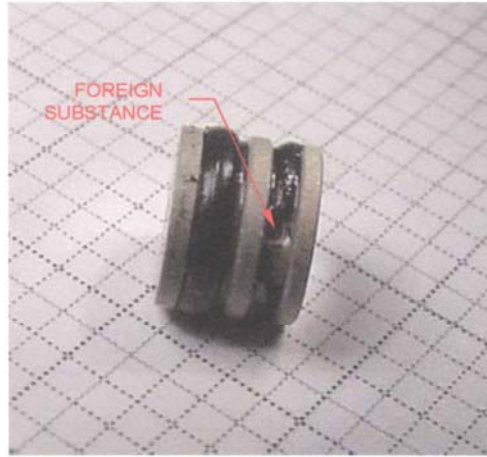
Figure 7 – C1 Orifice Plug

6. Removed C1 orifice plug – Foreign material was found on plug, see Figure 7. See Figure 8, C2 orifice plug, for comparison.
7. Removed filter seals and orifice and filter assembly – Damage was found on C1 filter seal, see Figure 9. See Figure 10, C1 filter seal, for comparison.

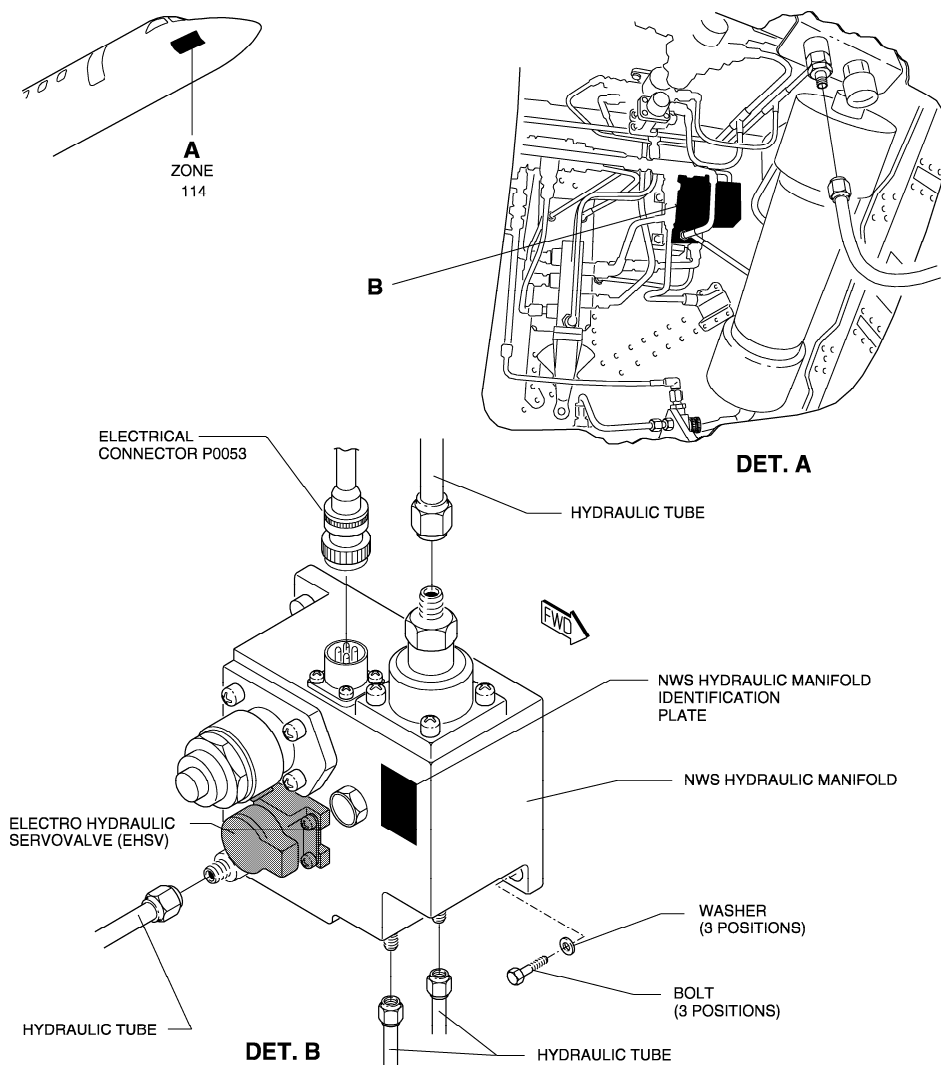
FIGURE 01 – NOSE WHEEL STEERING (NWS) HYDRAULIC MANIFOLD
(SHEET 01 OF 01)

There have been three (3) confirmed occurrences of an aircraft swerving off the runway upon touch-down of the nose landing gear during landing. In each case, the nose wheel steering did not respond to steering commands from the aircraft tiller. Also, in each case, the loss of steering control was determined to be due to a failure in the NWS Hydraulic Manifold. The manifold failures were traced to premature deterioration of an O-ring in the electro hydraulic servovalve (EHSV), which converts the electrical steering command to hydraulic pressure.

- (1) This service bulletin informs operators of the potential for the NWS hydraulic manifold, 308570-1003, to be unable to respond to the steering commands from the aircraft tiller and provides instructions to return the NWS Hydraulic Manifold, 308570-1003, to Parker inspection, repair, and re-identification of the NWS Hydraulic Manifold to the 308570-1007 configuration or higher.
- (2) The workscope consists of repair or replacement of the EHSV, 308590-1003. Compliant EHSV's will have the suffix letter "A" following the serial number.

WORK PHASES	MAN-HOURS
Replace EHSV with new or re-worked EHSV.	0.5
Test the NWS hydraulic manifold per CMM 32-50-15.	1.0
Re-identify the NWS hydraulic manifold per this service bulletin.	0.5
Total Man-Hours	2.0

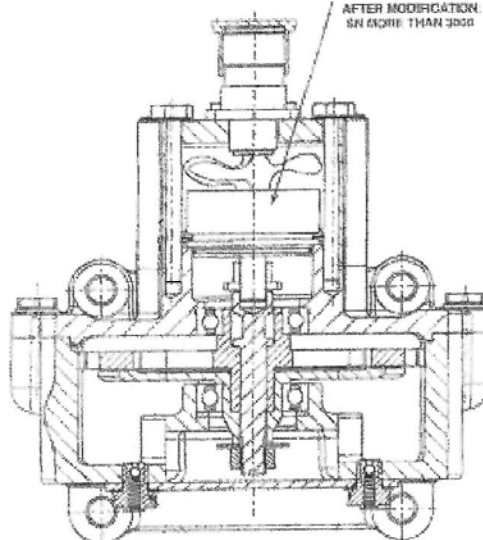
Feedback Unit Potentiometer
Figure 2

* POTENTIOMETER PN 0070B6022-01
BEFORE MODIFICATION:
SN LESS THAN OR EQUAL TO 3000

AFTER MODIFICATION:
SN MORE THAN 3000

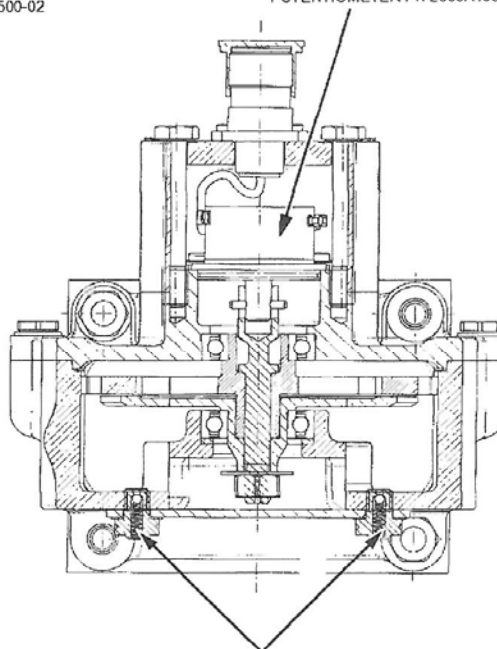
Feedback Unit Potentiometer PN 1170A3500-02 After Modification
Figure 4Issued: Dec 14/05
Rev.: 01170C-32-10
Page 5 of 15DATE: 27/Jan/2006
REVISION No.:SB No.: 145-32-0110
PAGE: 15

AFTER MODIFICATION
FEEDBACK UNIT POTENTIOMETER
PN 1170A3500-02

POTENTIOMETER PN 2000A1067K01

PRESSURE RELIEF VALVE PN 9049A0022-01
