FINAL REPORT
ON THE COLLISION BETWEEN A
CARGOLUX OPERATED BOEING 747-400F
REGISTERED LX-OCV
AND A MAINTENANCE VAN
ON RUNWAY 24
AT LUXEMBOURG AIRPORT (ELLX)
ON 21 JANUARY 2010, 11:53 UTC

DATE OF ISSUE : 10 DECEMBER 2012

Report N° AET-2012/AC-01

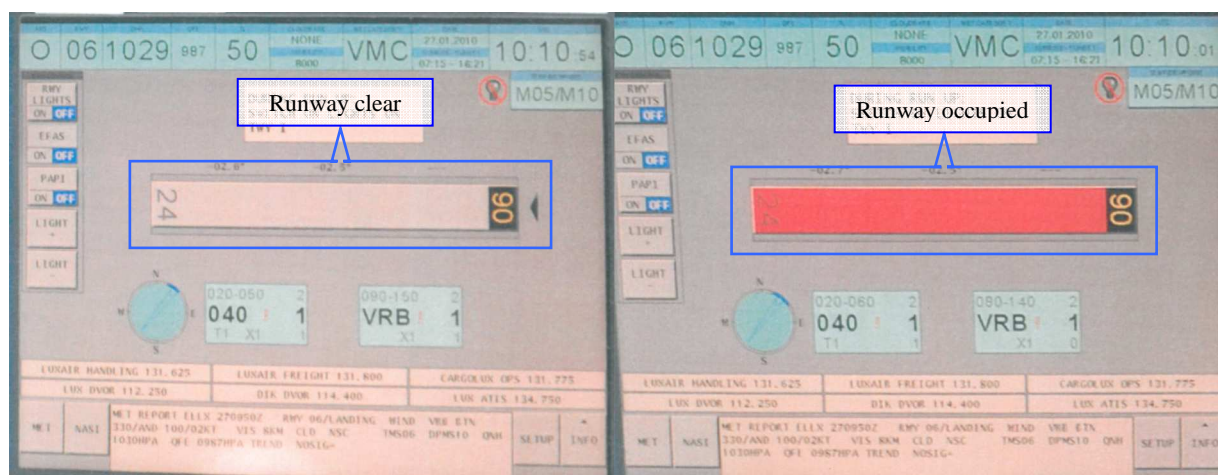
Picture 5: ADD (Source ANA)

The ADD is available on both tower working positions and provides the ATCO with the possibility to visually mark the runway in red colour by means of manual activation when it is occupied or closed. The ADD can also be monitored in approach control unit, enabling the approach control staff to see the red runway marking when activated.

The ADD was in an evaluation phase at the time of the occurrence and did not have operational status. The decision whether or not to use the system was left to the ATCO's on duty.
