FINAL REPORT
ON THE ACCIDENT OF 24 SEPTEMBER 2003
IN LUXEMBOURG
TO THE LUXAIR EMBRAER E145
REGISTERED LX-LGZ

Final issue: December 2010

Administration of Technical Investigations

Report N° AET-2010/AC-01

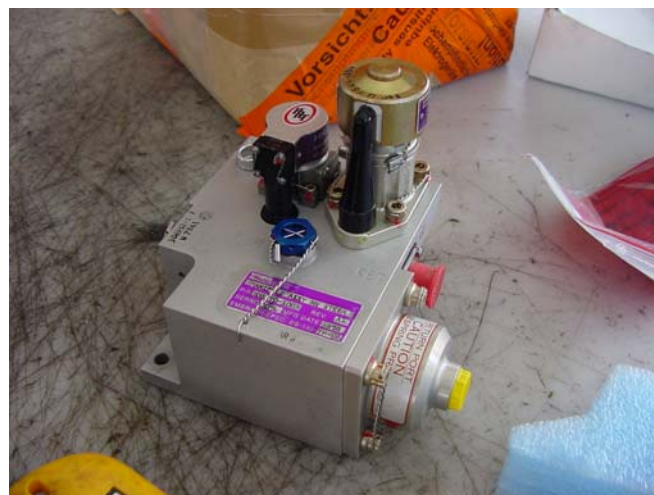
Figure 16. NW steering hydraulic manifold SN 0096

During the internal leakage test it was noted that the Electronic Hydraulic Servo Valve (EHSV) P/N 22253282-103 S/N 102 pressure was fluctuating ± 100 psi around neutral. This has been considered to be an anomaly and was specified in the test record. A first reaction was that the EHSV would get an unstable flow which might result in an oscillating nose gear.

The manifold was disassembled, witnessed also by an FAA inspector, for a precautionary visual inspection for any abnormalities. The only finding was that the inlet check valve (P/N 72900-301) cap retention fingers had all four broken off, but retained in the cavity. As implied above, the check valve was still functioning properly during test. No secondary damage was noted in the Nose Wheel Steering assembly as a result of the cap failure.

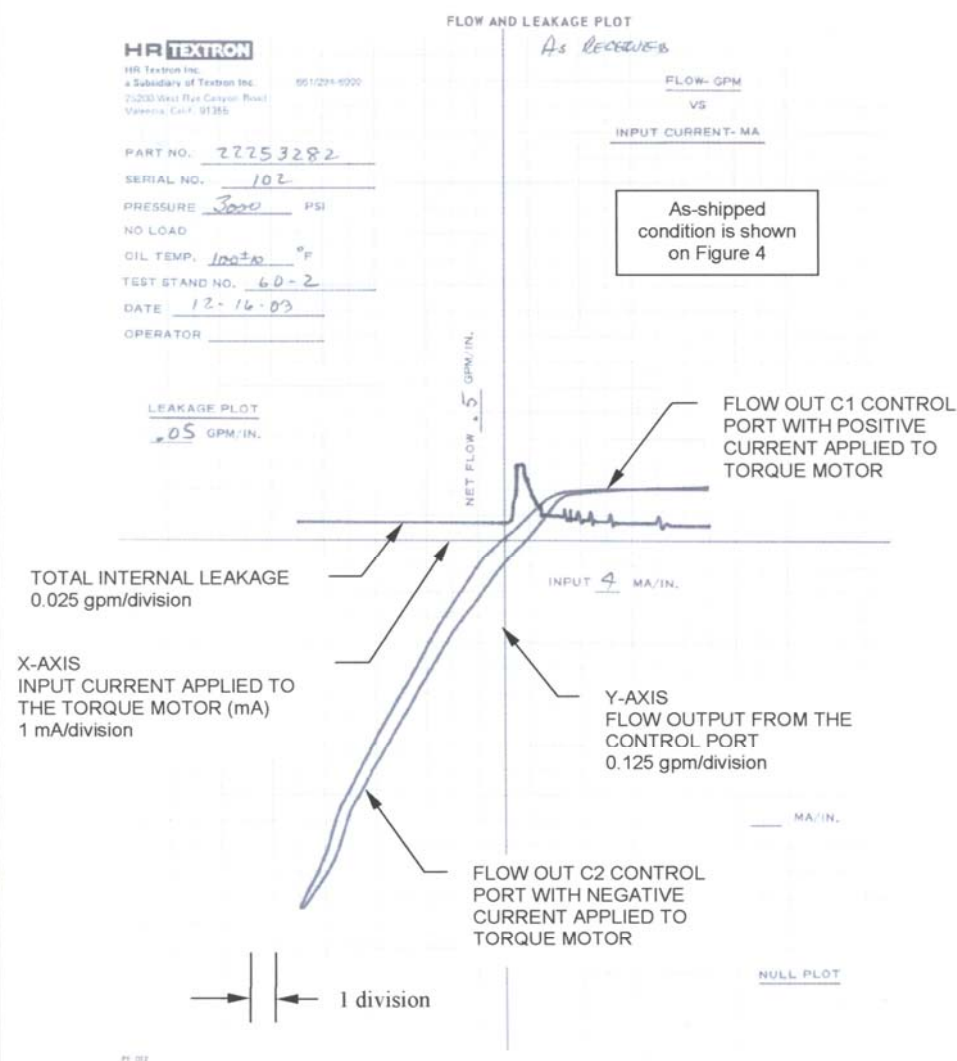
Figure 3 – As Received Flow Gain and Internal Leakage Plot

If contamination was present in the C1 nozzle, the C1 end chamber pressure could not decrease enough to allow the spool to travel to its commanded position and the first stage flow was restricted. In the case of the subject unit, the reduced second stage flow output observed in Figure 3 is evidence that the spool did not travel far enough to the left to fully open supply pressure to cylinder 1 and the low internal leakage is further evidence that the first stage was restricted.

1. Visually examined unit for external damage – No anomalies were noted.
2. Ran flow gain, internal leakage and pressure gain – Flow gain and pressure gain did not meet specification, see Figures 3 and 4. Figures 5 and 6 show the as shipped functional test plots for comparison.

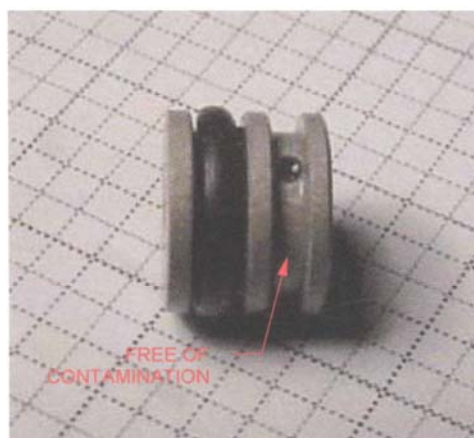
Figure 8 – C2 Orifice Plug

6. Removed C1 orifice plug – Foreign material was found on plug, see Figure 7. See Figure 8, C2 orifice plug, for comparison.
7. Removed filter seals and orifice and filter assembly – Damage was found on C1 filter seal, see Figure 9. See Figure 10, C1 filter seal, for comparison.

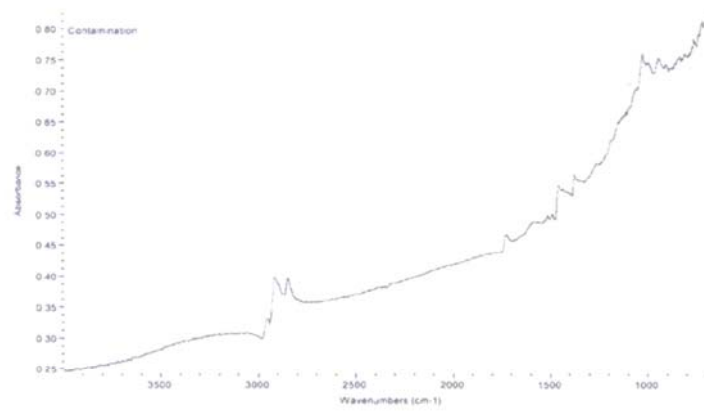
Figure 1

FTIR Spectrum for Contaminate particle

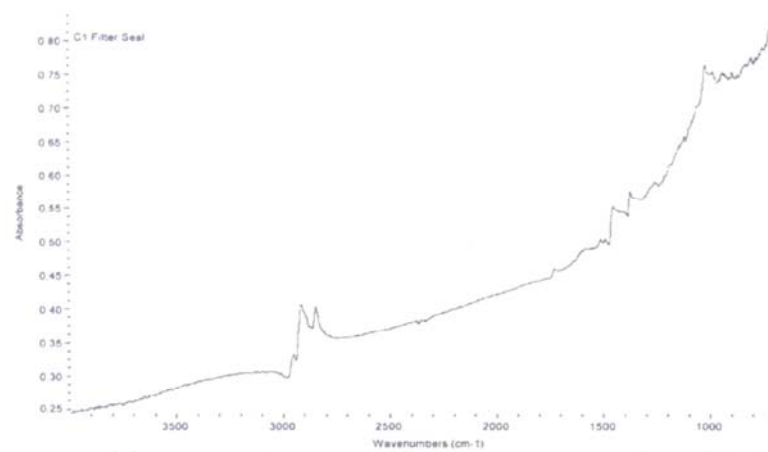
Figure 2

FTIR Spectrum for C1 Filter Seal Specimen

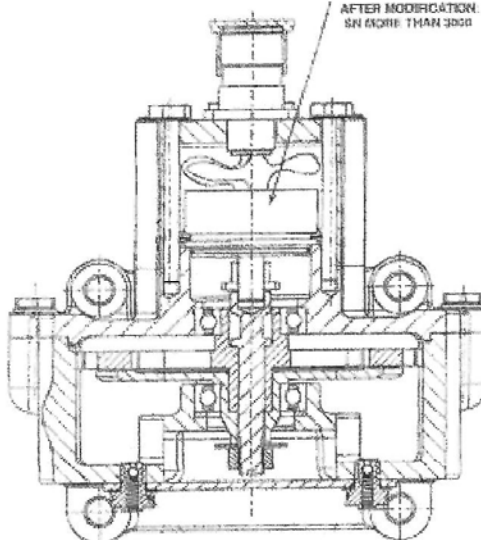
Feedback Unit Potentiometer/
Figure 2

* POTENTIOMETER PN 8070B6022-01
BEFORE MODIFICATION:
SN LESS THAN OR EQUAL TO 3000

AFTER MODIFICATION:
SN MORE THAN 3000

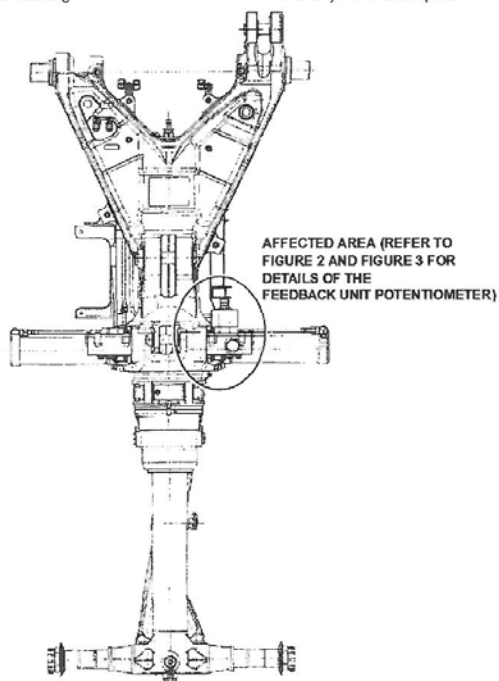
F. Approval

AFFECTED AREA (REFER TO
 FIGURE 2 AND FIGURE 3 FOR
 DETAILS OF THE
 FEEDBACK UNIT POTENTIOMETER)

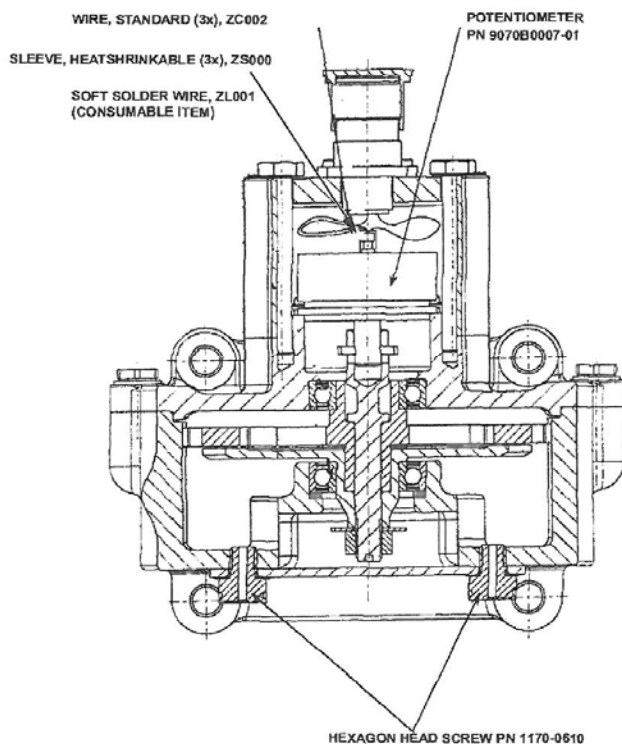
Feedback Unit Potentiometer PN 1170A1800-01 Before Modification
Figure 2

FEEDBACK UNIT POTENTIOMETER PN 1170A1800-01

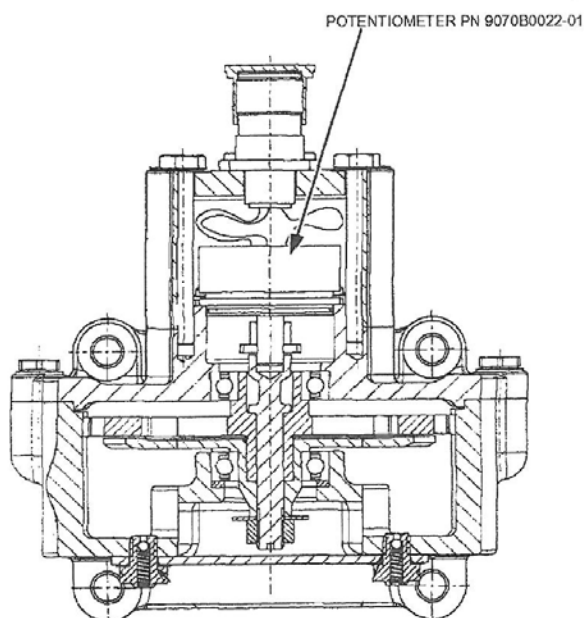
Feedback Unit Potentiometer PN 1170A3500-01 Before Modification
Figure 3

BEFORE MODIFICATION
FEEDBACK UNIT POTENTIOMETER PN 1170A3500-01

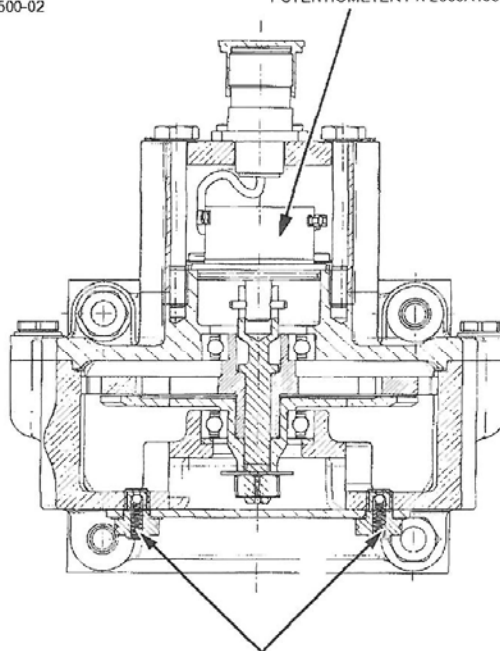
Feedback Unit Potentiometer PN 1170A3500-02 After Modification
 Figure 4

AFTER MODIFICATION
 FEEDBACK UNIT POTENTIOMETER
 PN 1170A3500-02

POTENTIOMETER PN 2000A1067K01

PRESSURE RELIEF VALVE PN 9049A0022-01
