Report N° AET/TM-2016/01

**Fatal accident on board *Juan Sebastian de Elcano*
on 3 November 2014**

Administration des enquêtes techniques (AET)

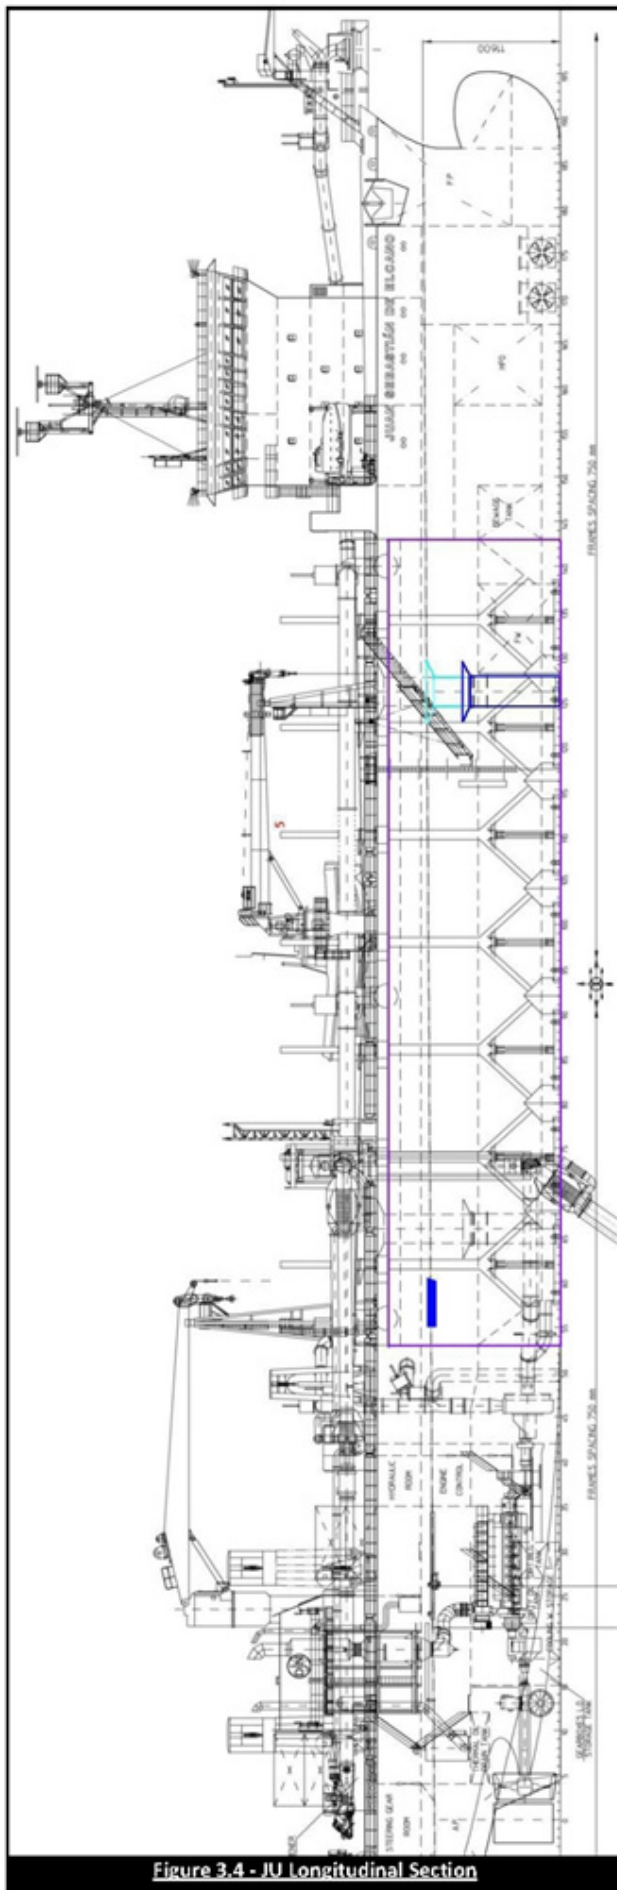
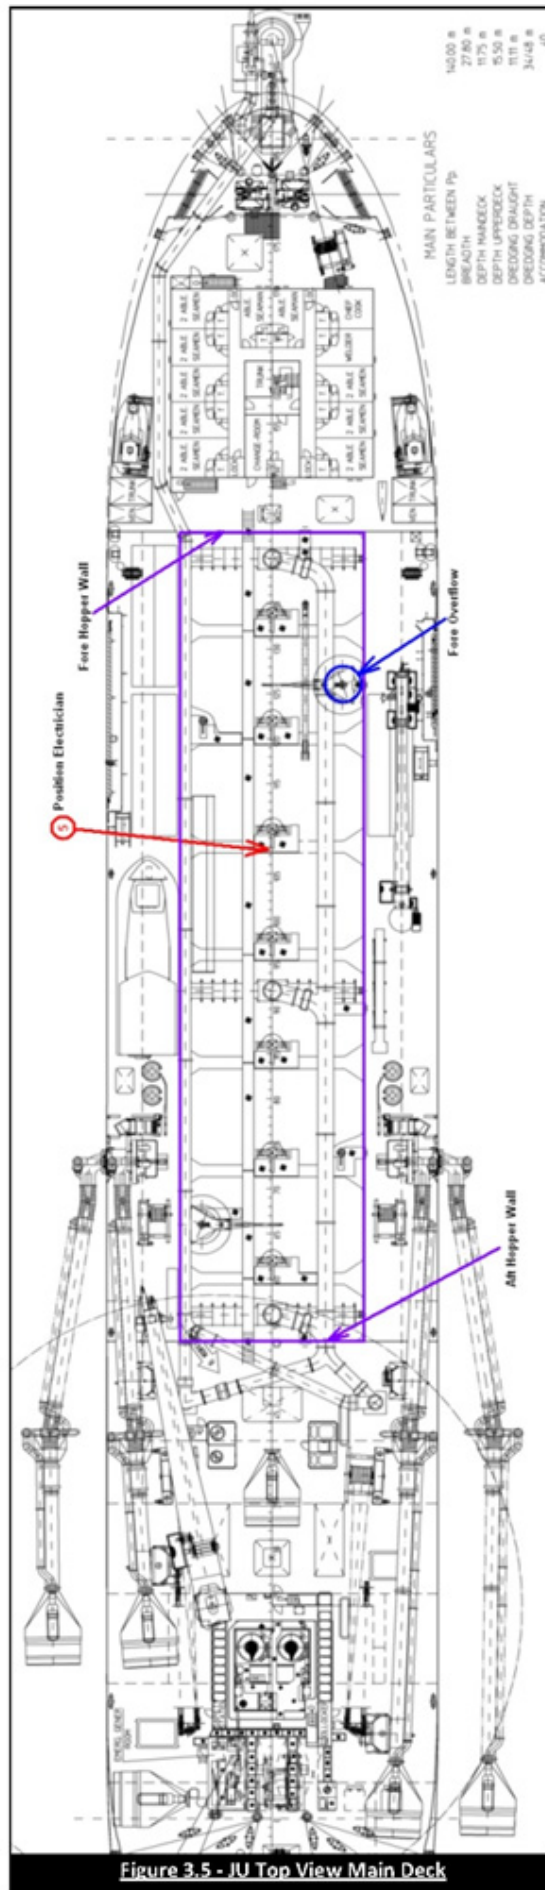
(Source: Operator)

Both Pipe Operators assigned to the task boarded the boat taking along two paddles, a small grinder (on batteries), the thickness measurement device (Pocket Mike), some cleaning product, a radio and two small bottles of water. They did not wear a life jacket. They started their measurements at the fore (upper) hopper wall, then paddled back to the aft for further measurements.

At around 11:05 AM, when the thickness measurements at the upper aft were completed, the 2nd Pipe Operator (day shift) called the Chief Officer Day over the radio with a request to lower the overflow to the next position. At that time the Chief Officer Day had visual contact with the boat and the crew. He followed the request and started to lower the overflow.
