# **Final Report No. 2384**

## **by the Swiss Transportation Safety Investigation Board STSB**

concerning the serious incident involving  
the aircraft PA-28-181, LX-AVA,

on 19 July 2020

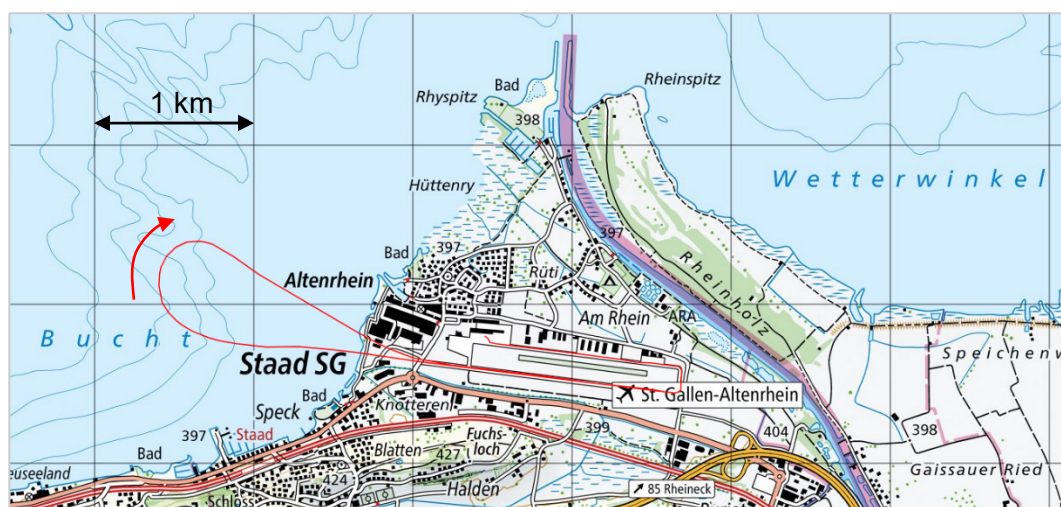
After the preflight check, the pilot started the engine and performed the run up without any abnormalities. Also during the take-off run on runway 28, the two occupants did not detect any abnormalities based on the on-board instrument readings. The LX-AVA took off at 18:25 hrs at around 60 KIAS<sup>2</sup>. After accelerating to 85 KIAS and about one minute after takeoff, at an altitude of 1550 ft QNH<sup>3</sup>, about 250 ft above the lake, a noticeable loss of power associated with engine stuttering occurred. Although the pilot immediately leveled off the aircraft, the speed rapidly decreased to 68 KIAS (see figure 1).

**Figure 1:** Flight path of LX-AVA (red line) after take-off from St. Gallen-Altenrhein (LSZR) on runway 28, followed by a reversal turn and subsequent landing on runway 10. Source of map: Federal Office of Topography.
