## Accident to the Pilatus – PC-12 - 47E registered LX-JFD

on 30 March 2020

on approach to Nice-Côte-d'Azur airport (Alpes-Maritimes)

## In-flight lightning strike, structural damage observed on ground

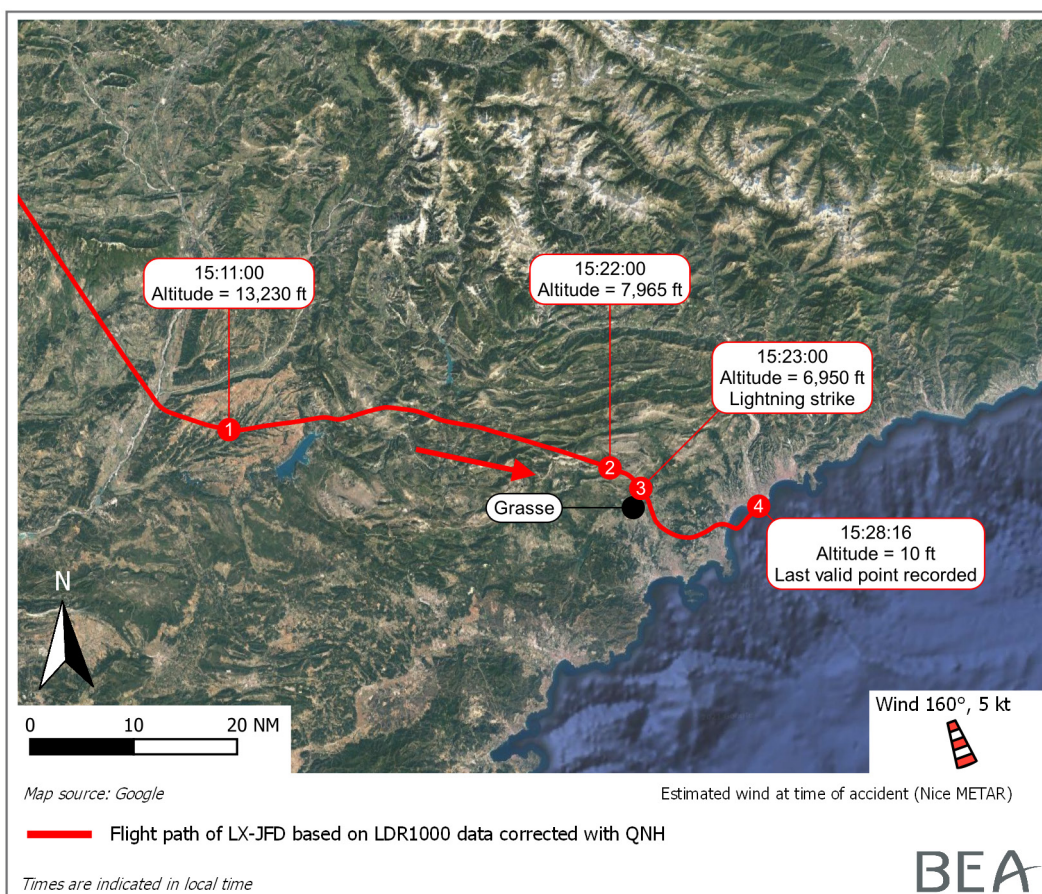
Figure 1: LX-JFD's flight path

At 15:11 (see [Figure 1](#), point ❶), the crew asked the Nice controller if they could change heading as required for avoidance purposes<sup>(3)</sup>. The controller replied that they could change heading at their discretion.

At 15:22 (see Figure 1, point ②), the crew descended to FL 060 and changed their heading by 30° to the right for a heading of 160° for avoidance purposes.

At 15:23 (see Figure 1, point ③), the crew told the controller that they were in good conditions. When descending through FL 60 and at this point in calmer conditions, there being no turbulence, they saw a brief flash of lightning and heard a loud bang. The crew reported that a few seconds later they were outside the clouds. The propeller and engine parameters remained normal and there was no evidence to suggest that the aircraft's operation was impaired. Nevertheless, the crew decided to land at Nice as quickly as possible.

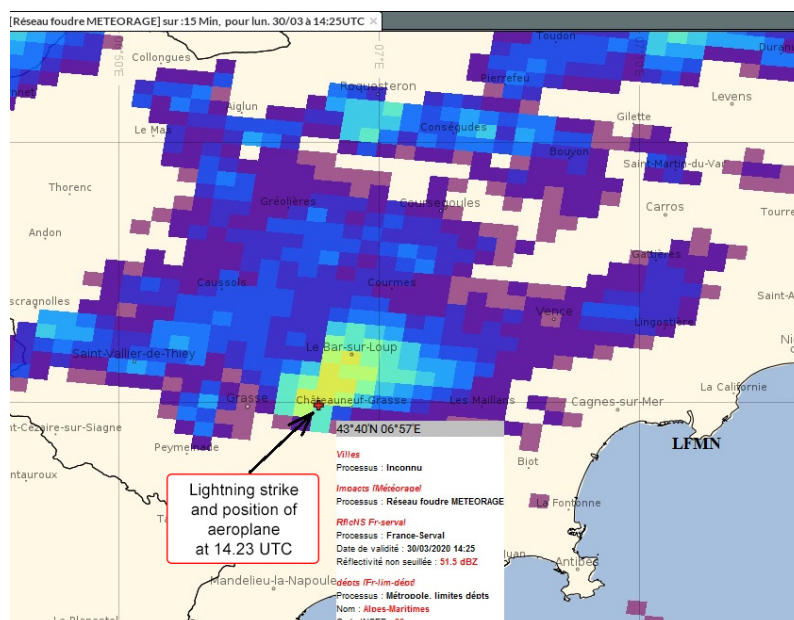
Figure 4: Radar image of precipitations at 15:25

The image shows a calculated reflectivity in the area of the heaviest precipitations (yellow pixels) which suggests hail. Generally speaking, turbulence is strong under, in and around such Cumulonimbus. However, the accuracy of the (Météo-France) weather radar means that it is not possible to have more information about the strength of small-scale turbulence.

At 15:23, the position of the lightning strike (red cross on Figure 4) was consistent with that of the plane.
