EMERGENCY LANDING OF A CESSNA C177 NEAR STEGEN (L) ON 18 JANUARY 2015

DATE OF ISSUE: 14 DECEMBER 2018

Report N° AET/AC-2018/02

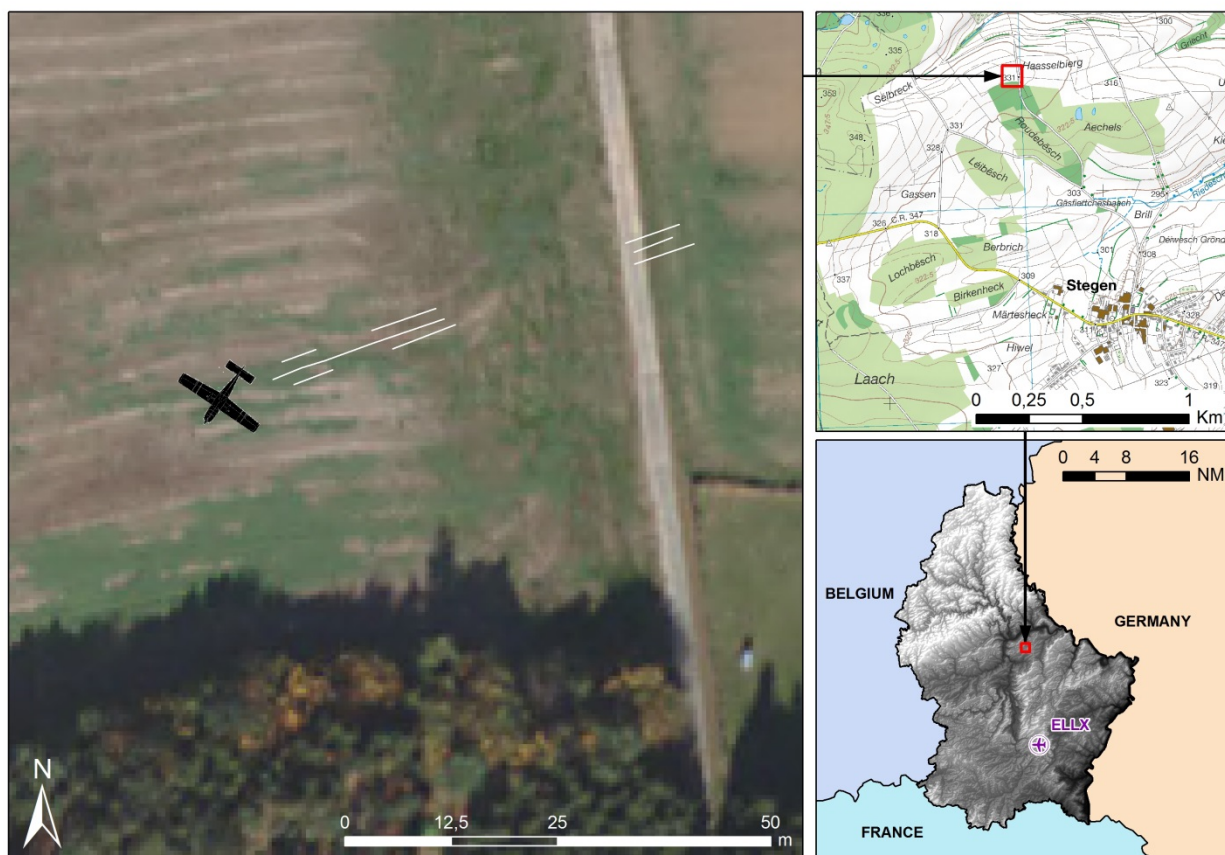
During the landing sequence, the aircraft suffered damage to the rear fuselage structure, the propeller, the nose and main landing gear, the right wing and the rear back window. All three occupants left the aircraft uninjured.
