**SERIOUS INCIDENT**

<b>Aircraft Type and Registration:</b>	Bombardier Global 6000, LX-NST	
<b>No &amp; Type of Engines:</b>	2 Rolls Royce BR700 engines	
<b>Year of Manufacture:</b>	2017 (Serial no: 9814)	
<b>Date &amp; Time (UTC):</b>	7 April 2022 at 1625 hrs	
<b>Location:</b>	London Luton Airport	
<b>Type of Flight:</b>	Commercial	
<b>Persons on Board:</b>	Crew - 2	Passengers - None
<b>Injuries:</b>	Crew - None	Passengers - N/A
<b>Nature of Damage:</b>	Damage to right wing tip, flap fairing, leading edge slat and aileron	
<b>Commander's Licence:</b>	Airline Transport Pilot's Licence	
<b>Commander's Age:</b>	51 years	
<b>Commander's Flying Experience:</b>	7,200 hours (of which 1,350 were on type) Last 90 days - 34 hours Last 28 days - 0 hours	
<b>Information Source:</b>	AAIB Field Investigation

**Synopsis**

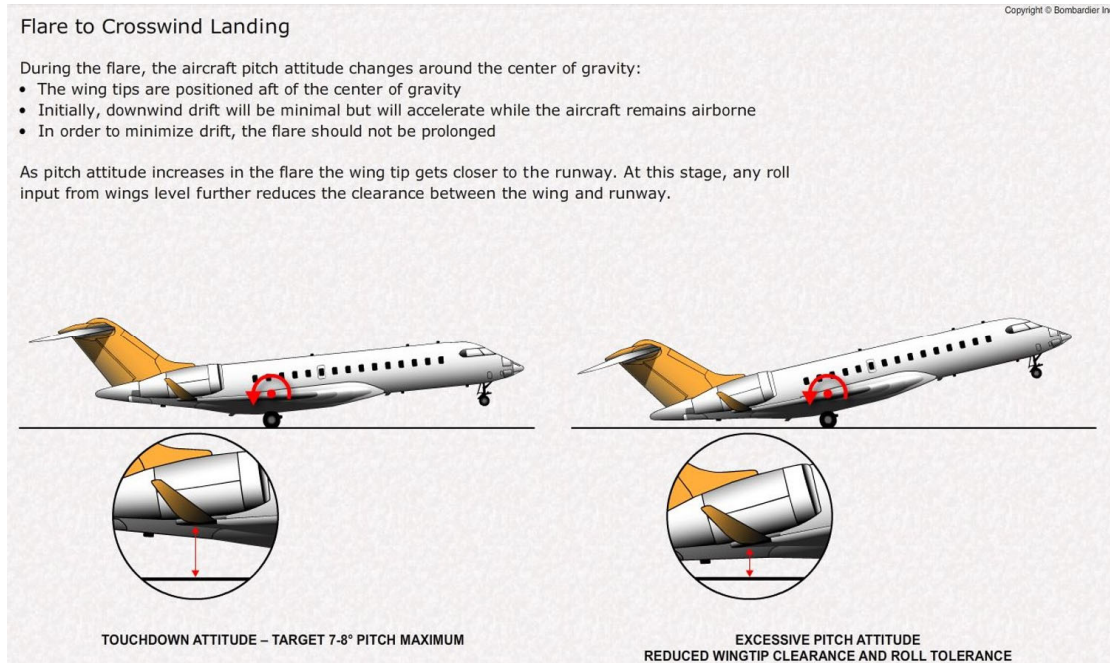
**Figure 5**

The Flight Crew Operations Manual (FCOM) for the aircraft type specifies that pilots are to use the wings-level crab technique until the flare for landing with the aircraft pointing into wind and tracking the extended centreline. The flare is commenced at approximately 30 ft agl when downwind rudder is applied to align the aircraft with the centreline. Opposite aileron is required to maintain wings-level with the aim to touch down as soon as the aircraft is aligned with the runway. The FCOM warns against extending the flare or delaying the touchdown as this usually results in an increasing pitch attitude reducing the wingtip clearance in bank (as shown in Figure 5). For gusty conditions the FCOM recommends a '*deliberate positiv touchdown*'.

Flare to crosswind landing
