FINAL REPORT

FATAL OCCUPATIONAL ACCIDENT ON BOARD OF THE VESSEL MV MEDI ZUOZ ON 4 APRIL 2019

Report N° AET/TM-2020/01

**Fatal occupational accident on board of the vessel MV Medi Zuoz
on 4 April 2019**

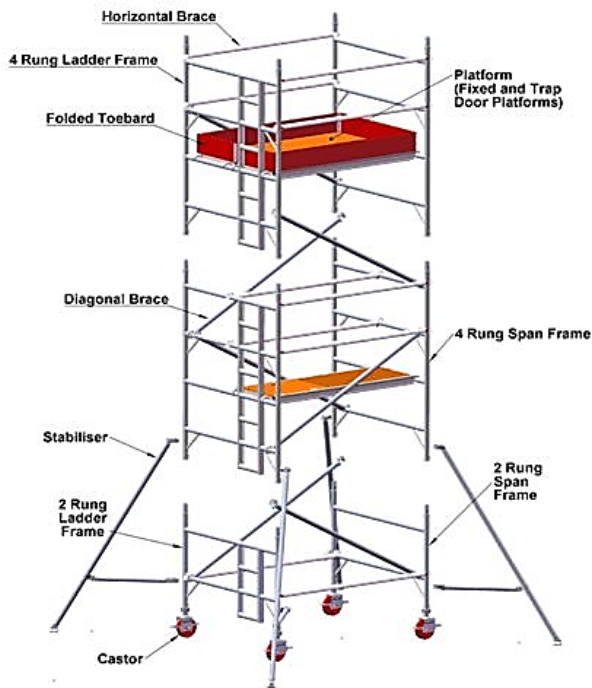
Figure 3.5 – Scaffolding tower
(Source: Ares scaffolding)

The two scaffolding towers used by the contractor to execute the cleaning of the cargo holds were common scaffolding towers as used on building sites ashore. After being assembled, the structural integrity and stability of the towers have to be checked and approved by the contractor performing the assembly. After each change of location, the scaffolding tower is required to be checked again for stability by trained, so called competent personnel.

At the accident scene, one of the two fibre ropes was found to be broken and the scaffolding tower in hold number 4 was hooked to one rope only (connected to two corners of the top 'lift' of the tower). This resulted in an unstable configuration during lifting.
