Report on the collision between  
fv Z.575 – HEIN SENIOR and mv ACEROMAR  
on August 3<sup>rd</sup> 2020

in the traffic separation scheme Terschelling - German Bight  
near Schiermonnikoog  
with material and structural damage to the vessels.

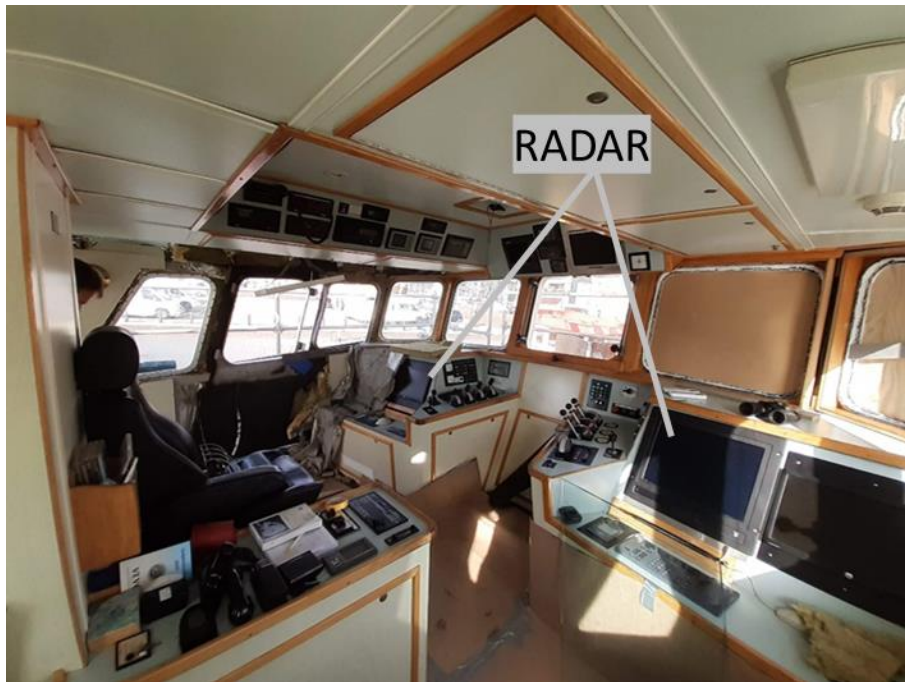
Figure 3 - Position of helmsman chair in the back of the wheelhouse

The watchkeeper was sitting in the helmsman chair located in the back of the wheelhouse and had the autopilot switched on. Figure 3 shows where the helmsman chair was located.

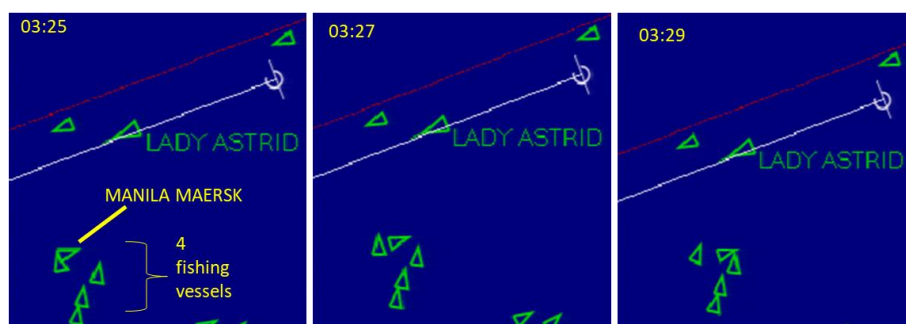
Figure 5 - Radar observation of four fishing vessels crossing the heading of the mv MANILA MAERSK

Around 03:27 hours the first fishing vessel, Z.41-ALBERT BOS, started to cross the heading of the mv MANILA MAERSK, sailing in the inbound lane from the Atlantic Ocean. The officer of watch noticed that two fishing vessels altered course to cross the heading of the mv MANILA MAERSK with, from his point of view, an apparent small CPA as observed on his radar screen.

Mv ACEROMAR is represented by the white circle in the upper right corner in this figure. The radar was set to a range of 24nm, North up.

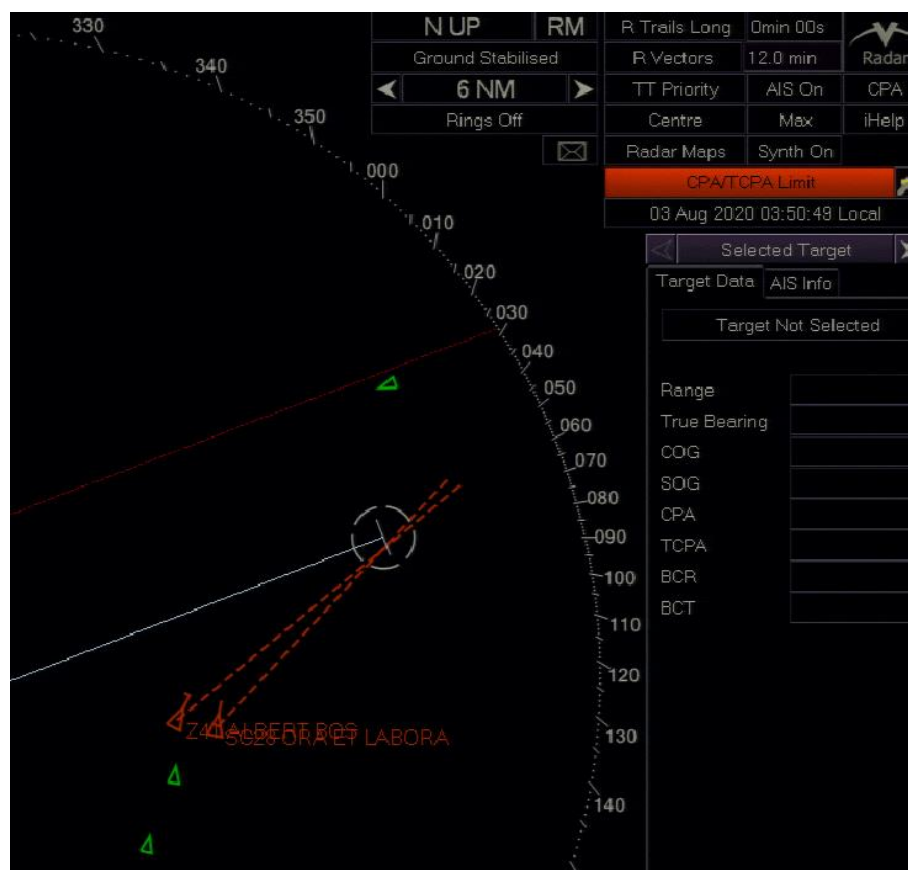
Figure 6 - CPA/TCPA limit alarm on radar on board mv ACEROMAR

At 03:50 hours, the officer of watch on board mv ACEROMAR had set the radar to a 6nm range and the radar indicated two *CPA/TCPA limit* alarms<sup>3</sup>, one from fv Z.41-ALBERT BOS and one from fv SC.28-ORA ET LABORA, as indicated in Figure 6.

At 03:51 hours, a third alarm, from fv Z.575-HEIN SENIOR also appeared on the screen.

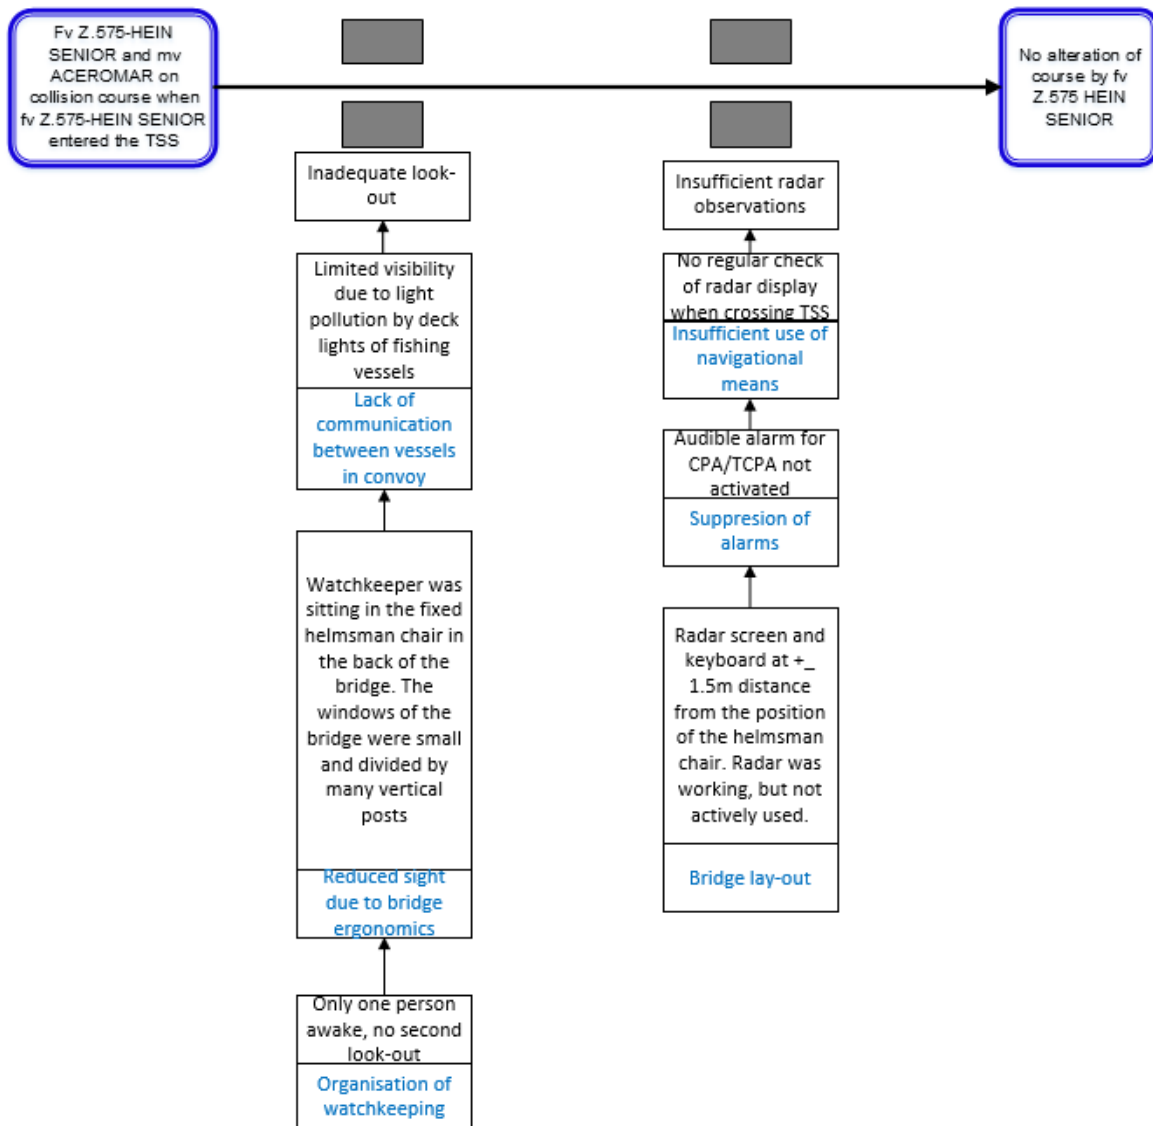
No alteration of course made by fv Z.575 HEIN SENIOR

<b>Incident Barrier Failed</b>	<b>Performance / RC categories</b>	<b>Barrier Challenge / Causes</b>	<b>Remarks regarding performance</b>
Inadequate Lookout	BFA Primary Causes	Lack of communication between vessels in convoy	Limited visibility due to light pollution by deck lights of fishing vessels
	BFA Secondary Causes	Reduced sight due to wheelhouse ergonomics.	Watchkeeper was sitting in the fixed helmsman chair in the back of the wheelhouse. The windows of the wheelhouse were small, divided by many vertical posts.
	BFA Tertiary Causes	Organisation of watchkeeping	Only one person awake, no second lookout
<b>Incident Barrier Failed</b>	<b>Performance / RC categories</b>	<b>Barrier Challenge / Causes</b>	<b>Remarks regarding performance</b>
Insufficient radar observations	BFA Primary Causes	Insufficient use of navigational means	No regular check of radar screen when crossing TSS
	BFA Secondary Causes	Suppression of alarms	Audible alarms for CPA/TCPA not activated

BFA Tertiary Causes	Wheelhouse lay-out	Radar screen and keyboard at +-1.5m distance from position of chair where lookout was sitting. Radar was working, but not actively used

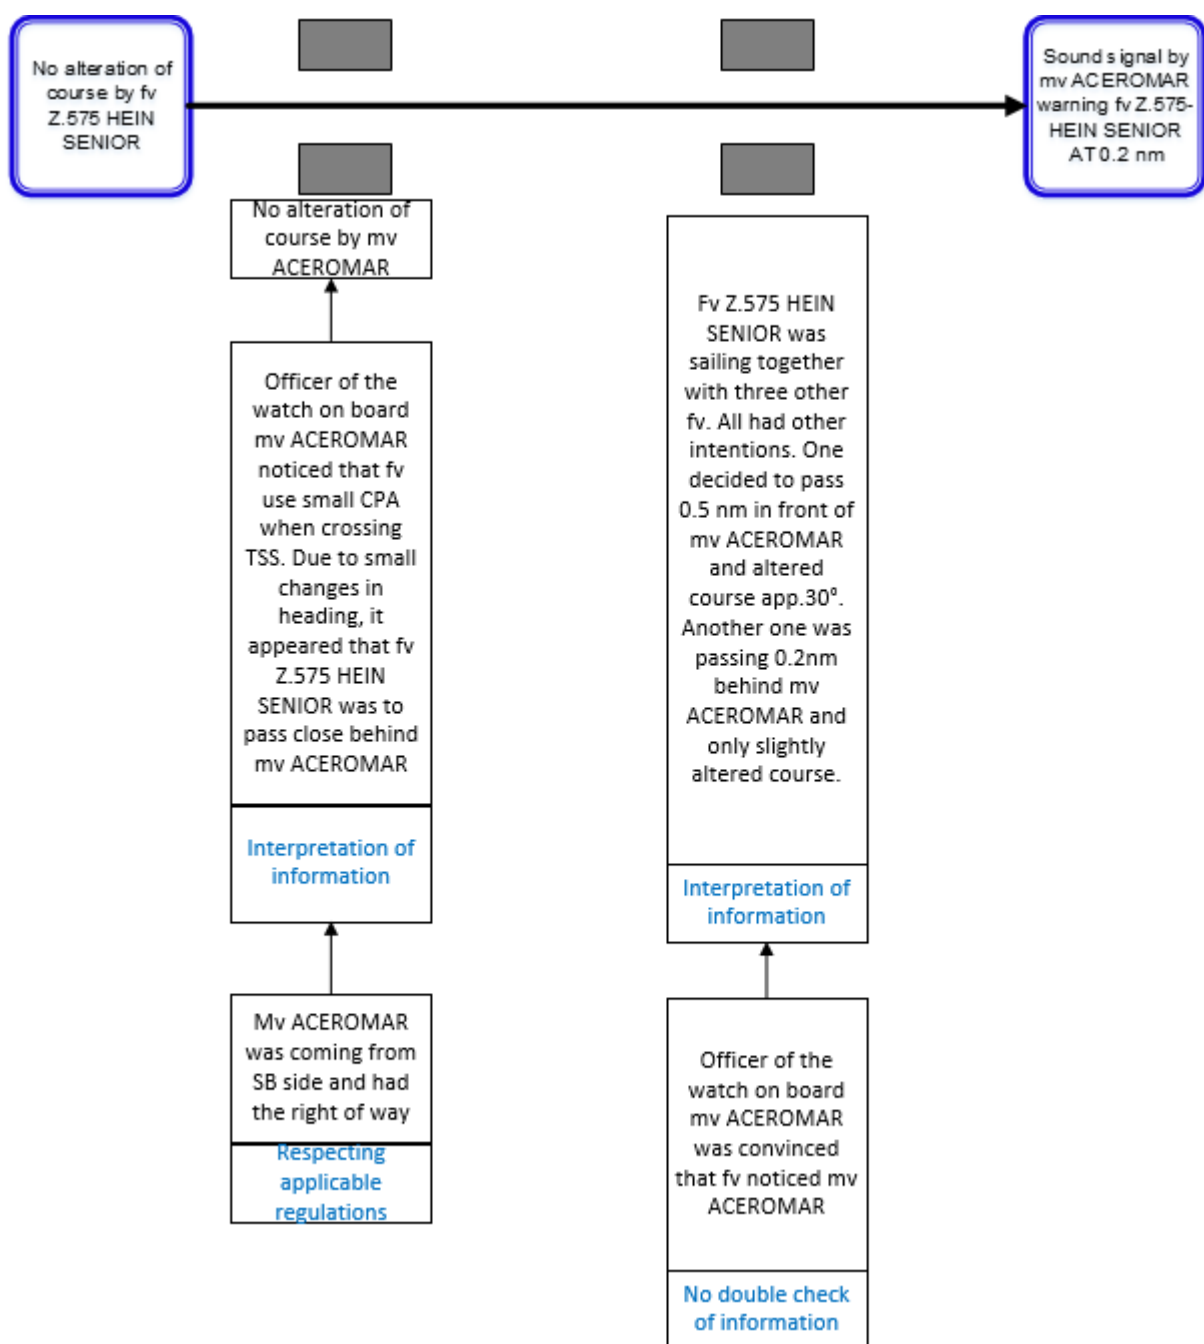
Sound signal by mv ACEROMAR to warn fv Z.575 HEIN SENIOR at 0.2nm

<b>Incident Barrier Failed</b>	<b>Performance / RC categories</b>	<b>Barrier Challenge / Causes</b>	<b>Remarks regarding performance</b>
No alteration of course made by mv ACEROMAR	BFA Primary Causes	Interpretation of information	Officer of the watch noticed that fishing vessels apply small CPA when crossing vessels. Due to small changes in heading, it looked like fv Z.575 HEIN SENIOR was to pass at close CPA behind mv ACEROMAR
	BFA Secondary Causes	Regulations do not encourage to initiate action	mv ACEROMAR was coming from SB side and had right of way, so watchkeeper had not the intention to take action early
<b>Incident Barrier Failed</b>	<b>Performance / RC categories</b>	<b>Barrier Challenge / Causes</b>	<b>Remarks regarding performance</b>
No VHF communication	BFA Primary Causes	Interpretation of information	Fv Z.575-HEIN SENIOR was sailing with 3 other fishing vessels, all had other intentions; One decided to cross 0,5 nm in front of mv ACEROMAR and made a wide alteration in course ( $>30^{\circ}$ ), another one was passing at 0.2nm behind mv ACEROMAR and made a small alteration in course ( $< 10^{\circ}$ ).

BFA Secondary Causes	No double check of information	Officer of the watch on board mv ACEROMAR was convinced that fishing vessels noticed mv ACEROMAR

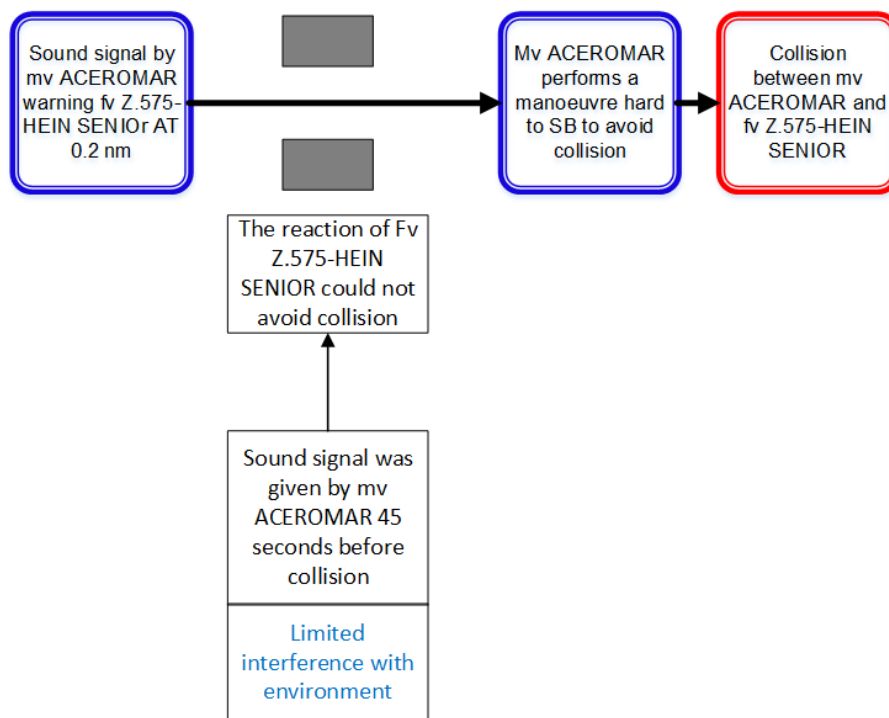
mv ACEROMAR makes an emergency manoeuvre, hard to SB to avoid collision

Incident Barrier Unreliable	Performance / RC categories	Barrier Challenge / Causes	Remarks regarding performance
The reaction of Fv. Z.575-HEIN SENIOR could not avoid collision	BFA Primary Causes	Limited interference with environment	Sound signal was given 45 sec before collision

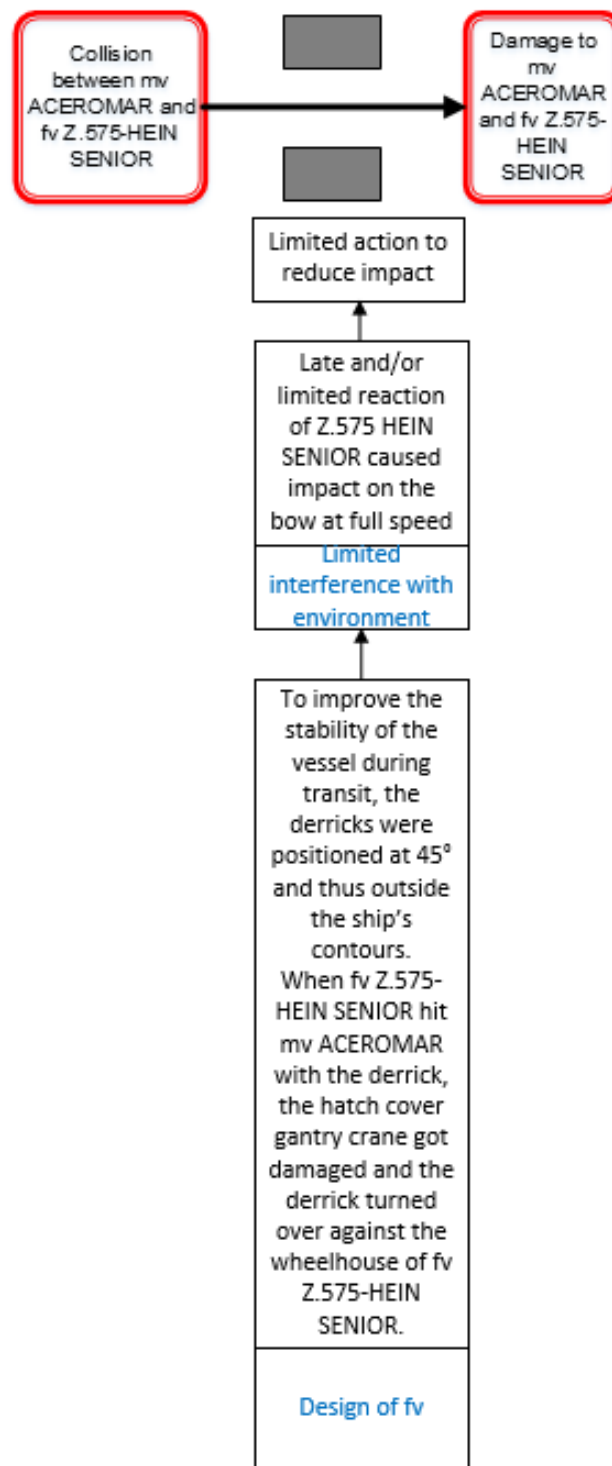
Sound signal by mv ACEROMAR to warn fv Z.575 HEIN SENIOR at 0.2nm

<b>Incident Barrier Failed</b>	<b>Performance / RC categories</b>	<b>Barrier Challenge / Causes</b>	<b>Remarks regarding performance</b>
Limited action to reduce impact	BFA Primary Causes	Limited interference with environment	Late and/or limited reaction of fv Z.575 HEIN SENIOR caused impact on the bow at full speed
	BFA Secondary Causes	Design of vessel	To improve the stability of fv Z.575-HEIN SENIOR during sailing, derricks were placed at 45° and outside ship's contours. When fv Z.575-HEIN SENIOR hit mv ACEROMAR with the derrick, the hatch cover gantry crane got damaged and the derrick turned over against the wheelhouse of fv Z.575 HEIN SENIOR.

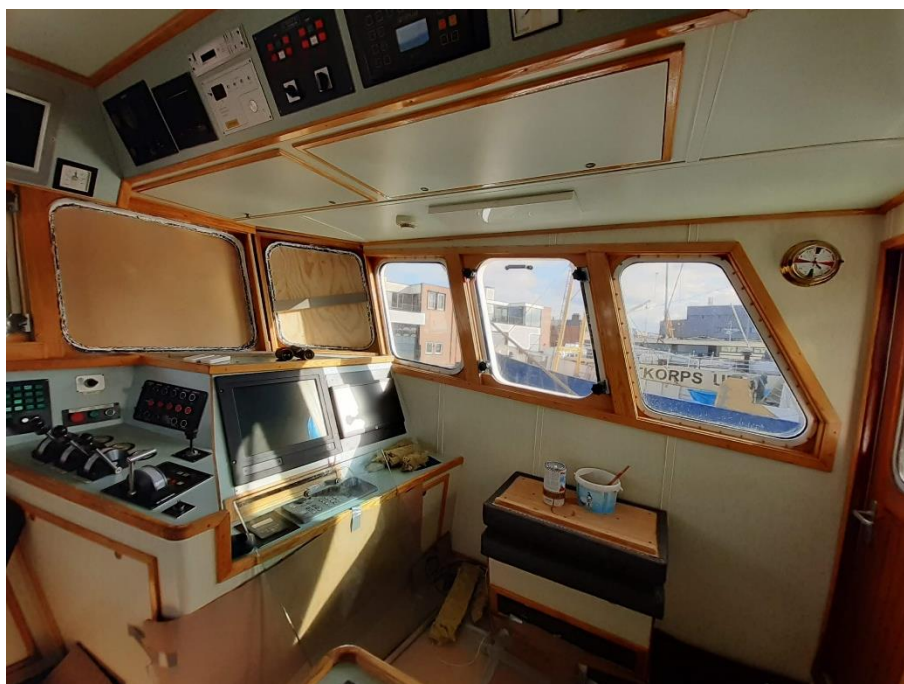
*Figure 21 - SB view from helmsman chair*

Figure 20 and Figure 21 give an indication of the outside view when sitting in the helmsman chair.

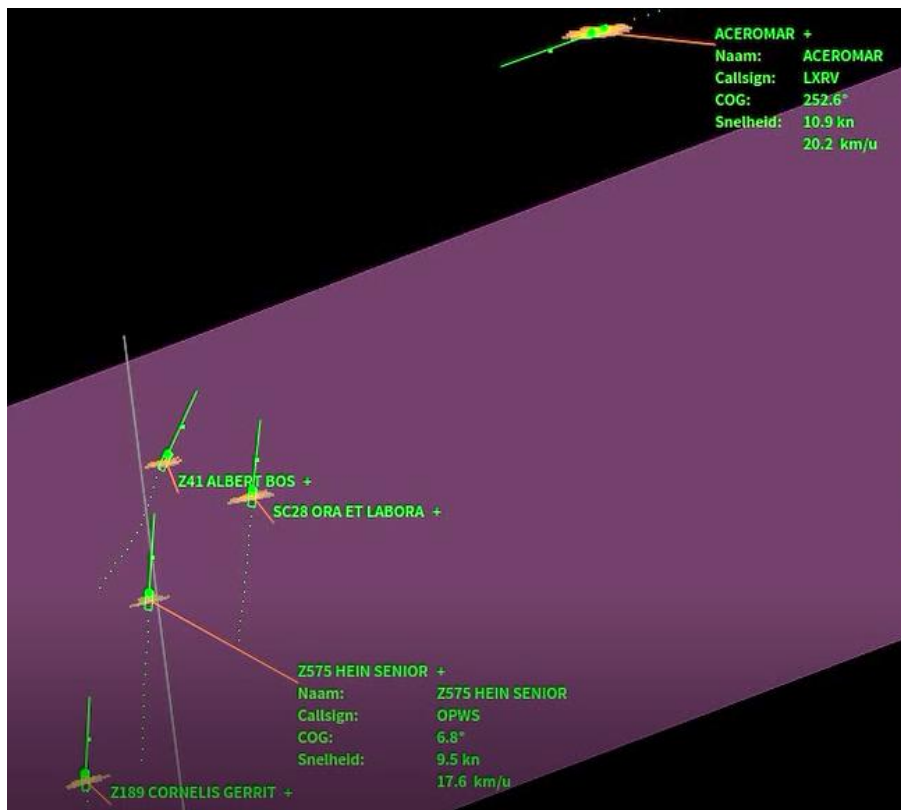
Figure 22 - Position of fishing vessels at 03:52 hours

Fv Z.575-HEIN SENIOR was not sailing alone. Three other fishing vessels were sailing in the same direction, at distances of approximately 0.6 nm.

Figure 22 gives a radar overview at 03:52 hours when the fishing vessels were in the traffic separation zone, in the middle of the TSS.

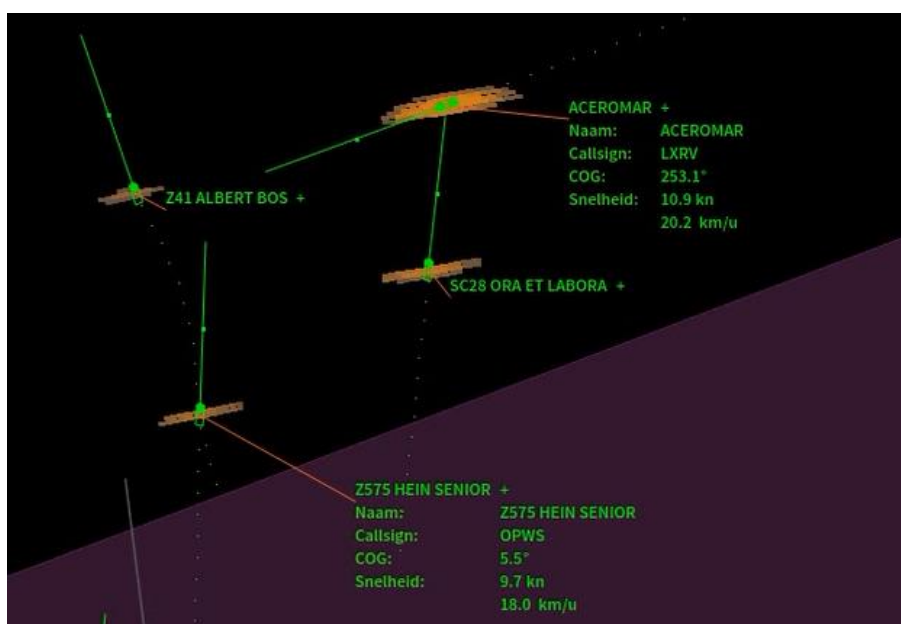
Figure 24 – Radar positions at 03:59 hours

Figure 24 shows the traffic situation at 03:59 hours. At that moment, there is a difference in bearing of approximately 030° between both fishing vessels.

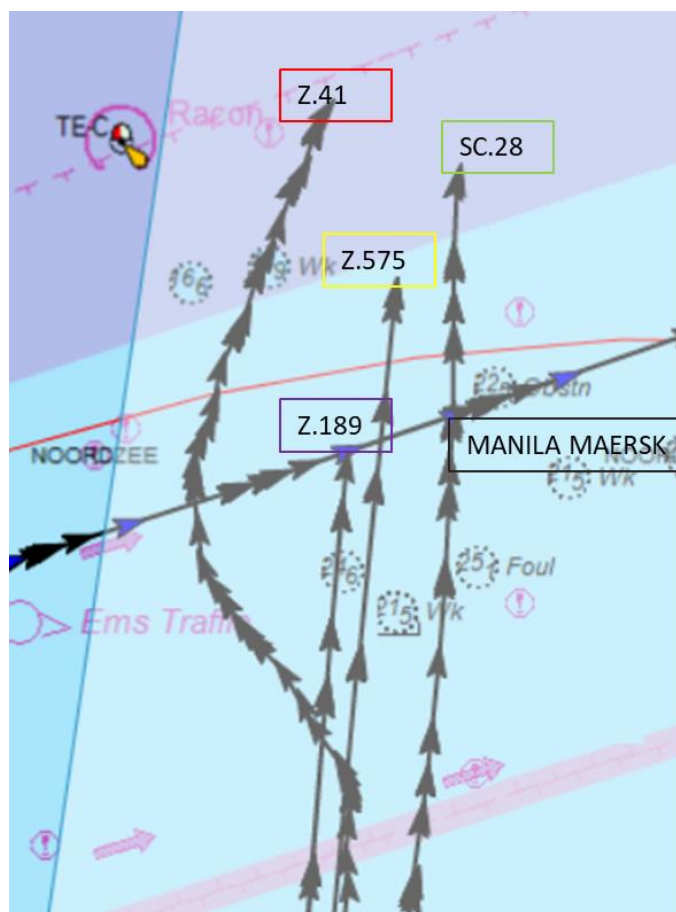
Figure 26 - Fishing vessels crossed mv MANILA MAERSK

Figure 26 shows the tracks of the fishing vessels that crossed the track of the mv MANILA MAERSK.

After crossing mv MANILA MAERSK, around 03:43 hours, fv SC.28-ORA ET LABORA altered her course approximately 010° to SB and subsequently altered her course back to PS in order to pass behind mv ACEROMAR at a distance of 0.2nm.

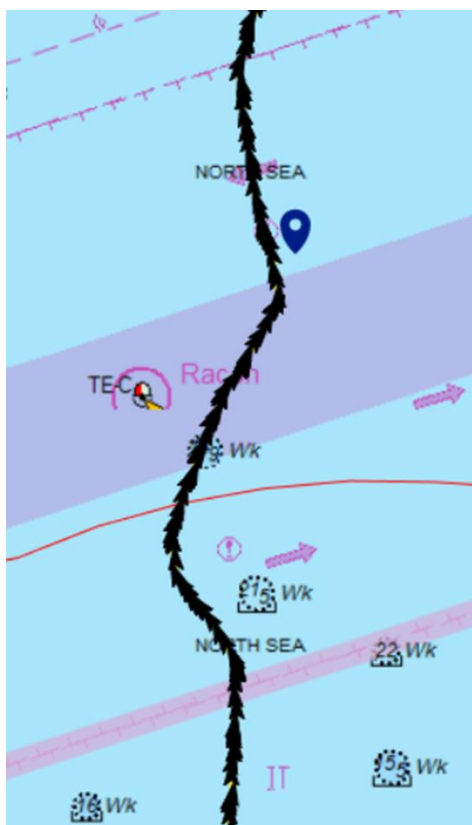
Figure 27 - Track of fv Z.41-ALBERT BOS

Figure 27 shows how fv Z.41-ALBERT BOS clearly showed her intentions by altering course.

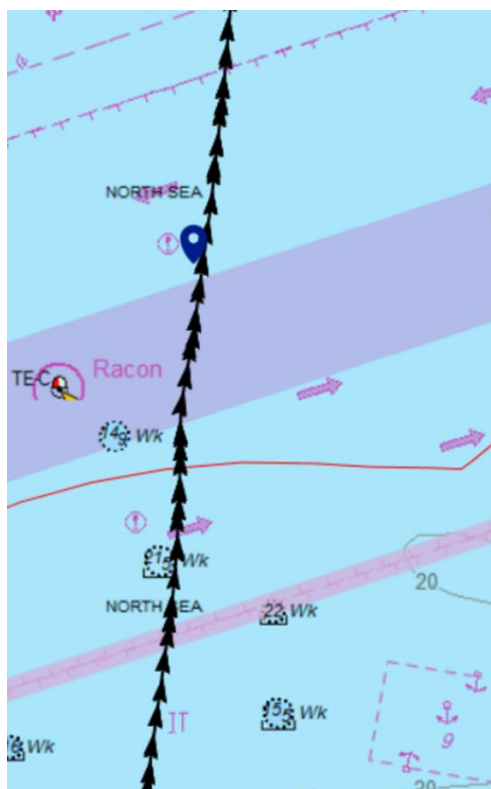
Figure 28 - Track of fv SC.28-ORA ET LABORA

Figure 28 shows the small course alterations made by fv SC.28-ORA ET LABORA and Figure 29 shows the track of fv Z.575-HEIN SENIOR.

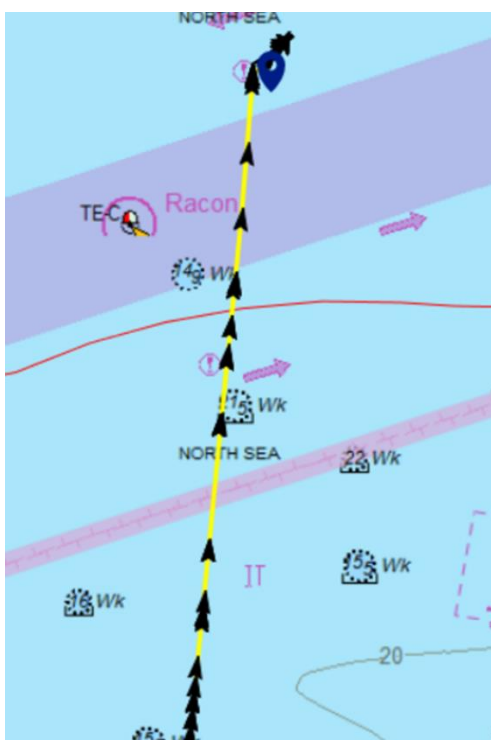
Figure 29 - Track of fv Z.575-HEIN SENIOR

The track of fv Z.575 HEIN SENIOR was straight , since she did not alter course during the passage of the TSS.
