FINAL REPORT

FATAL ACCIDENT ON BOARD *IBN BATTUTA* ON 29 SEPTEMBER 2011

Report N° AET/TM-2018/01

**Fatal accident on board *IBN Battuta*
on 29 September 2011**

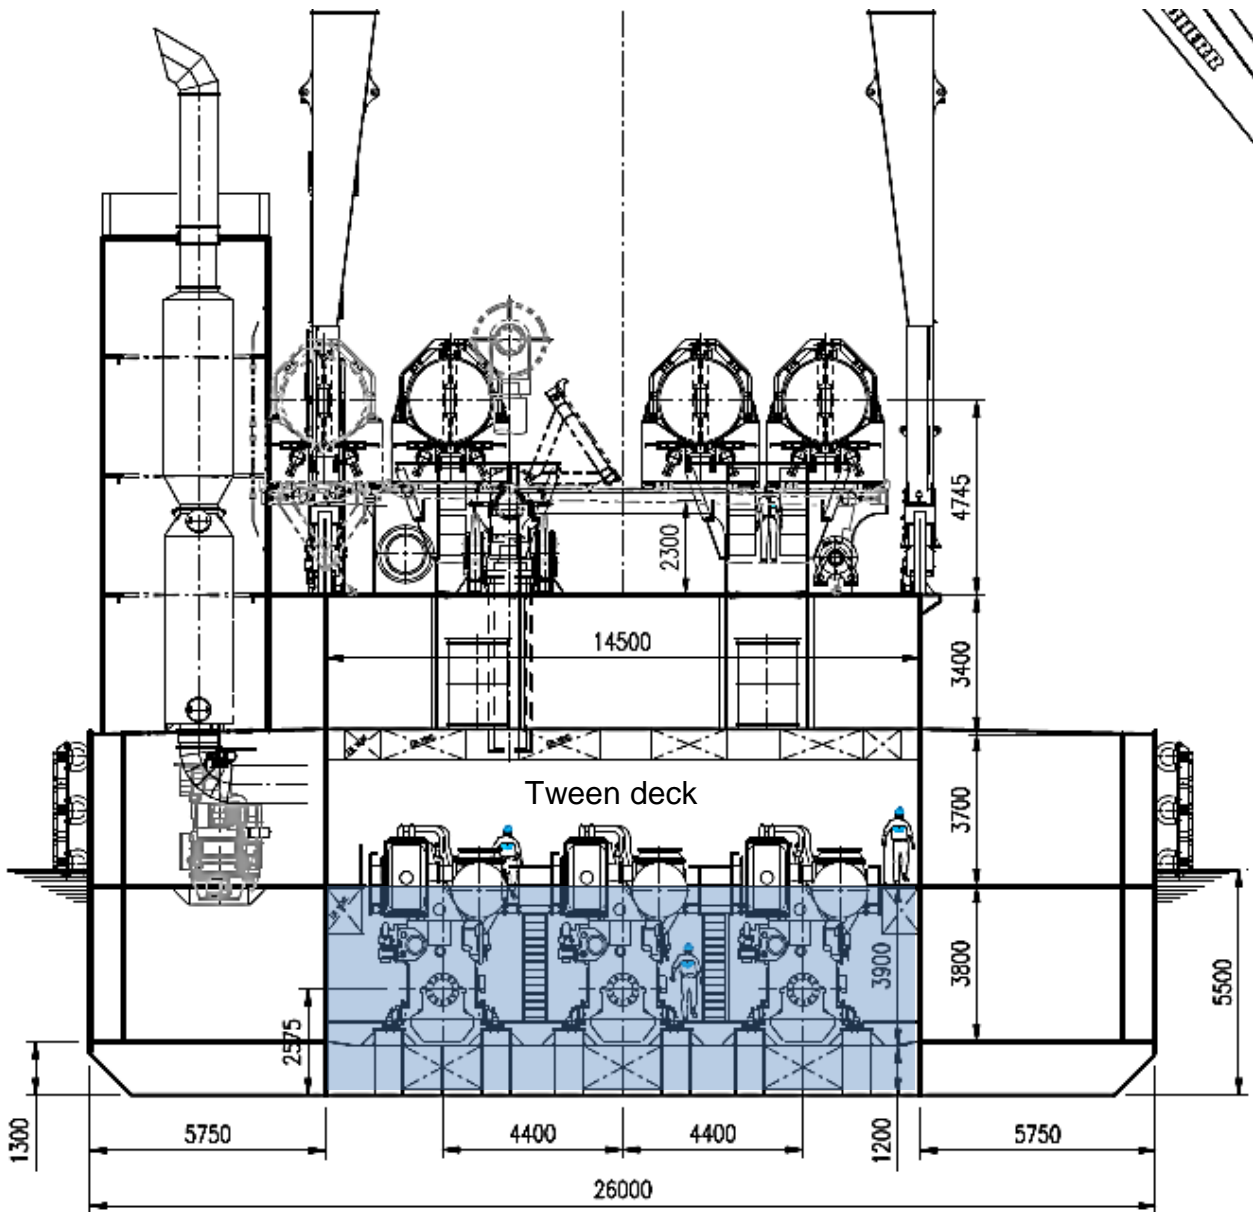
Figure 3.1 – Cut plane of IBN Battuta
(Source: Operator)

The Apprentice Dredge Operator's last known working location was in the pump room where he was painting. The pump room is below the starboard barge loading system located on the deck below the tween deck.

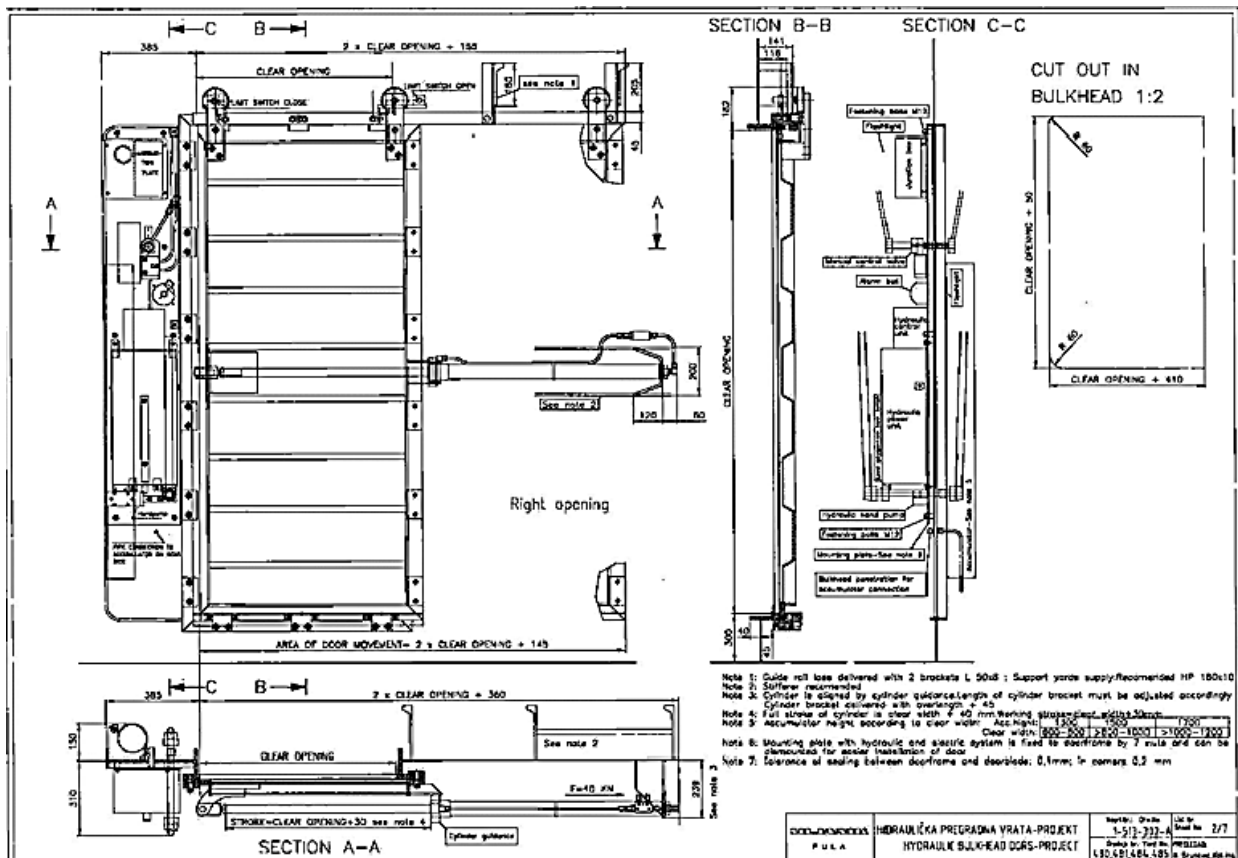
Figure 3.4 – Scheme of a watertight door
(Source: Operator)

The 4 power operated sliding watertight doors on board IBN Battuta, manufactured by the German company “Schoenrock Hydraulik Marine Systeme GmbH”, have a clear opening of 80 x 180 centimetres.

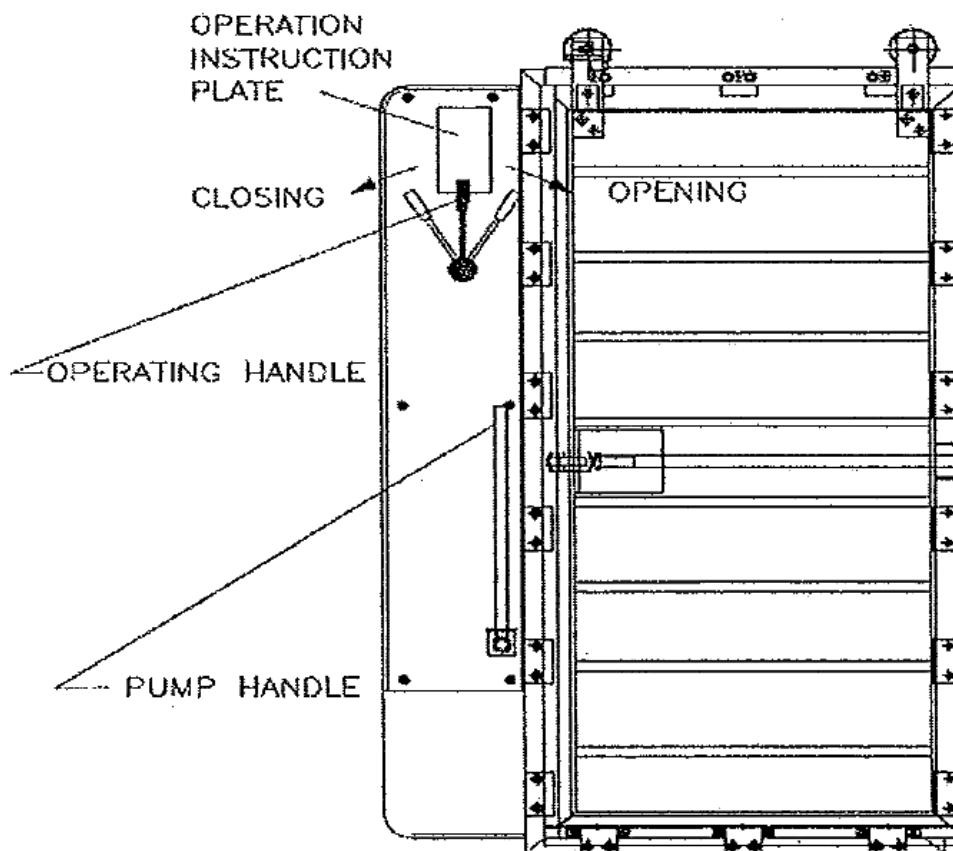
Figure 3.5 – Description of a WTD
(Source: Schoenrock Hydraulik Marine Systeme GmbH)

Moving the control handle to 'open' position triggers the limit switch, cutting the power to the solenoid valve and activating the mechanical valve. Hydraulic pressure will be applied to the cylinder to open the door. The door stops moving when the control handle is released to neutral position.

Moving the control handle to 'closing' position also triggers the limit switch, the power to the solenoid will be cut and the door closes.
