FATAL ACCIDENT ON BOARD <u>IBN BATTUTA</u> ON 29 SEPTEMBER 2011

DATE OF ISSUE: 2 Mai 2018

Administration of Technical Investigations

Report N° AET/TM-2018/01

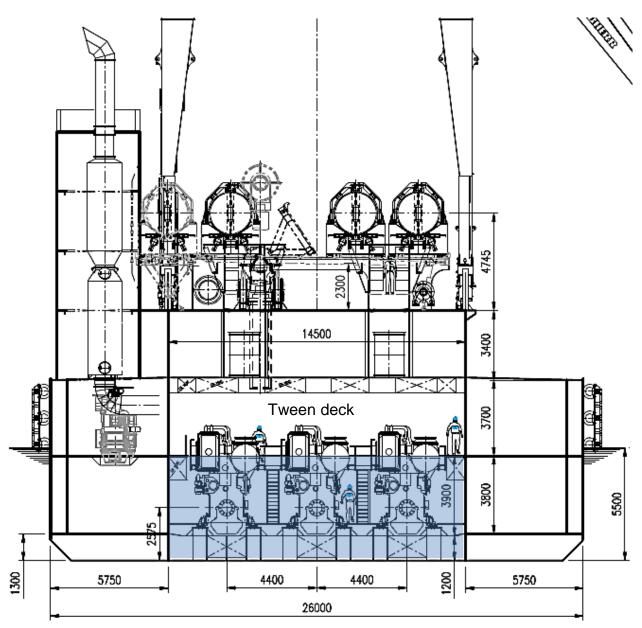
The Apprentice Dredge Operator's last known working location was in the pump room where he was painting. The pump room is below the starboard barge loading system located on the deck below the tween deck.

According to the Voyage Data Recorder (VDR) logs, at 10:04:11 AM, the control handle of WTD 3 (door between the pump room and the engine room) was moved to 'open' position. The VDR logs show that WTD 3 was not fully opened during that operation, as the proximity switch 'Door fully open' has not been triggered.

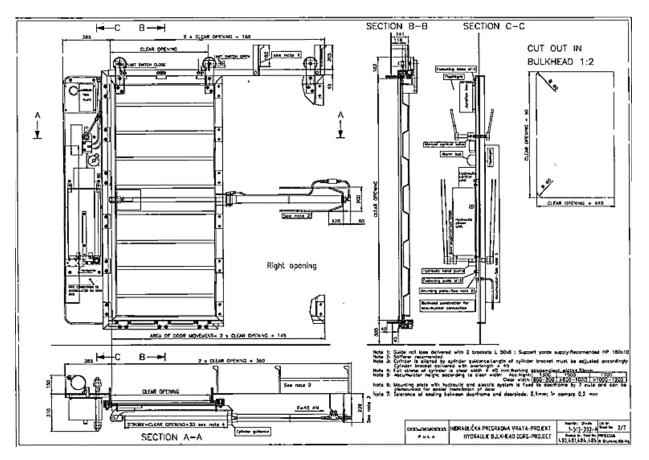
Figure 3.4 – Scheme of a watertight door (Source: Operator)

The 4 power operated sliding watertight doors on board IBN Battuta, manufactured by the German company "Schoenrock Hydraulik Marine Systeme GmbH", have a clear opening of 80 x 180 centimetres.

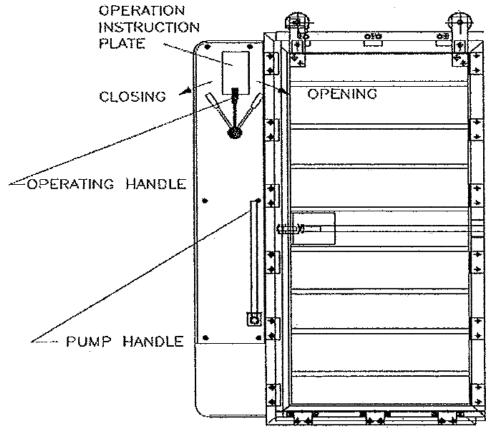
Figure 3.5 – Description of a WTD (Source: Schoenrock Hydraulik Marine Systeme GmbH)

Moving the control handle to 'open' position triggers the limit switch, cutting the power to the solenoid valve and activating the mechanical valve. Hydraulic pressure will be applied to the cylinder to open the door. The door stops moving when the control handle is released to neutral position.

Moving the control handle to 'closing' position also triggers the limit switch, the power to the solenoid will be cut and the door closes.

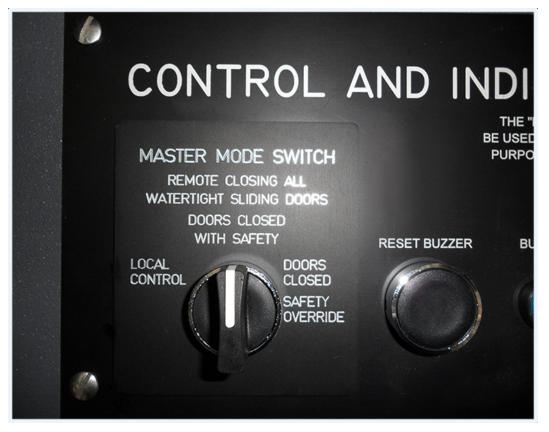
As an example, the manufacturer of the WTDs of the occurrence vessel has developed an anti-crush protection system which uses a laser beam sensor to detect obstacles in the doorway during power operated closure and to subsequently stop the remote operation of the door. In order to account for the added protection system, the manufacturer has implemented a 'Master Mode Switch' with 3 different modes on the control and indication panel (Figure 3.8):

- 'local control'
- 'doors closed with safety'
- 'doors closed safety override'

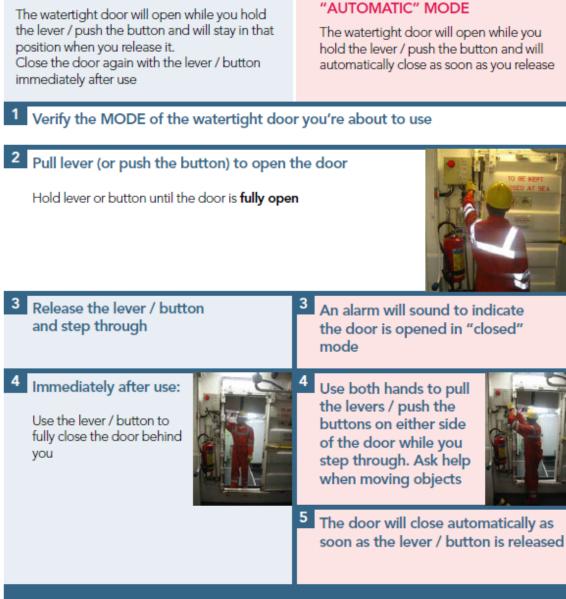
ALL WATERTIGHT DOORS ARE TO BE KEPT CLOSED AT SEA

"CLOSED" "REMOTE" OR

If it's moving: you don't step through!
